Service Bulletin

JANUARY 1957

NO. 320

Studebaker and Packard Clipper

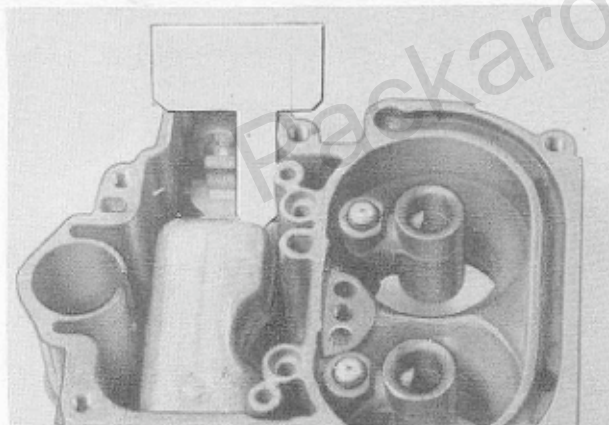
Fig. 1

When the engine is hot, it was found that gasoline foam was being ejected from the bowl vent tube into the air stream. This is caused by the float dropping on a left turn and allowing gas to enter the float chamber under temperatures at which the gas was boiling.

A new Air Horn Gasket, Part No. 1543362 has been designed in which the vent hole in the gasket is not in line with the bowl vent tube, also a Baffle, Part No. 1543363, (see Fig. 1) has been released to be installed in the bowl chamber between the float and float needle valve (see Fig. 2). This baffle restricts the surge of gas from one end of the bowl to the other.
