Service Bulletin

NO. 321

SOUTH BEND 27, INDIANA

Studebaker and Packard Clipper

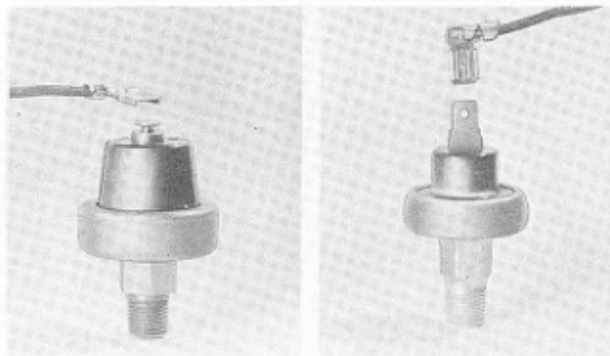
Two types of oil pressure signal switches are being used on the Studebaker and Packard Clipper sedan and station wagon models. Although there is a difference in the terminals of the two switches, the connector on the wire will fit both types. Fig. 1 illustrates the installation of the connector on both types of switches.

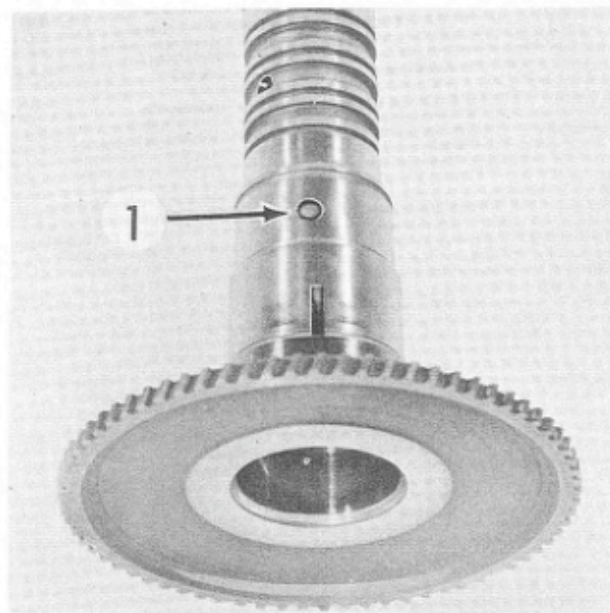
Fig. 3

Inability to secure rear clutch application or any automatic upshift despite the fact that the control pressure and all adjustments are normal, can be caused by shifting of the distributor tube in the output shaft. Shifting of the tube, depending on the direction, may obstruct or not confine the governor and clutch pressures to their respective passages. Furthermore, inspection of the governor, control and pressure valves, front and rear clutch operating parts, and all sealing rings may indicate that all these parts are normal.

1. No governor action, in which case the transmission would not upshift automatically.
2. Obstruct the rear clutch passage, in which case the transmission would not provide third gear or reverse.
3. Allow a common passage to supply pressure to both front and rear clutches simultaneously, in which case a locking (or partial locking) condition will exist in D, L, or R range.

1. Governor Drive Ball Pocket

The correct position of the tube within the output shaft can be determined as follows: With the output shaft out of the transmission locate the governor drive ball pocket in the shaft (see Fig. 3). Then, looking at the front of the output shaft assembly, locate the elongation of the oil passage in the center of the distributor tube (see Fig. 4). Using the governor drive ball pocket as a reference point, the elongated portion of the passage should be located 180° from (or relatively opposite) the governor drive ball pocket.

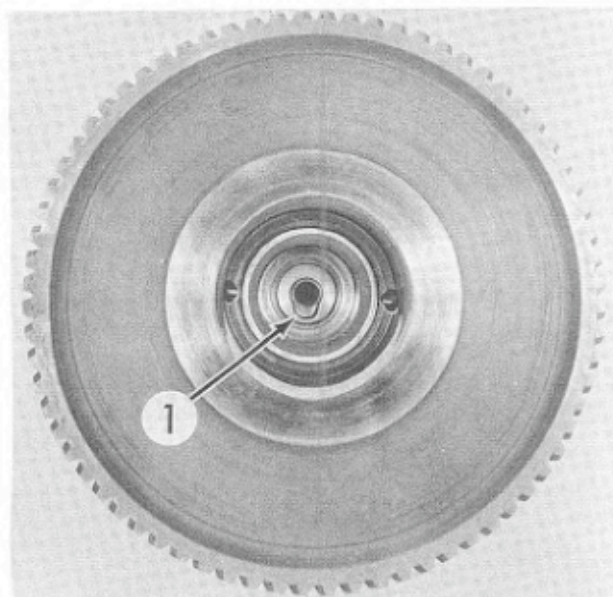
Fig. 4

1. Elongation of Oil Passage
