Service Bulletin

NO. 322

Studebaker and Packard Clipper

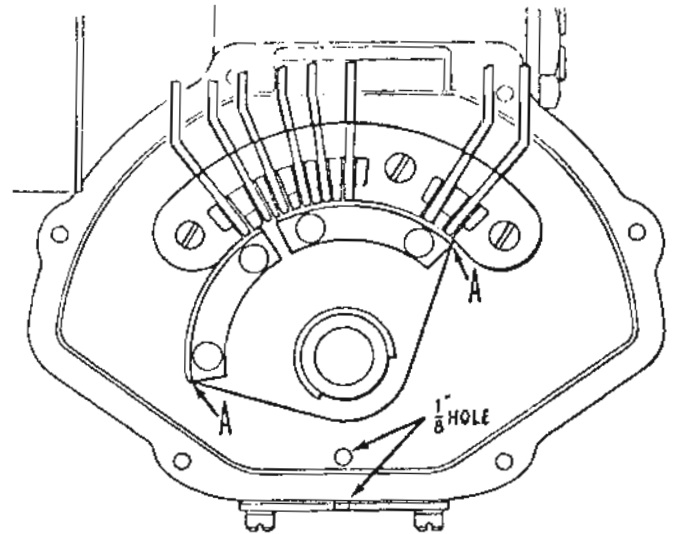
FIG. 3

Under certain conditions condensation may accumulate in the actuator unit of push button control and cause corrosion of the contacts; also, an accumulation of transmission oil in the unit, if leakage occurs at the manual valve lever shaft seal.

When the contact segment of the actuator unit is permitted to overtravel by malfunctioning of some member or circuit in the control system damage may be caused to the contact fingers on the finger and lead assembly. This is particularly true of the early production units.

The contact segment may have a sharp edge at each corner. When the unit is permitted to overtravel, on the return, the sharp edge may dig into the contact finger which will make the unit inoperative and usually create severe

arcing when the control buttons are pushed or operated for a change of position.

To provide ventilation so that condensation is held to a minimum and in the event of a leak at the seal so that the oil may drain, we suggest that you make the following modification.

Drill a 1/8" hole at the center lower inner edge of the base plate to provide a vent into the lower main housing and another 1/8" hole in the inspection plate and gasket to provide a vent and drain from the main housing. Fig. 3 illustrates the approximate locations of the holes.

This modification will also reduce the tendency of the transmission oil to seep past the seal. Therefore, it is recommended if the actuator is removed for any reason that the modification be made. Obviously, if a condition of oil in the actuator is encountered, also replace the seal.

To prevent this interference when a over-travel occurs, round-off or chamfer the two corners (A, Fig. 3) of the contact segment.

This should be done when the segment is removed for any reason and the unit involved has sharp edges.
