# Service Bulletin

1957

NO. 327

## Studebaker and Packard Clipper

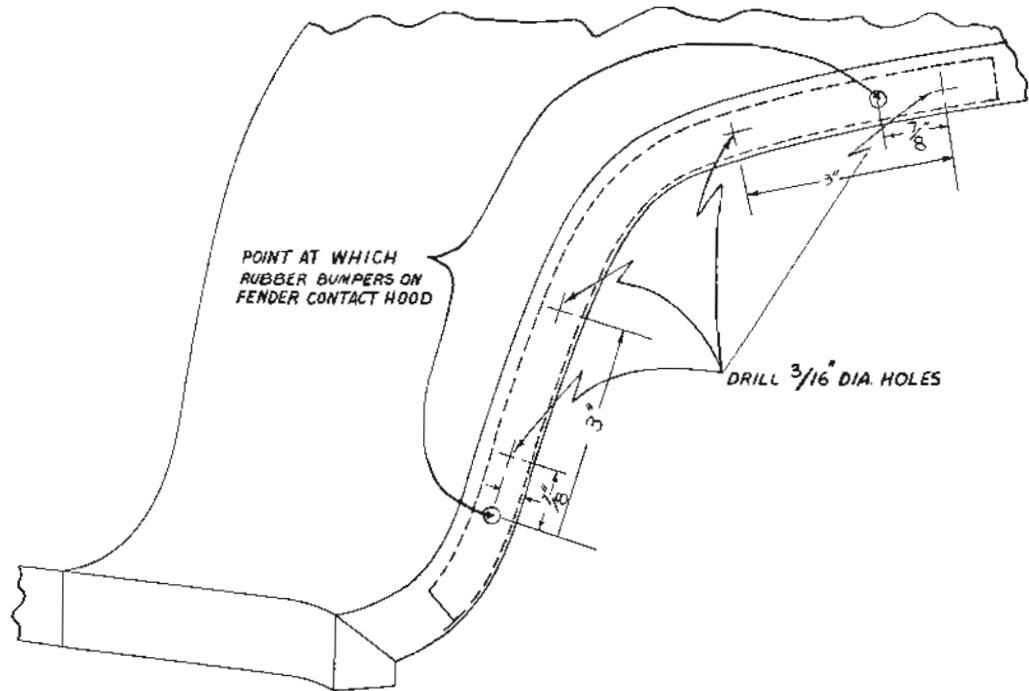
Fig. 1

Reinforcements are now being added in production to the hoods of all sedans and station wagons. A reinforcement is located in each side flange near the front corner. Although the reinforcements are being welded in production, they may be installed in the field by using small bolts and nuts. However, a flat oval-head bolt must be used to prevent interference at the fender when the hood is closed.

Layout and center-punch the hole locations

on the hood flange to the dimensions shown in Fig. 1. Then, drill the holes with a 3/16" diameter drill. The bracket may be held in position on the flange with lock-type pliers and, the flange and bracket drilled at the same time. After installation of the bracket, check the clearance between the bolt heads and the fender. Provide clearance if necessary, by carefully striking the head of the bolt with a rubber mallet.

- 1 - 1320686 Bracket, right
- 1 - 1320687 Bracket, left
- 8 - 2055X1 Bolts
- 8 - G271166 Nuts

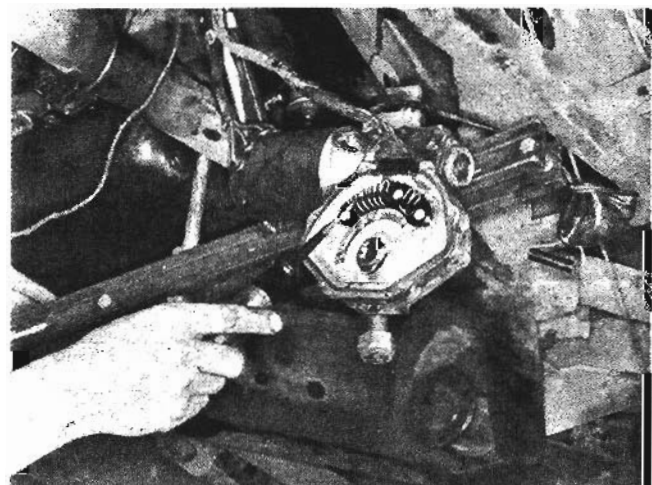
Fig. 2

In most cases of malfunctioning of the Ultramatic push button control, the trouble is found in the contact finger and lead assembly of the actuator.

If there is evidence of shorting or a previous bad arcing condition at any of the fingers, causing the fingers to lose their tension, the contact finger and lead assembly should be replaced.

Method of Checking -- Disconnect one of the cables from the battery. Disconnect the wires from the pressure switch and join them with a connector; all other wiring must remain connected. Remove the motor and actuator as described in the Packard Service Manual. Mount

the assembly on the engine support bar or some suitable location to make it accessible and to provide a good ground. (See Fig. 2). Wipe all loose dirt from the unit, and remove the actuator cover. Connect the battery cable.

Remove the contact finger assembly and check the finger or fingers that are not making good contact on the segment. If the finger assembly is in good condition, bend the finger or fingers just enough to provide proper bearing on the segment. When the fingers are properly aligned on their support they should have a contour to conform to the segment. This alignment should also be checked every time a new finger assembly is installed.

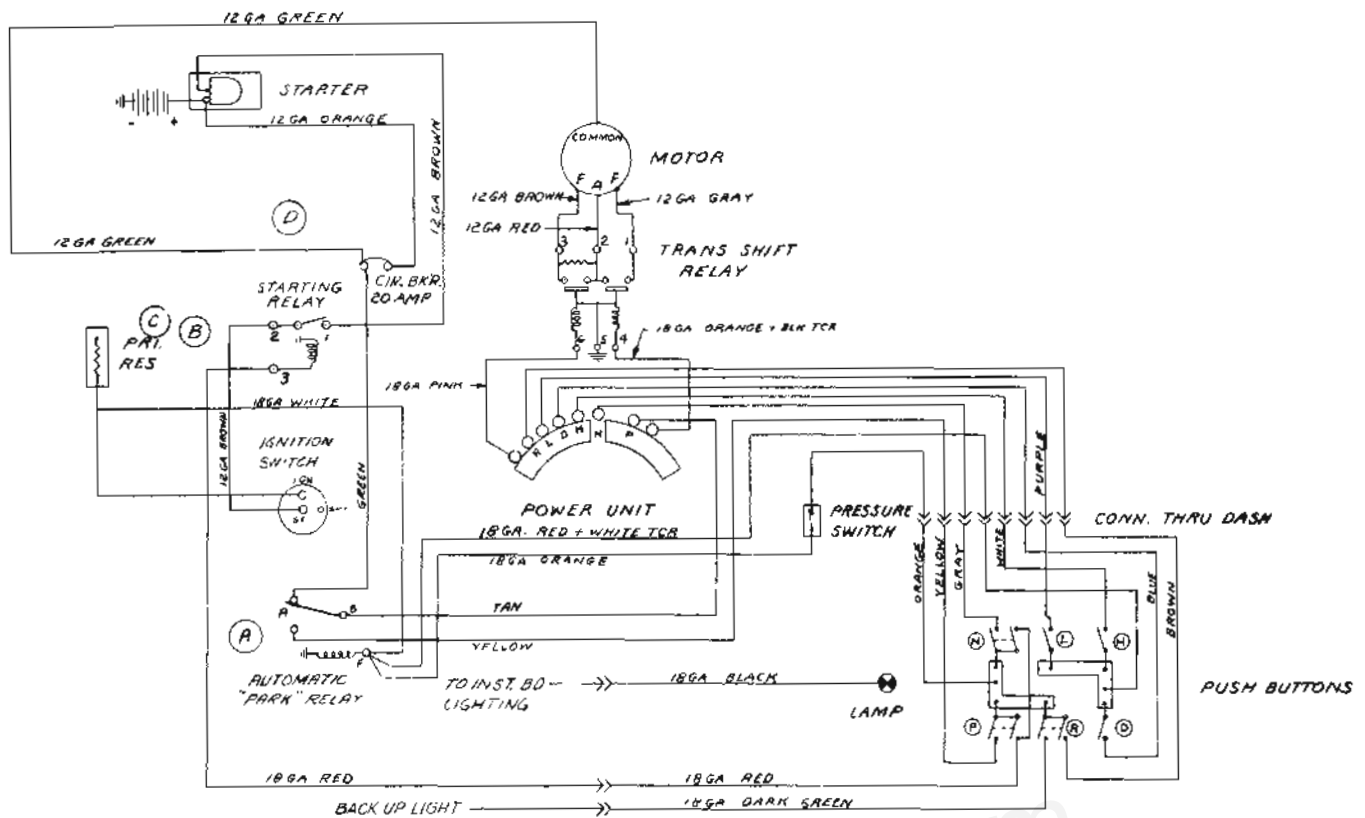
Fig. 3 WIRING DIAGRAM OF PUSH BUTTON SYSTEM

determine to which circuit the trouble is confined and trace the circuit or circuits involved to find and correct the trouble. Fig. 3 illustrates a schematic wiring diagram of the system.
