# Service Bulletin

NOVEMBER

NO. 331

## Studebaker and Packard Clipper

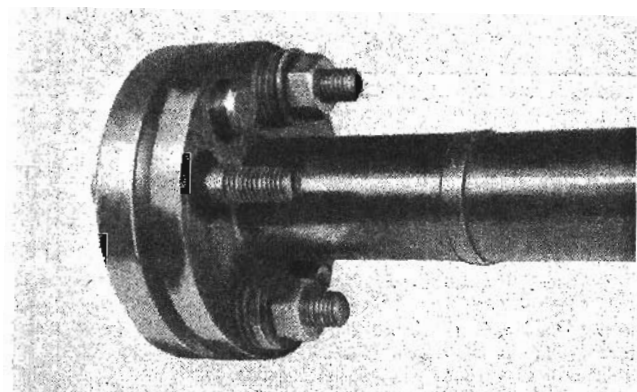
Fig. 1

2. Remove the steering gear post from the jacket assembly. Assemble the old steering gear shaft flange to the post using a new lower rubber insulator between the two flanges. Be sure that the "T" marks on the steering post flange, the steering gear flange and the rubber insulator are aligned before assembly. Using sufficient quantity of flat washers (5/16 x 9/16) so that the two flanges can be secured together, install and tighten the nuts on two of the flange studs (see Fig. 1).

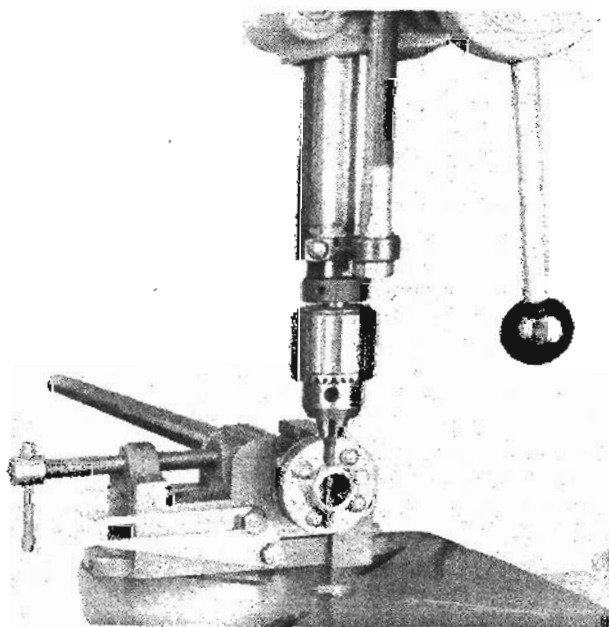
Fig. 2

3. Using a drill press vise or V blocks and clamps to hold the assembly, place the assembly on the drill press table. Insert a 3/16" drill bit in the drill chuck. Then, use the drill bit as a guide, position the assembly so that the drill is aligned with the hole in the old flange. See Fig. 2. Fasten the assembly securely to the drill press table.

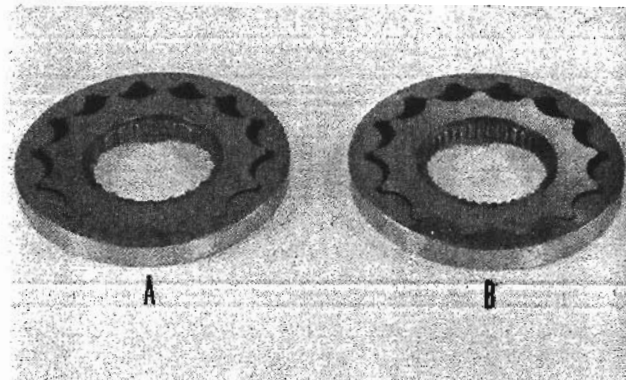
When the converter shaft assembly of the gear-start type Ultramatic transmission is replaced because of worn or stripped splines, it is advisable to check the front oil pump rotor. If the rotor is one having 20 teeth in the driving section, replace it with one having 40 teeth, Part No. 6489367. Whenever it is necessary to replace both the shaft and rotor, it is advisable to order either Part No. 6484523, Rotor and Shaft Kit, or Part No. 6484524, Pump Assembly and Shaft Kit. This will insure lon-

The front oil pump rotor ('A' in Fig. 3) having 20 internal splines is used in the 54th

**Fig. 3**  
A. 20 Spline Rotor  
B. 40 Spline Rotor

Series Gear-Start, 55th and early 56th Series. 'B' shown in Fig. 3 is the 40 tooth splined rotor, Part No. 6489367.

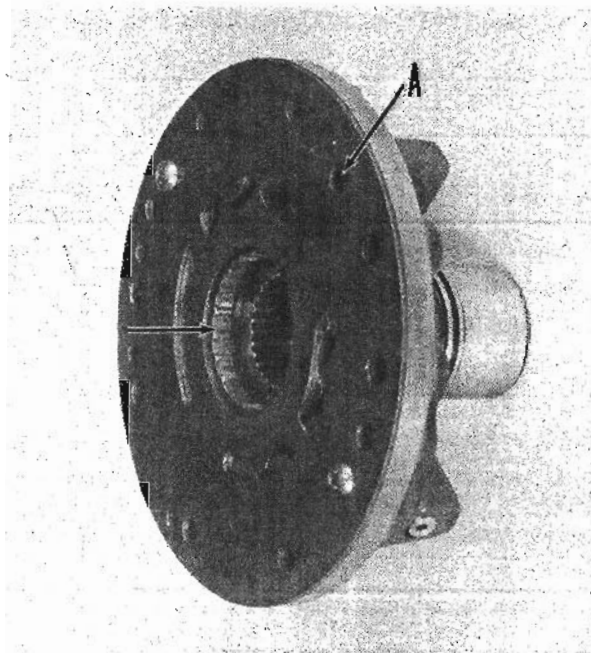
On the 54th Series Gear-Start, all 55th and early 56th Series Packard and Clipper models, the oil pressure for the direct drive clutch came out of a passage on the front side of the pump. See A, Fig. 4. The oil pressure was

**Fig. 4**  
A. Direct Drive Clutch Oil Pressure Passage

directed through a passage in the bell housing then past the open splines in the rotor to the input shaft.

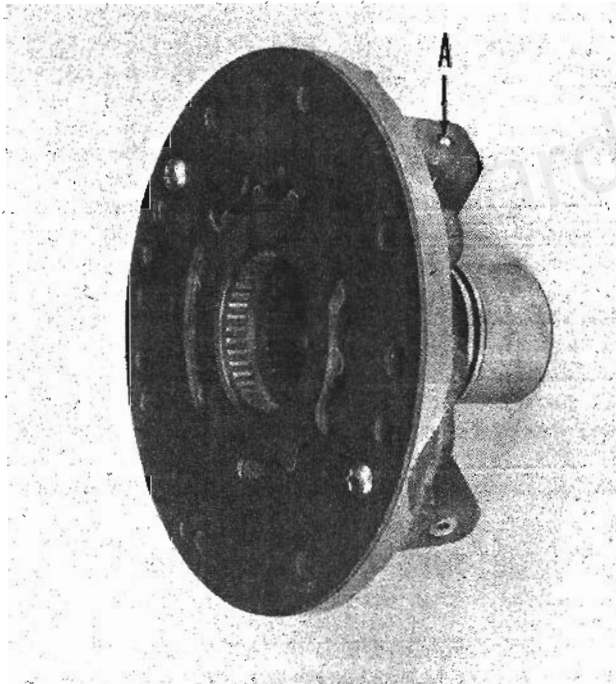
Fig. 5

On the 56th Series Packard transmission after transmission serial number 5-40469, and all Studebaker 56J Golden Hawks, the front oil pumps have the direct drive clutch oil passage in the rear side of the pump. See at A in Fig. 5. The outlet for this passage is in between the two bushings inside the pump hub. Note that there is no oil passage in the front plate. However, this type pump originally had the 20 tooth splined rotor. (40 tooth shown in the illustration)

A. Direct Drive Clutch Oil Pressure Passage

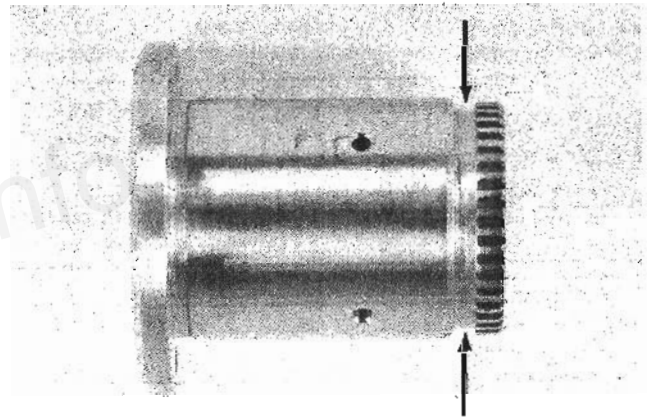
Fig. 6

has 40 splines, therefore, it will be necessary to drill six 1/8" holes evenly spaced through the annular groove just back of the splines in the converter shaft to provide an oil passage to the direct drive clutch. "See arrows Fig. 6." This also applies when replacing the rotor assembly. When necessary to drill holes in the groove of the converter shaft, remove burrs from the edges of the 1/8" holes and internal bushing after drilling.

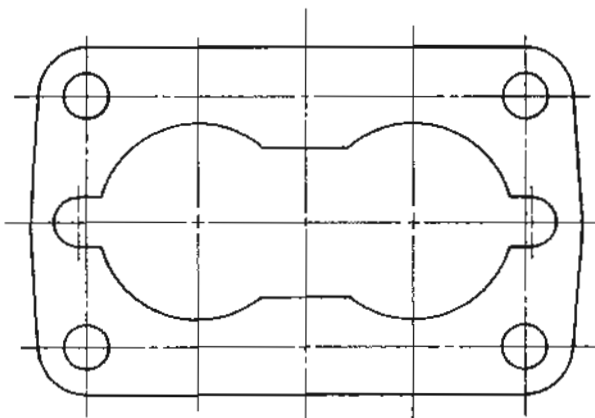
FIG. 7

(a) It has been found that an improper gasket has been installed below the carburetor that either restricted or entirely cut off the vacuum to the vacuum-solenoid control assembly. With no vacuum acting on the control diaphragm, the downshift and throttle valves are held wide open. As a result, high control oil pressure and, high and rough upshift points will be experienced.

Carburetor Gasket, Part No. 1540006, (see Fig. 7) must be used with the Warner Gear Automatic Transmission.

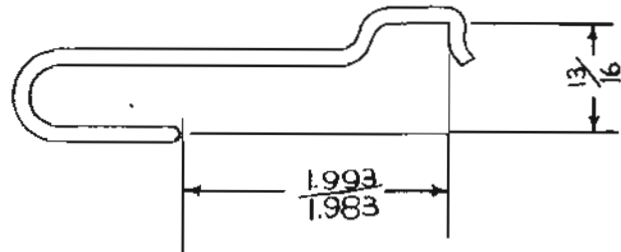
Fig. 8

(b) Also check the Downshift and Throttle Valve Control Hook, Part No. 1687316, for distortion. Should this hook be distorted it will change the relative position of the downshift and throttle valves and thereby affect control pressure.

If the control hook has "opened-up" (see Fig. 8), it can allow the downshift valve to come out of its bore far enough to cock and not re-enter the bore correctly. When this happens the downshift and throttle valves will not respond to adjustments of the vacuum-solenoid control assembly and control pressure will be abnormally low.

To check for this condition, remove the vacuum-solenoid control assembly. Insert a length of 1/8" rod directly against the control hook rocker arm. Pressure against the rod should cause the downshift valve to move inward. If the rocker arm cannot be moved in this manner, it indicates the downshift valve is sticking. In this case, remove the control valve assembly and check the control hook, downshift valve, and throttle valve.
