Service Bulletin

JANUARY

NO. 333

*Studebaker and
Packard*

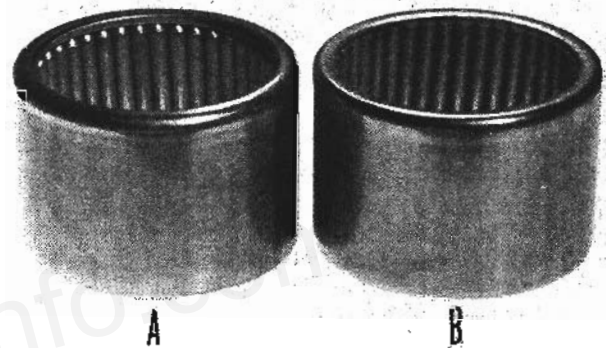
Fig. 1

The steering knuckle needle bearings used on 1958 Model Studebaker and Packard passenger cars are not held in their case on the ends. The rollers are flat on the end and the case is not crimped over their ends (see B in Fig. 1). Care must be taken during disassembly not to

The service bearings, Part No. 196859, have the case crimped to prevent the bearings from coming out of the case (see A in Fig. 1).

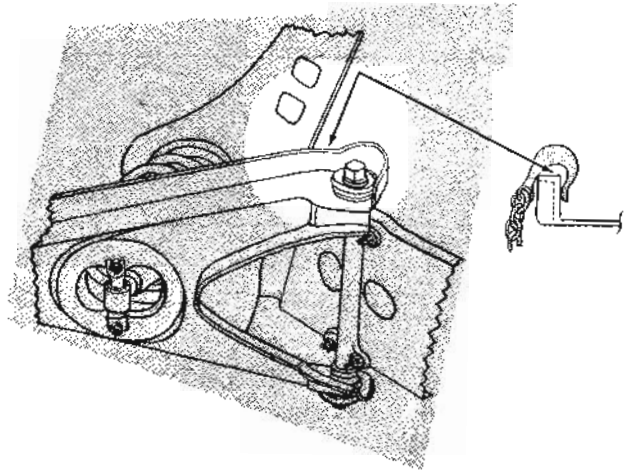
Fig. 2

It has been brought to our attention that the operators of auto wash stations have been hooking a tow chain or hook to the front stabilizer bar link on 1958 model Studebaker and Packard cars. This results in bending of the link and pulling the bar out of the outer rubber bushing.

Unsatisfactory points for attaching the tow chain are:

1. Stabilizer bar or link because of reasons outlined above.
2. Radiator stud bar. Danger of entering hook into radiator core.
3. Jacking bracket on 58L models. This bracket is designed for vertical loads and is only

held by one bolt. Pulling on this bracket could distort the bracket or turn it out of proper alignment.

The best point of attachment is on the lower support arm near the inner shaft as shown in Fig. 2.

Dealers should make sure that all auto laundries or Hi-Speed Auto Wash Stations in the area are informed of the proper points for attaching the tow chain or hook to avoid damage to the stabilizer bar.

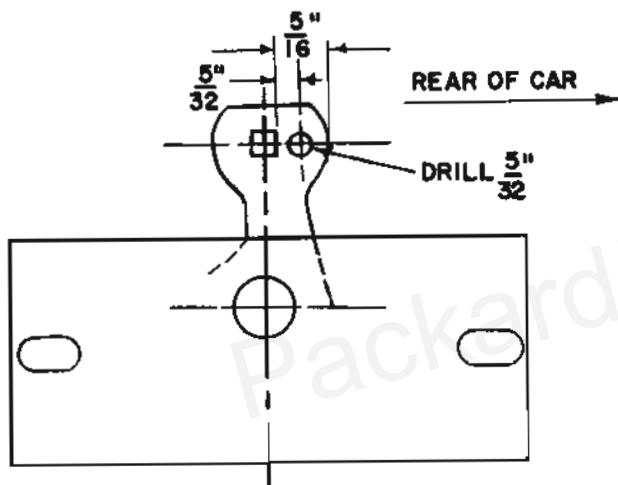
Fig. 3

Occasionally you may encounter binding of the door latch remote control or experience difficulty in locking front doors on 1958 Model Scotsman 4-door sedans after the installation of arm rests. When you find these conditions they can be corrected as follows:

1. Remove the inside door handle and regulator handle. Remove the arm rest and trim panel.
2. Remove the remote control retaining screws and disconnect the remote control wire from the remote control. Remove the control assembly.
3. Relocate the remote control wire hole $\frac{5}{32}$ " toward the rear of the remote control (see Fig. 3).

4. Connect the remote control wire to the remote control and install the control and retaining screws. Adjust as required.
5. Position the remote control wire in the guide clip and test the remote control and the inside door lock push rod for proper operation.
6. Install trim panel, arm rest, and door and regulator handles.
