# Service Bulletin

NO. 335

SOUTH BEND 27, INDIANA

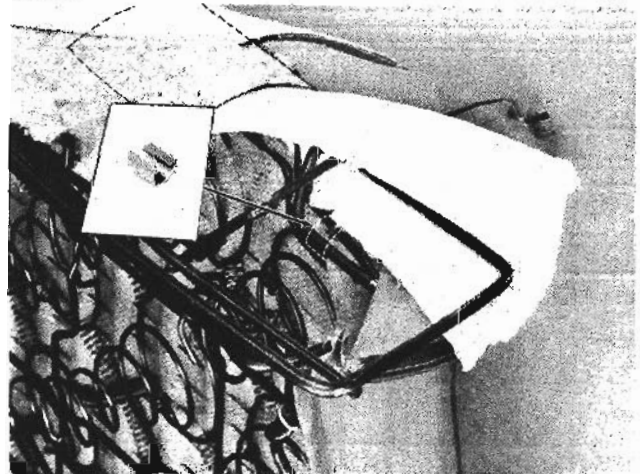
In some instances the clips which hold the spring assembly in position in the front seat cushion on 1958 two-door models may have loosened to permit one or both of the following conditions:

- A) Fore and aft movement of the top of the cushion
- B) Irregular appearance along the side rear top edge of the cushion trim cover.

When this condition is found remove the hog rings from the cushion cover and uncover the spring assembly as shown in Fig. 5 or as required.

To correct the fore and aft movement, install a second clip as indicated in Fig. 5. This clip may be fabricated from a piece of sheet metal (3/64" x 5/8" x 1-5/8") or the two wire frame members may be taped together securely. Make sure that the flat side of the top rim wire is directly on top of the round frame member.

To correct the irregular appearance along the side rear top edge of the cushion trim cover, fold the padding and/or sponge rubber from the cushion cover in the area indicated by the dotted lines in Fig. 5 and extend it rearward. Then secure it to the assembly with hog rings. Use two hog rings on the top and one on the rear edge of the frame.

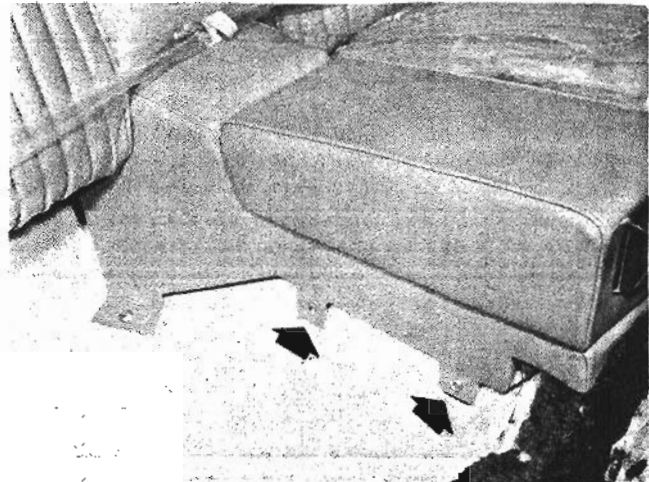
Fig. 6

In early production 58L K9 models, the screws which attach the center arm rest to the floor pan at the right side (see Fig. 6) may extend through far enough to cause interference with the propeller shaft.

To prevent this interference, remove the two screws and drill out the two holes to take 3/16" bolts. Install the bolts from below, with the heads of the bolts on the underneath side of the floor pan. Install lock washers and nuts on the bolts and when properly tightened, cut off the end of the bolt flush with the nut. It is only necessary to remove the right side cushion to perform this operation.

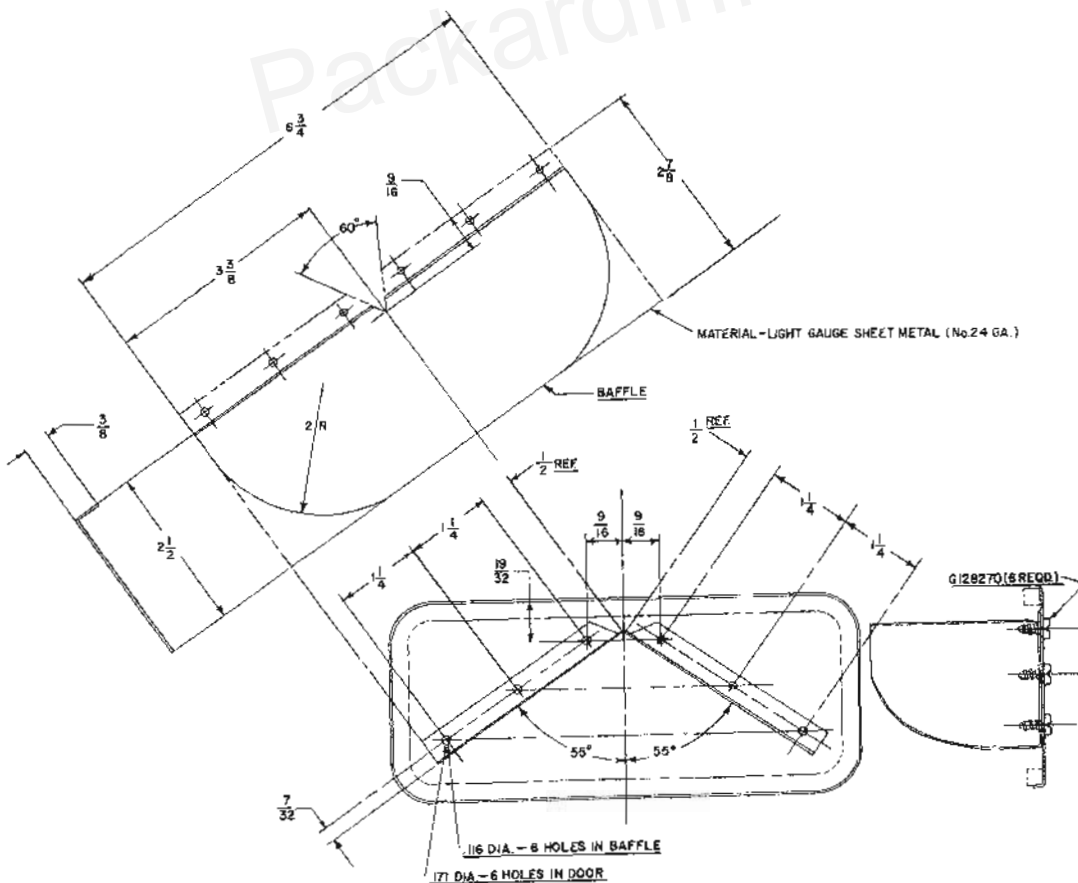
Fig. 7

We have received occasional complaints on trucks equipped with a Climatizer, that too much heat is directed onto the driver's foot and not enough heat to the passenger side of the cab. A baffle, which can be readily made in your shop, can be installed on the Climatizer door to divide the air flow so that more heated air is deflected to the passenger side of the cab. The dimensions and the installed position of the baffle are shown in Fig. 7.
