Service Bulletin

1958

NO. 337

Studebaker and Packard

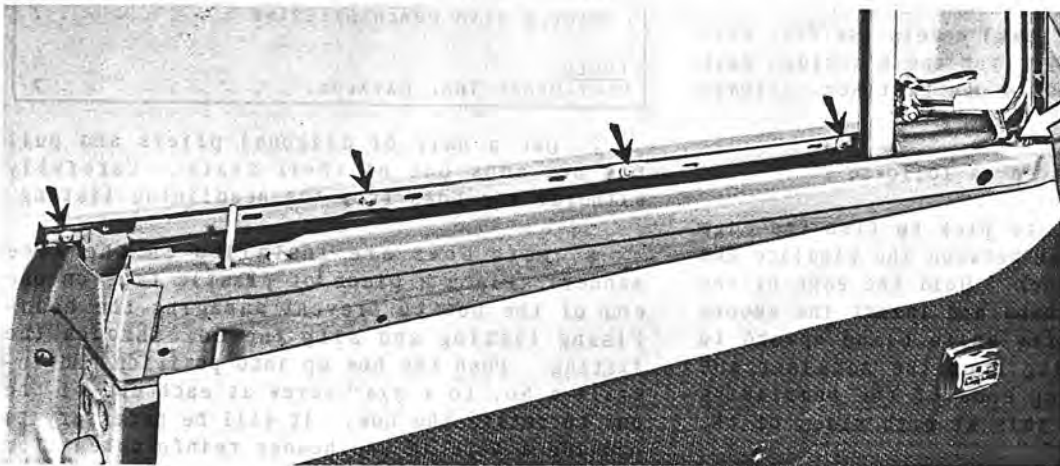
Fig. 1

Remove the window lower stop and bracket assembly. Then, lower the window as required to permit removal of the window weatherseal (fuzz strip). Remove the weatherseal. Then, remove the front screw below the ventilator window, turn back the rubber ventilator weatherstrip which will expose a hole to provide access to the front screw. (See Fig. 1) Note: This screw is different from the other moulding

screws in that it is a course thread screw. Then remove the remaining screws indicated by the arrows and remove the moulding.

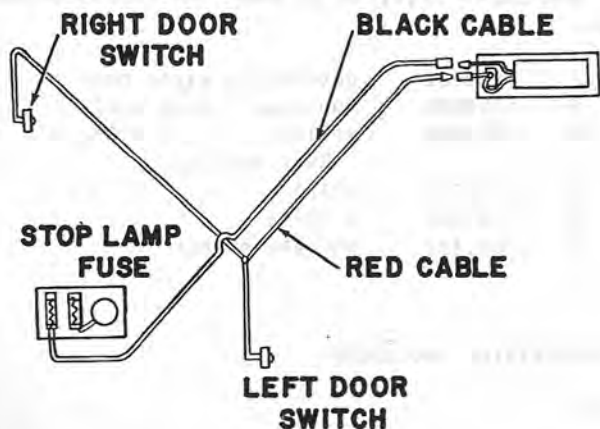
Fig. 2

8. Connect the black cable end to the terminal on the fuse block. See Fig. 2. Use screw, Part No. G-122159 and lock washer, Part No. 121752.

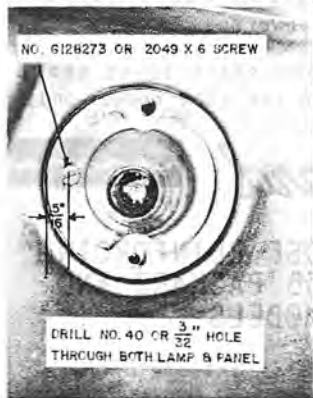
Fig. 3

A condition of poor ground can be corrected by the installation of a No. G128273 or 2049x6 Screw at a point 5/16" from the outer edge of the light housing as shown in Fig. 3.
