Service Bulletin

NO. 338

Studebaker and
Packard

FRONT SEAT CUSHION SPRING MODIFICATION AND RELOCATION OF COVER TO ELIMINATE CUSHION COVER DAMAGE - 1958 2-DOOR MODELS

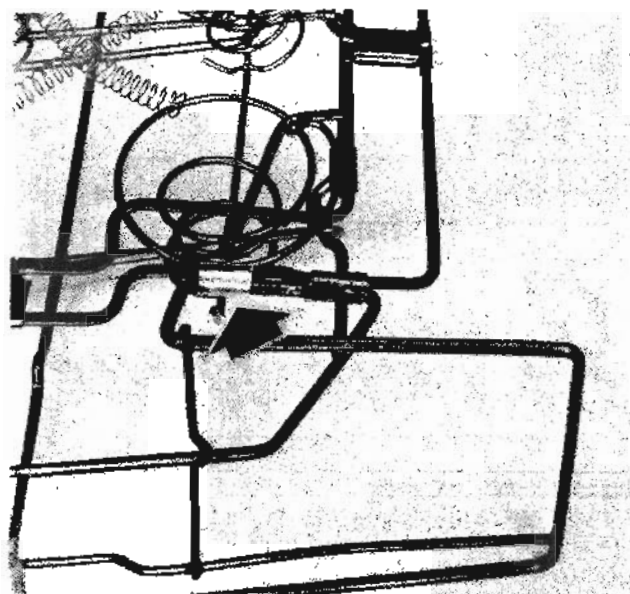
The installation of a second clip (see Fig. 1) on each side of the cushion spring assembly and relocation of the cushion padding as shown in Fig. 2 will eliminate the possibility of cushion cover damage in the clip area. This change entered production with the following serial numbers:

When the clip loosens, the spring assembly top rim and skirt wires separate and cause additional pressure on the cushion cover which may result in damage. Should evidence of this condition appear, on the vehicles manufactured prior to the above serial numbers, immediate action should be taken to fabricate and install a second clip and relocate the padding as described.

The clip may be made from a piece of stock .045" - .050" thick, 5/8" wide and 1 1/2" long.

Place the flat side of the top rim wire directly on top of the skirt wire as shown on Fig. 1 then install the fabricated clip securely.

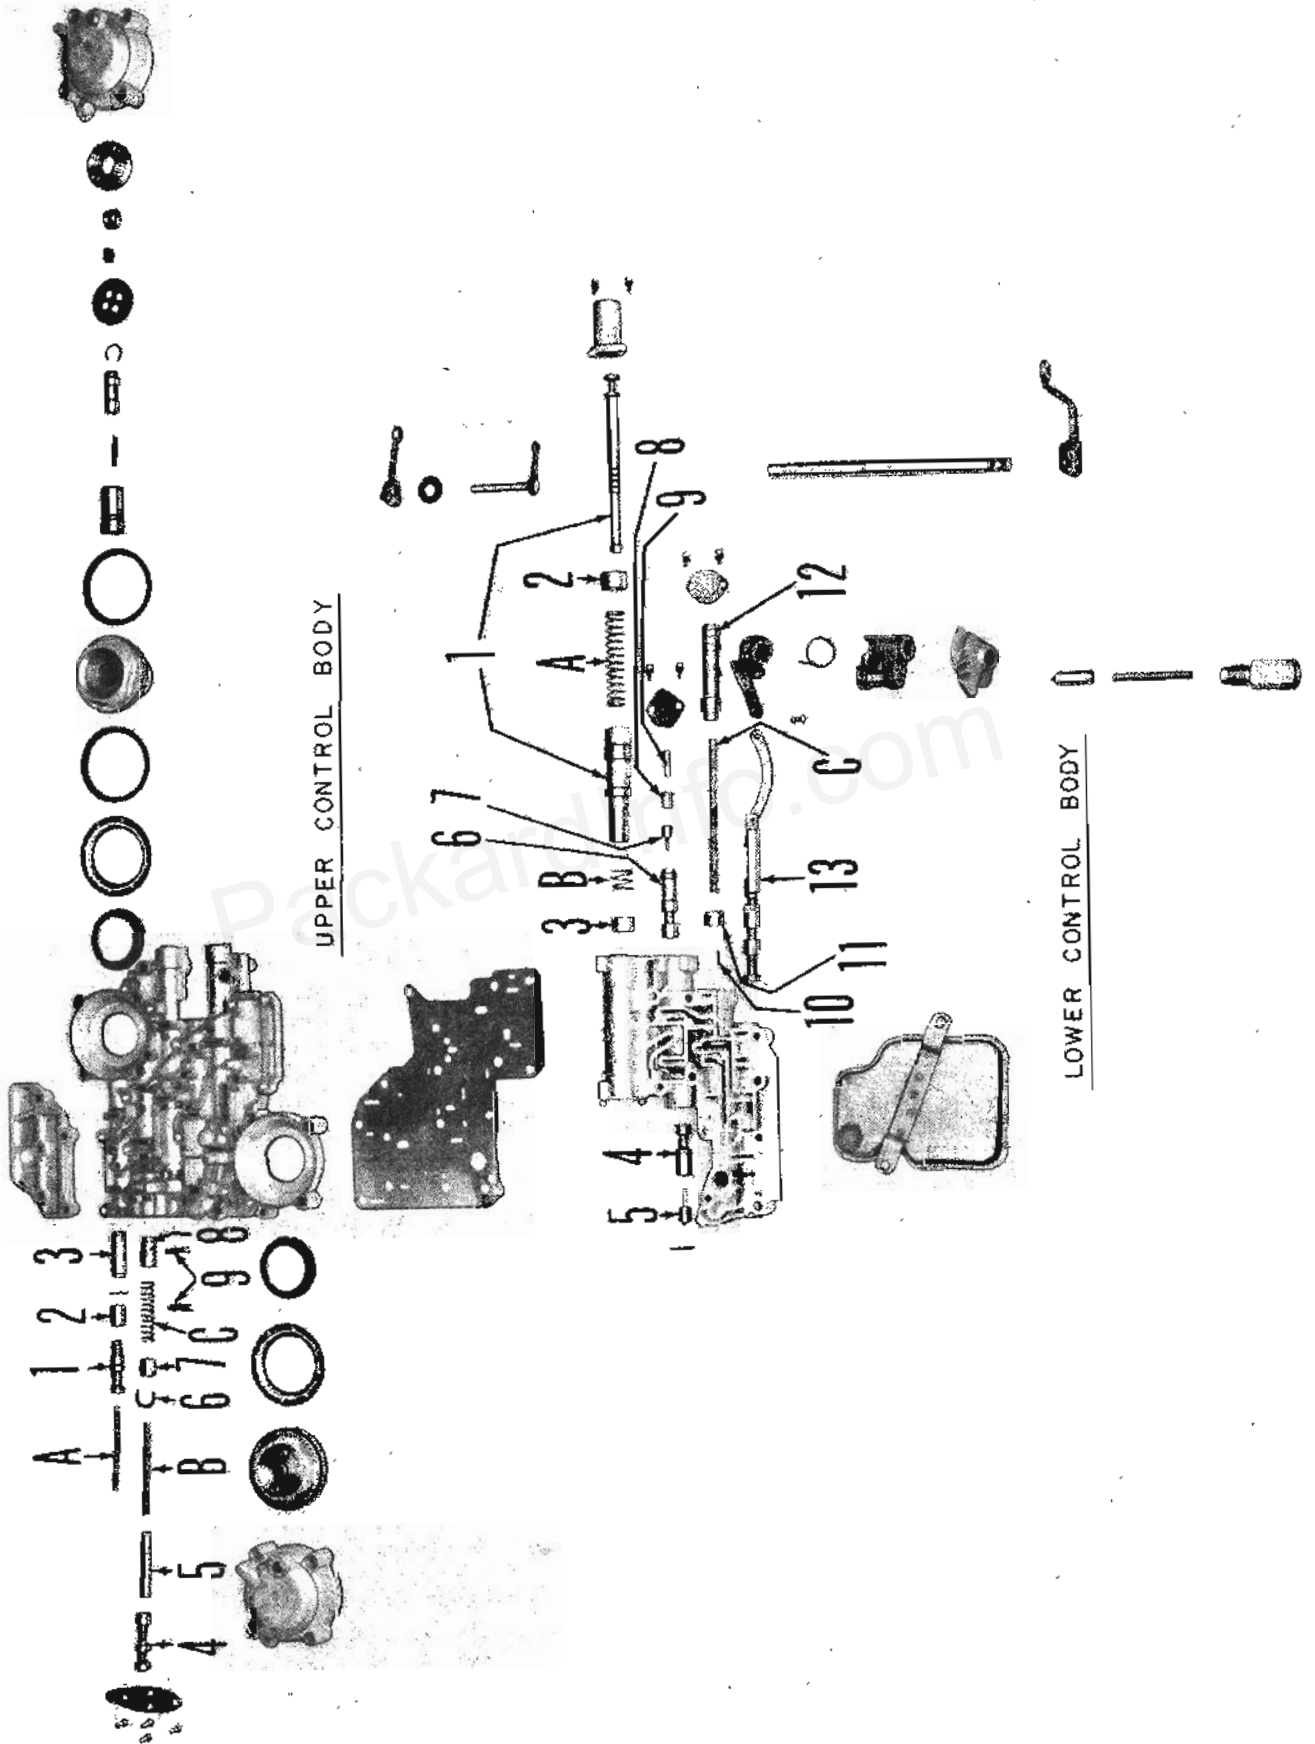
FIG. 3

The Valve Control Assembly illustrated in Fig. 3 is Part No. 423800 and is the standard control unit as used in the 1954 Ultramatic prior to gear start. It is supplied for service as a complete assembly replacement for all Ultramatic Transmissions of the 23rd Series after transmission No. 101509, Model 2301 and transmission No. 5360, Models 2302-06, and all 24th Series through the 54th.

When assembling the upper and lower valve bodies and separator plate, torque tighten the cap screws evenly to 5 foot pounds (1/4-20 screws).

When securing the valve control body assembly to the transmission case tighten the cap screws evenly to 9 foot pounds torque (5/16 - 18 screws).
