Service Bulletin

JULY

NO. 339

Studebaker and Packard

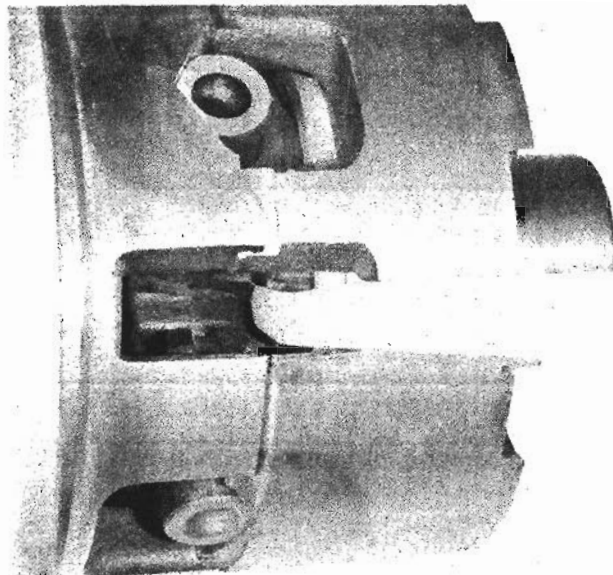
Fig. 1

When removing an axle shaft, one end of the shaft thrust pin may be pulled out of position and the roll pin which retains the two parts of the thrust pin may drop out. This is usually not discovered until you attempt to reinstall the shaft; because the thrust pin is out of position, it will not permit the full installation of the shaft. This, of course, makes it necessary to tear-down the axle and replace the thrust pin and retaining roll pin.

1. Drain the rear axle differential case.
2. Remove the differential case cover.
3. Using a modified hacksaw blade as shown in Figs. 1, 2 and 3, insert the hacksaw blade between the pinion mate shaft and the differential side gear. The hacksaw blade should be

positioned so that it bears against the thrust pin with the saw teeth forward.

4. Pressure should be maintained against the hacksaw blade and thrust pin while the rear axle shaft is removed. The hacksaw blade should be placed between the pinion mate shaft and right hand differential side gear while removing the right side axle shaft and between the pinion mate shaft and left hand differential side gear while removing the left side axle shaft.

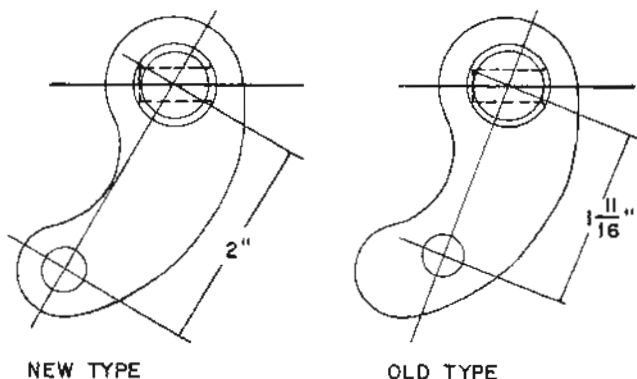
Fig. 4

Under certain circumstances it is possible some gear clashing may occur even though the clutch pedal free travel is properly adjusted. Where this condition occurs it is recommended that Clutch Operating Shaft and Lever Assembly, Part No. 1546329, be installed.

This shaft and lever assembly has a lever radius of 2" instead of 1 11/16" radius originally installed and provides a greater release area for the clutch driven plate (See Fig. 4)

Effective with Serial No. G-1428648 the clutch operating shaft and lever assembly with the 2" lever radius entered production.
