Service Bulletin

NO. 340

*Studebaker and
Packard*

SPEEDOMETER CORRECTIVE SERVICE

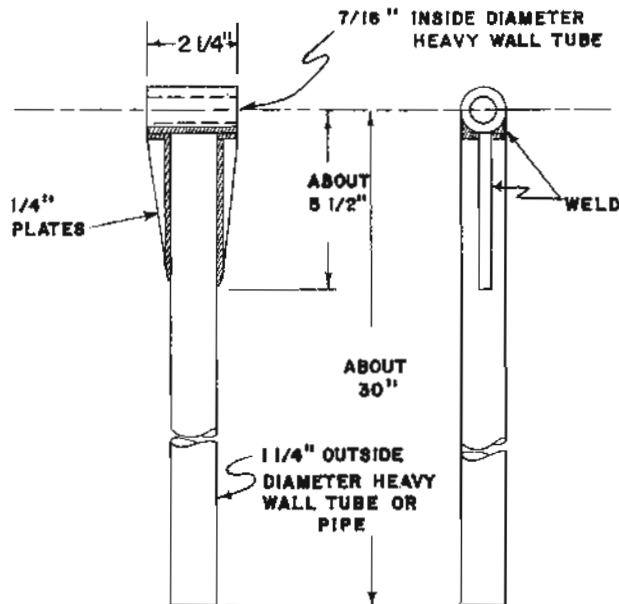
Fig. 1

REAR SHOCK ABSORBER FRAME CROSS-MEMBER BENDING BAR

With reference to alignment of the rear shock absorbers and bushing replacement as covered by the articles in Service Bulletin Nos. 336 and 338, Figure 1 provides a sketch of a suggested tool that may be easily fabricated for bending the rear frame cross member when such procedure is required to obtain satisfactory rear shock absorber alignment.

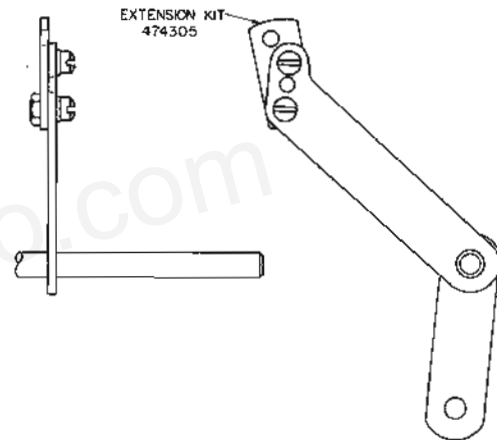
Fig. 7

Unexpected or unwanted kickdown into low range converter range when driving at full throttle or near full throttle position may be encountered in some 55th Series Twin-Ultramatic Transmissions.

Because of the stack-up of tolerances in the throttle linkage and adjustments, the throttle valve kickdown position is being reached before the carburetor throttle valves are fully open.

To take care of the slight variations, the linkage geometry can be changed by installing an extension on the throttle control cross shaft lever as shown in Fig. 7.

Part No. 474305, Carburetor Control Cross Shaft Lever Extension Kit is available from your Parts Depot.

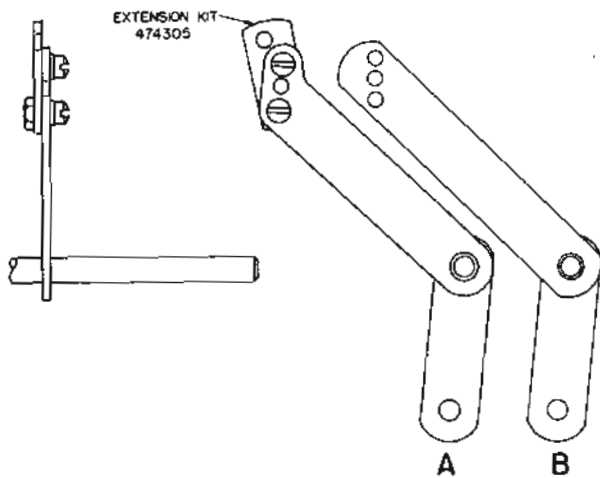
FIG. 8

Some early 56th Series cars had the 55th Series throttle lever 'A' as shown in Fig. 8. Some of these may be equipped with Extension Kit, Part No. 474305; depending on unwanted kickdown or too-easy-a-squeeze-out with wide open throttle.

All 56th Series cars having the throttle lever as indicated by 'B' in the illustration do not require the extension.

If unwanted kickdown or squeeze-out is encountered on 56th Series cars equipped with 55th Series lever, install the Extension Kit 474305 and readjust the linkage as per the Service Manual.
