Service Bulletin

1959

NO. 345

STUDEBAKER-PACKARD CORPORATION

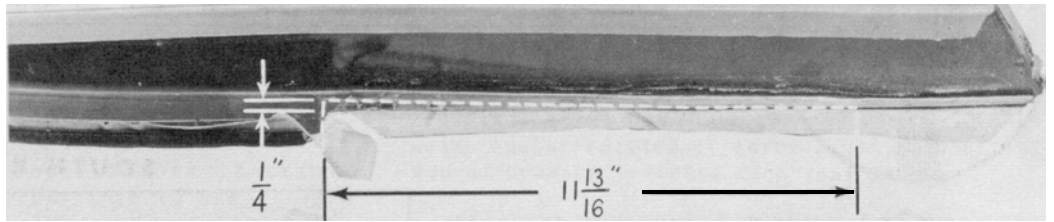
FIG. 1

There have been reports of rattles caused by excessive side movement of the rear quarter windows on Lark Hardtop models when the window is in the full down or open position.

To correct the condition, it is necessary to bring the inner and outer window weather seals closer together to stabilize the quarter glass assembly when it is fully lowered. The following steps will effect a suitable improvement.

1. Remove the rear seat cushion and seat back. **Remove** the rear quarter trim retainer and peel back the vinyl trim. Measure in $1/4$ " from the offset in the retainer and mark, then toward the rear of the retainer from the $1/4$ " mark, measure $11-13/16$ " and place a mark at edge of the metal. Scribe lines to the marks, see Fig. 1.

with a hack saw, cut on the lines scribed on the metal and remove the marked section.

Place the trim back over the edges of the retainer, being careful so the trim will not be torn or damaged, and cement the trim in place. This will permit a closer fit of the assembly at the rear of the window opening in the body, when the retainer is in place.

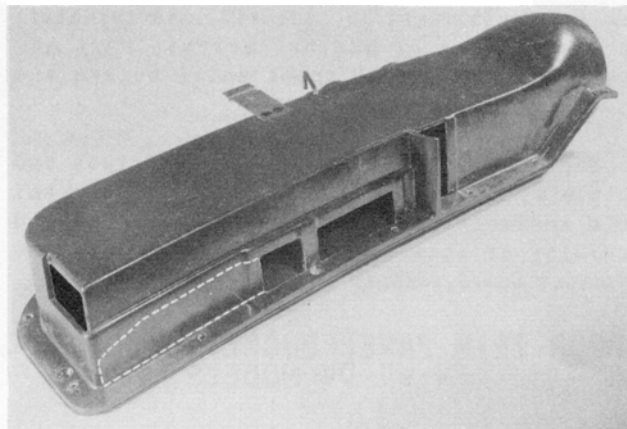
FIG. 6

To direct more warm air to the driver's feet, a change has been made in the Climatizer air distribution duct.

3. Scribe the bottom surface of the duct, as shown by the dotted lines on Figure 6.

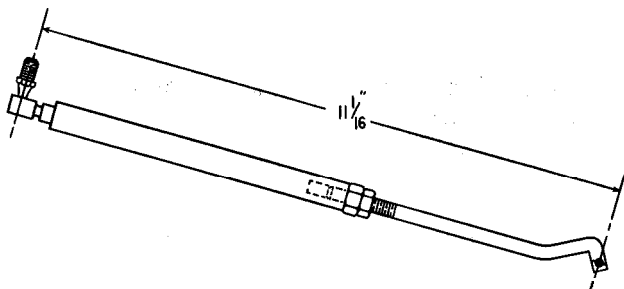
FIG. 8

In order to obtain proper throttle valve linkage relationship in a Lark VI Model equipped with a Flightomatic transmission, the throttle valve linkage adjustment procedure in the 1959 shop Manual, Group IV, Page 39, should be supplemented with the following information:

As step 1 for performing the carburetor-to-transmission throttle valve linkage adjustment, the throttle control Dellcrank-to-carburetor rod assembly (see Fig. 8) should be checked and adjusted to provide 11-1/16" between the centerline of the ball stud and centerline of the cotter pin hole. After adjusting the carburetor rod assembly to this length, it should not be altered during any subsequent adjustment operation.
