Service Bulletin

AUGUST

1959

NO. 349

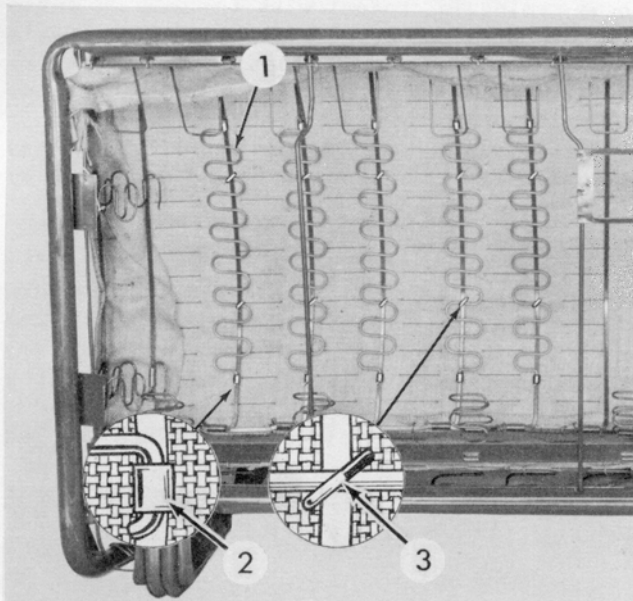
FIG. 1

Some seat cushion and seat back sagging has occurred on 1959 cars; especially on taxicab and severe service vehicles. To correct this sagging condition a Front Seat Cushion or Back Heavy Duty Kit AC-2986 (Part No. 1333999) has been released for service. This kit consists of Reinforcing Elements, Part No. 13331396, Clips, Part No. 1333553, and instructions for installing the elements in the seat cushion and seat back. See Fig. 1

1. REINFORCING ELEMENTS
2. CLIPS
3. HOG RINGS

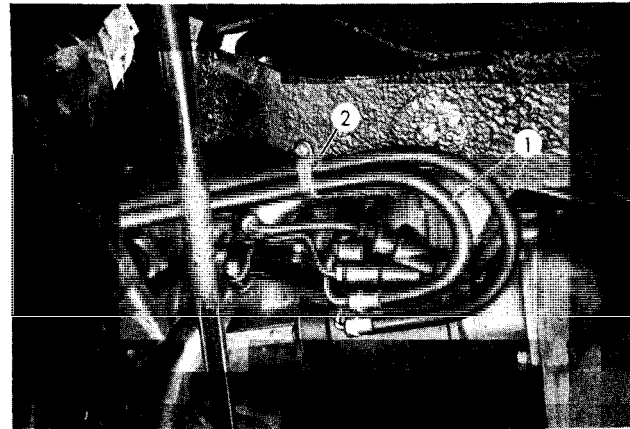
FIG. 2

We have received reports of power steering hoses coming in contact with the exhaust manifold and steering gear. Investigation reveals that in most cases the hoses were improperly positioned, twisted and not properly secured.

Figure 2, an underneath view of the left-hand side of the car, illustrates the position of the power steering control valve-to-cylinder hoses and their retaining clamp. Note that the retaining clamp should be approximately at a right angle to the center line of the car, also that the hoses parallel one another as well as the frame.

1. VALVE-TO-CYLINDER HOSES
2. HOSE RETAINING CLAMP

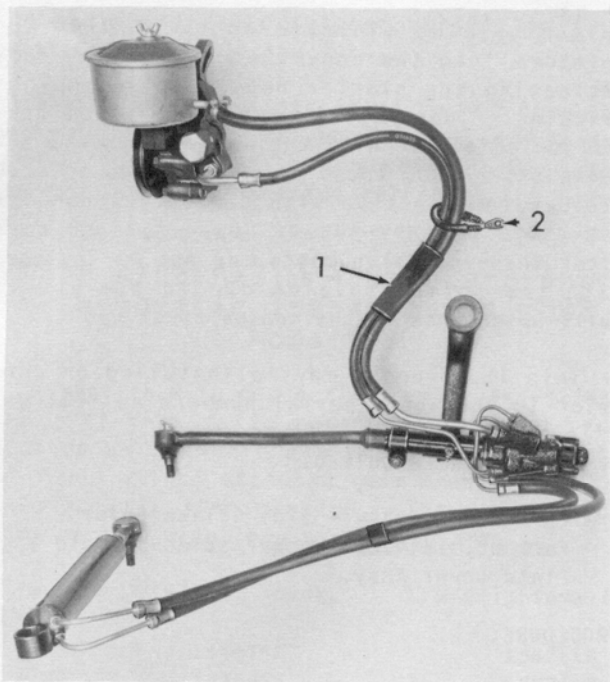
FIG. 3

The relative position of the power steering pump, control valve assembly, pitman arm and reach rod, and the power steering cylinder are shown in Fig. 3. This illustration reproduces, as closely as possible, the relative positioning of these units and hose assemblies in their installed positions. The protective grommet on the power steering pump-to-control valve hoses should be located approximately 7" from the lower end of the hoses. This is necessary to prevent any scuffing of the hoses by the steering gear housing. The spring wire and sleeve assembly must be wrapped around the two pump-to-control valve hoses approximately 3" above the protective grommet, with both ends of the spring secured to the retainer clip

1. PROTECTIVE GROMMET
2. SPRING WIRE AND SLEEVE ASSY

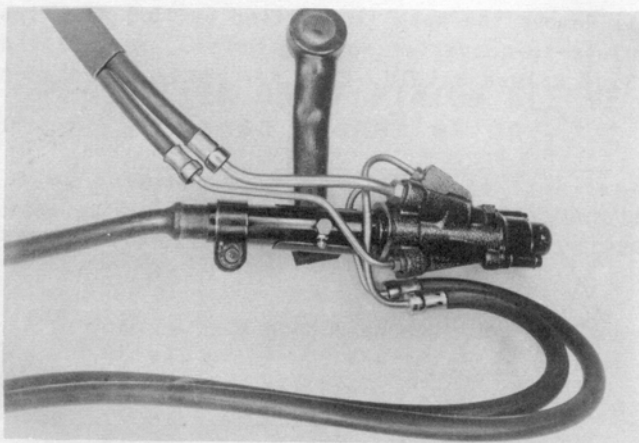
FIG. 4

A close-up side view of the control valve assembly, (see Fig. 4), shows the correct positioning of the hose and tube assemblies. Note that the control valve-to-power steering cylinder hoses are parallel and should be secured by the frame clip (see Fig. 2) so that the hoses do not droop downward at the looped portion of the hoses.

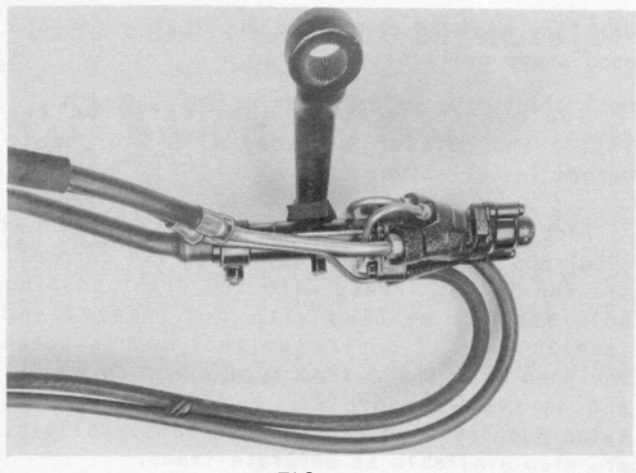
FIG. 5

The top view shown in Fig. 5, illustrates the correct position of the power steering

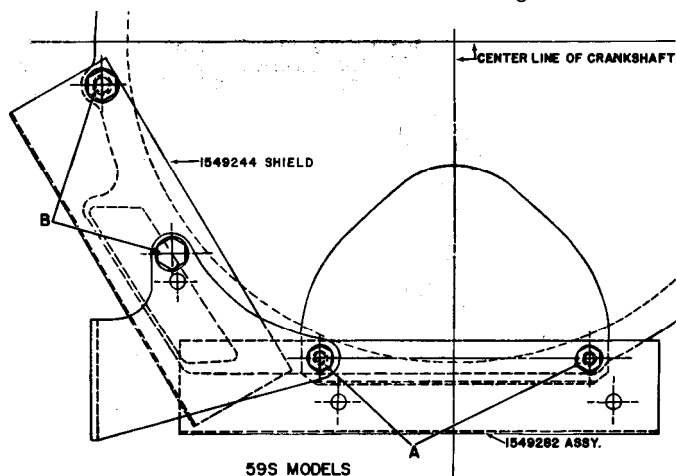
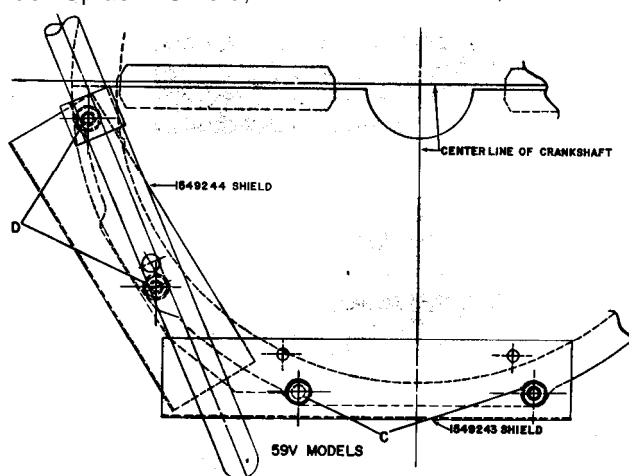
FIG. 6

Two new splash shields have been added to cars equipped with an automatic transmission. The combination of the new, lower splash shield assembly and the new side splash shield protects the converter air cooling system opening in the housing and also the torque converter drain hole in the converter housing. These

splash shields minimize entry of dirt and moisture into the Converter housing thereby protecting the starter Bendix Drive against sticking. These splash shields entered production effective with Engine Nos. S-89465 and V-448068. Also, these splash shields entered production effective with car serial numbers 59S-81022 and 59V-30608; however, some cars after these serial numbers may not be equipped with the splash shields due to previously built-up engines in the engine stock bank.

1) Remove the two bottom engine rear plate-to-converter housing cap screws (identified by "A" in Fig. 6). Remove the engine rear plate cover and clip assembly and discard.

2) Remove the two engine rear plate-to-converter housing screws identified by "B" in Fig. 6. Install Part No. 1549244, Side Splash Shield, and reinstall the cap screws. This shield should be installed between the exhaust pipe support bracket and the engine rear plate.

3) Install the Lower Splash Shield and Plate Cover Assembly, Part No. 1549282 and secure with the cap screw identified by "A"

1) Remove the nuts (identified by "D") from the plate-to-converter housing bolts. Install the Side Splash Shield, Part No. 1549244, between

the plate and the crankcase ventilator tube bracket. Reinstall the nuts.

2) Remove the nuts identified by "C" from the bottom torque converter housing-to-plate bolts. Install the Lower Splash Shield, Part No. 1549243, on the bolts and reinstall the nuts.

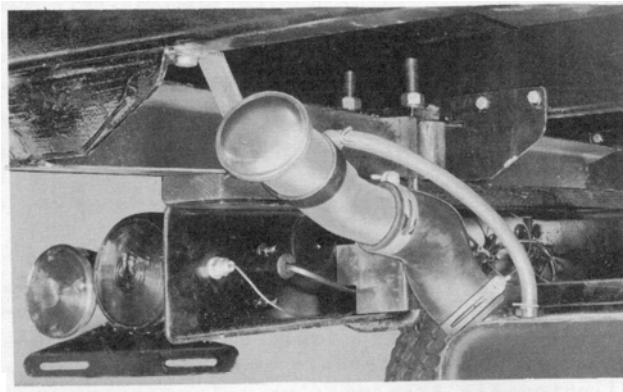
FIG. 7

It has come to our attention that when a stake or platform body is installed on a 4-wheel drive truck after production some difficulty may be experienced in filling the gasoline tank.

This difficulty can be corrected by modifying the gasoline tank filler neck as shown in Fig. 7.
