# Service Bulletin

DECEMBER

NO. 350

*Studebaker and  
Packard*

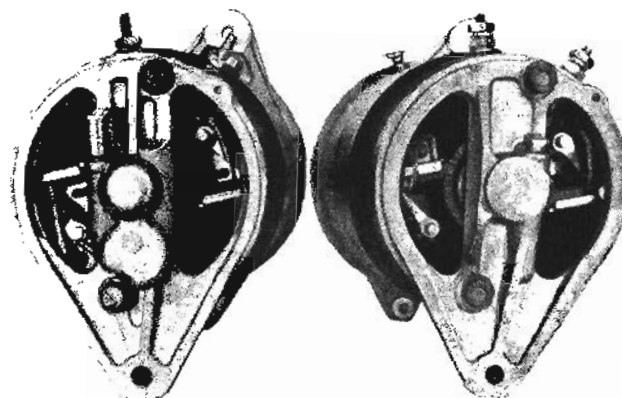
FIG. 1

An improved design generator commutator end plate entered late production of 1959 - V8 models. The latest plate, illustrated on the left in Figure 1, can be identified by the larger oil reservoir located below the bearing area. This end plate, Part No. 1544188, available for service installation incorporates the larger type oil reservoir.

In case of commutator end plate bearing failure on early production 1959 models, in addition to installation of the end plate, Part No. 1544188, a new armature, Part No. 458827, should be installed, if there is any evidence of damage to the armature.
