Service Bulletin

FEBRUARY

1960

NO. 351

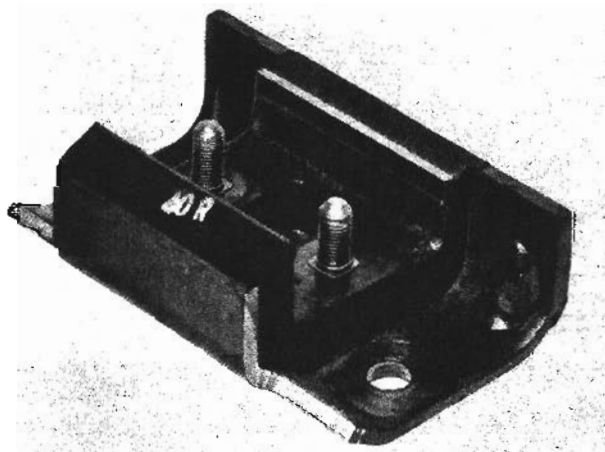
FIG. 1

When removing and replacing the clutch on models equipped with Engine Rear Support Insulator, Part No. 1550063 (see Fig 1), it is not necessary to remove the crossmember.

This new type rear support insulator, can be used on all S-Y1 Models.

To remove the clutch assembly, remove the two nuts and washers holding the insulator to the crossmember. Remove the two cap screws holding the insulator to the clutch housing. Raise the engine and slide the insulator forward and remove it from the crossmember. Push the clutch housing to the rear and rotate until the starter area is adjacent to the crossmember. Remove the pressure plate assembly from the flywheel. Then, the driven plate can readily be removed. To remove the pressure plate assembly, move it toward the starter area in the clutch housing and slip it out from between the clutch housing and engine rear plate. To install, reverse the procedure.

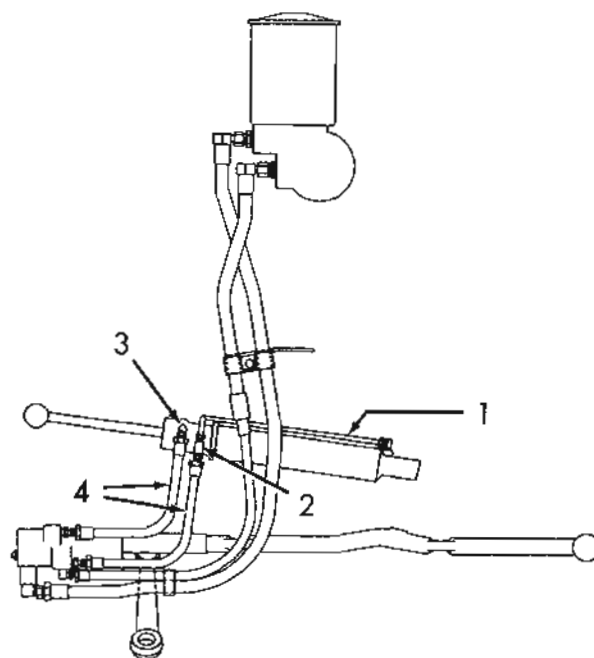
FIG. 2

When the supply of Power Steering Power Cylinder Assembly, Part No. 455211, is exhausted, it will be superseded by Power Cylinder Assembly, Part No. 443701.

To accommodate the installation of Power Cylinder 443701 as a replacement for 455211, the following parts will be included with Part No. 443701:

1. TUBE, 2. TEE FITTING, 3. ELBOW, 4. HOSE
