# Service Bulletin

NO. 353

## SERVICE CORRECTIONS - 1960 MODELS

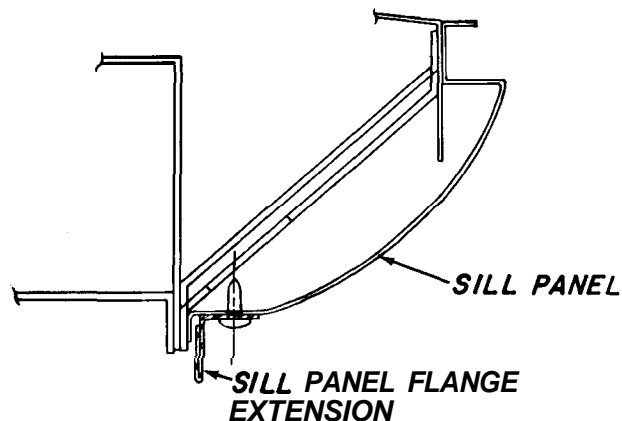
FIG. 2

Beginning with passenger car Serial Numbers, 60S-45256 and 60V-36305 Sill panel flange extensions are used on 1960 Model convertible cars (See Fig. 1). These sill extensions improve the appearance of the convertible models, by covering the welds along the lower edge of the body sills.

1. Prime and paint the new sill panel flange extensions to match the body color.
2. Place the flange extensions next to the body sill lower flange with the attaching holes upward (see Fig. 2) and with the rear of the extension flush with the rear of the sill panel flange (see Fig. 1).
3. Starting from the front, drill the sill panel at the 1st, 2nd, 4th, 6th, 9th, and 10th holes in the extensions. Use a 1/32 or 7/64" drill and secure the extensions to the sill panels with Part No. S-161857. sheet metal screws.

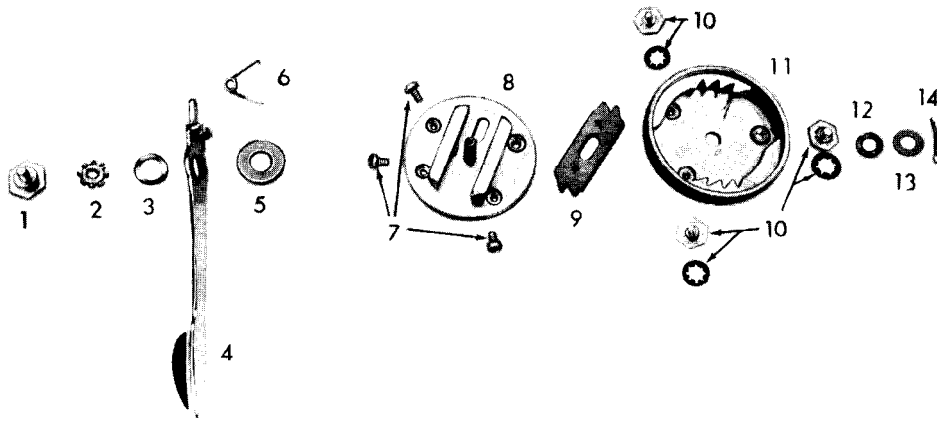
FIG. 3

Erratic operation resulting in excessive wear of the internal gear teeth can be caused by the backing plate and internal ring gear housing separating sufficiently to allow only partial engagement of the gear teeth.

Operating lever working loose allowing the lever to override the operating pin on the Shuttle gear making the mechanism inoperative.

1. The upper and lower seat frame brackets for the reclining seat mechanism must be exactly parallel. Carefully bend brackets as required to make them parallel.
2. Remove any accumulated paint from the external surfaces of the ring gear housing and the backing plate so that the ring gear housing seats properly.
3. A few early production seat mechanisms were assembled with a **11/32"** flat washer located on the backing plate pin next to the cotter key. In some instances this washer will allow the retaining cotter key to pull part way through the washer.
4. Install new ring gear housing and related parts as required, being sure to use **5/8"** backing plate pin retaining washer, Part No. G-120386, and a new **3/32" x 1"** cotter key.

Remove lever and reinstall using an external tooth lock washer, Part No. G-121753, rather than an internal tooth type lock washer.
