PACKARD

Service Counselor

VOL. 18, NO. 10

NOVEMBER, 1944

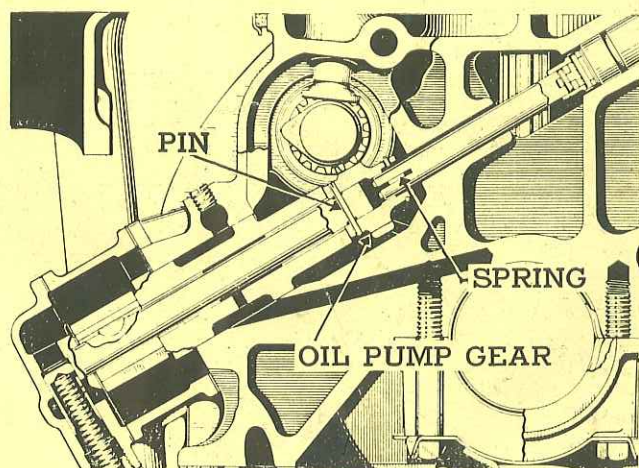
The oil pump camshaft gear is pressed on the upper end of the oil pump shaft. After it is in position the shaft is drilled through the pin hole in the gear, and the pin inserted.

There have been cases where the pump has locked, due to the presence of ice or of dirt particles, and the pin has sheared. The failure is usually caused by ice and, therefore, it is usually a cold weather condition.

When it occurs, the oil pump should be examined. Make sure it is clean and see that the gears have enough end play so that they are not pinched by the pump cover. Of course, you will not find ice, but you may find water or a rusted condition which shows that water has been present.

In making the repair, it is not enough simply to replace the pin. The pump drive depends largely on the press fit of the gear. If the gear has turned on the shaft so that the gear and shaft are worn and loose, the new pin will not be able to carry the load. The trouble will be repeated, and the pin will shear even though the pump is in perfect condition.

You must use whatever new parts are necessary to secure a good press fit.
