Shop Talk

FUEL KNOCK

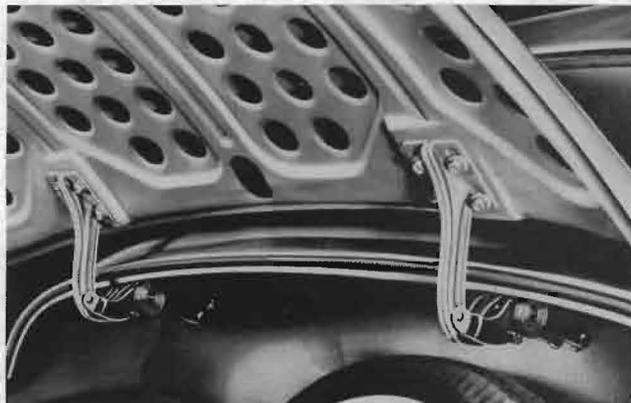
REAR DECK LID LEAKS

In checking rear deck lid leaks pay particular attention to the condition of the rubber weatherstrip where the top of the lid makes contact with the body.

It is at this point that leaks are most likely to occur and are the most serious. You must make sure that the edge of the lid makes a good contact and you must also be sure that it does not bear so heavily that the rubber is forced out of position.

In a few Clipper bodies you may find that as the lid closes, the shoulder at the upper edge of the reinforcing panel contacts the rubber, and that this contact pulls the rubber loose in the trough.

When you install a new rubber you must be certain that it is firmly seated when it is cemented in the retaining trough. Then coat the upper surface with soapstone or powdered graphite so that the edge of the metal does not pull or tear the rubber. For the same reason the metal edge should be as smooth as possible.

Sometimes the interference is caused by the fact that the door is improperly located, with insufficient clearance at the upper edge, and the centering of the door in the opening corrects the interference. In other cases, however, it may be necessary to relieve the corner of the reinforcing panel in order to obtain a clearance.

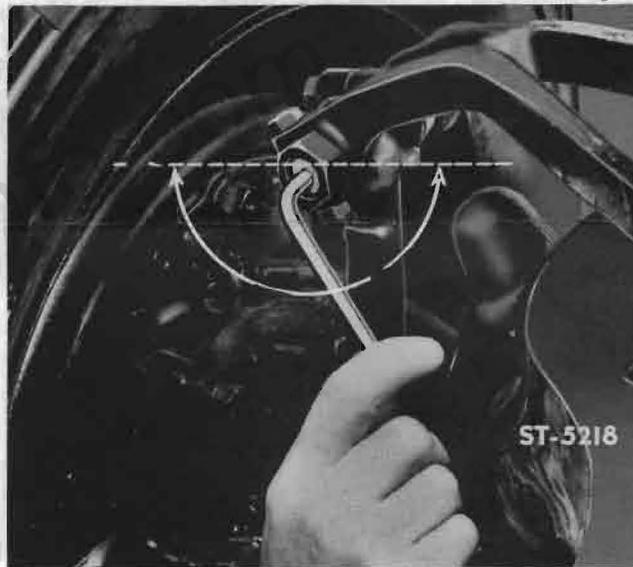
CAMBER 0° PLUS OR MINUS $\frac{1}{4}^\circ$

If there is a considerable variation between the camber of the two wheels you will probably notice two results. First, the car will tend to lead toward the side where the camber is the greatest. Second, you are apt to notice increased tire wear on this same side. The wear will occur on the outside of the tire.

When an owner complains that the steering leads to one side or the other you should make sure that the camber is correct. There is a greater tendency for the steering to lead to the right because the car is usually on the right side of the crown of the road, and the car tends to move down the slope. The weight of the driver, when he is alone, may offset this tendency. If not, see that you have a trifle less camber on the right side.

If the steering leads so strongly that a constant pull on the wheel is necessary to hold the car straight, you will find the tire wear, described above, on the side to which the car tries to travel.

The adjustment can be made easily and accurately, and we suggest that you modify our original specification of $\frac{1}{4}^\circ$ plus or minus $\frac{1}{2}^\circ$. Set the camber at 0° plus or minus $\frac{1}{4}^\circ$, and try to have the readings for the two wheels about the same.

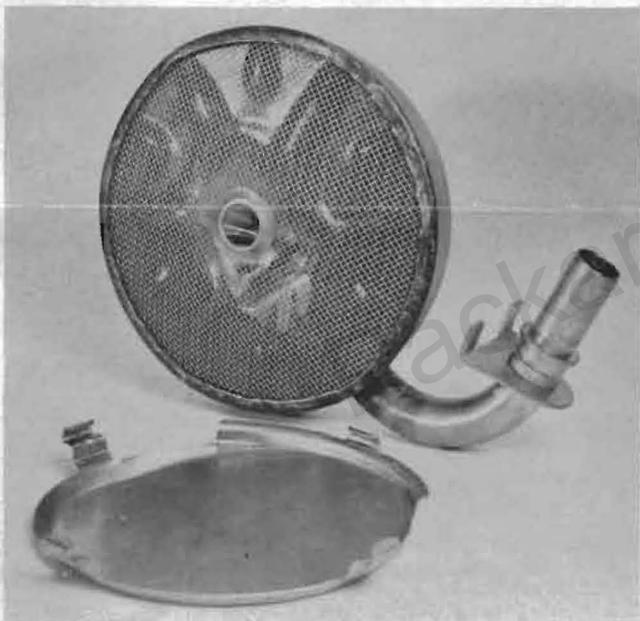
The clogging of the Float-O screen may cause a drop in oil pressure, although it will not cause a complete loss of pressure. When the screen clogs, the pump suction pulls the screen away from the cover so that the opening in the center of the screen permits the oil to enter the system. When the screen is clean the center ferrule bears against the cover, so that the opening is sealed.

If the screen is clogged a sludge deposit will also be found in the pan and inside the crankcase. The sludge should be removed as thoroughly as possible, otherwise it may be picked up by the oil and the screen may plug again.

It is good practice to clean the pan and screen at least once a year. (As recommended on Page 102 of the Service Manual). This is particularly important in the case of slow driven cars, whose operating temperatures are low, because it is in these cars that the sludge collection is greatest. When you find a heavy sludge deposit in the valve chambers you can be sure that there is a corresponding deposit in the pan.

The screen can be cleaned by washing it in gasoline, or a similar solvent, and blowing it out by directing compressed air in through the elbow. When you replace the screen make sure that the upper connection is tight, where the oil tube is fastened to the crankcase. This is particularly important in the case of the flanged connection in the Super Eight.
