FRONT SPRING SNAP

21st SERIES

HARD STARTING OF HOT ENGINE

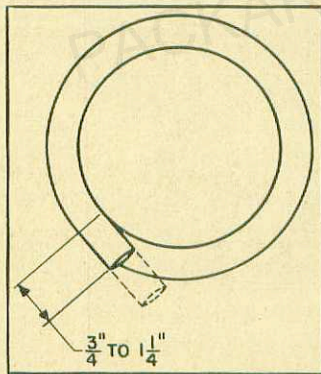
You may have an occasional complaint of a "grunt" or snap in the front end of a Clipper. If this noise seems to be in the springs, it probably is caused by improper seating of front springs in their recess in the lower wheel support arms.

Inspection can be easily made from under the car by checking the position of the end of the spring. If properly seated, the lower end of the spring will be as far down in the lower support arm spring recess as it will go and will cover the drain hole.

In some instances it may be impossible to seat the spring properly. It then becomes necessary to remove the spring and check its lower end.

The lower end of the spring should not follow the circle of the coil. The last inch of spring should be straight and approximately one half the diameter of the wire should project beyond the outside diameter of the coil as show in the illustration. If the straight portion of the spring is too long the end of the spring may protrude too far and rub against the recess in the support arm. This condition can be corrected by replacing the spring or by grinding off the straight section to a point where only half the diameter of the wire projects outside the outer diameter of the coil.

If the spring end does not cover the drain hole, it should be rotated into the proper position. The quickest way to do this is to disconnect the inner end of the wheel support arm to take the load off the spring. The load also could be removed by disconnecting the shock absorber arm from the vertical wheel support, but this method is not suggested as it necessitates resetting of caster and camber.

Defective springs may be returned to Zones for credit during warranty period. Use the regular Request for Parts Adjustment Form.

A credit for 0.6 hour labor at $\frac{1}{2}$ the Dealer's registered customer labor rate will be allowed when a spring is replaced during warranty period. Use Request for Labor Allowance Form.

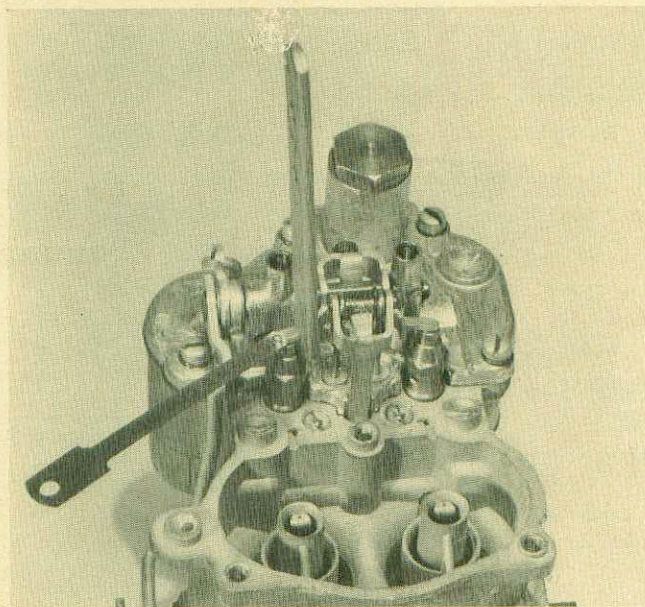
There have been a few reports from the field of hard starting when the engine is hot. This condition is likely to be caused by the "anti-percolator valves" not operating properly, or not properly adjusted. Before attempting to adjust the anti-percolator valves be sure the linkage is operating freely and the plugs are not loose in the carburetor body casting.

Anti-Percolator Adjustment: Carter WDO Carburetor used on the Packard Clipper Eight and Super Clipper:

Turn out the idle speed screw so the throttle valves seat tightly in the bores of the carburetor. With the throttle valves tightly closed, insert a .015" feeler (gauge T109-72) between the anti-percolator valve stem and the lip on anti-percolator arm. Bend the lip so the center of scribed indicator line on valve stem is just flush with top of anti-percolator plug. Re-

peat the procedure on the other anti-percolator valve. Be sure an even adjustment is made on both anti-percolator arm lips.

To be sure hard starting of a hot engine is corrected, check the choke unloader for proper operation and the float for correct level.
