PACKARD

Service Counselor

VOL. 20, NO. 2

FEBRUARY, 1946

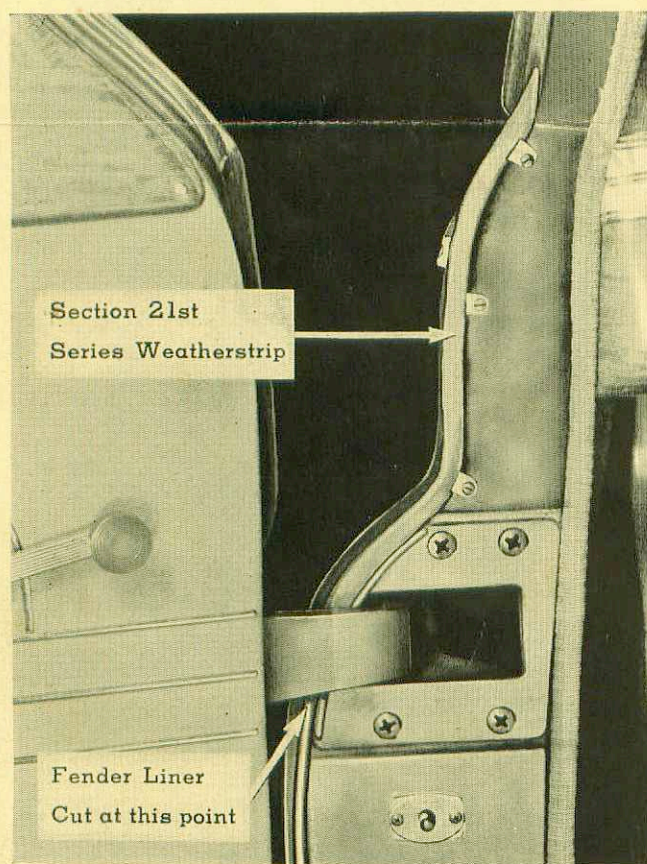
1. Water is admitted at the rear side of the front door body pillar at the belt moulding, runs down the face of the pillar and travels back along the scuff plate. It then runs outward under the scuff plate and between the side sill and rubber mat.

Section of 21st Series weatherstrip cemented to door hinge pillar on 20th Series car.

To prevent water from entering at the front body pillar a section of the front fender to body liner is removed. This is replaced by a section of the 21st Series weatherstrip, piece number 385082—right, and piece number 385083—left.

Approximately $\frac{1}{2}$ inch of the fender liner extends beyond the rear edge of the

fender. Cut the liner along the edge of the fender down to a point opposite the lower edge of the door upper hinge. The upper section of the new weatherstrip is then cut off and should be cut so that, when installed, the lower end will meet the fender liner at the point opposite the door hinge and the upper end should extend approximately 1 inch above the end of the drain gutter.

The section of the weatherstrip which is normally between the fender and body is also cut off along the step or shoulder on the back of the weatherstrip. The curved section is then cemented to the pillar and the three tabs are secured to the face of the pillar with metal screws, piece number 8077.

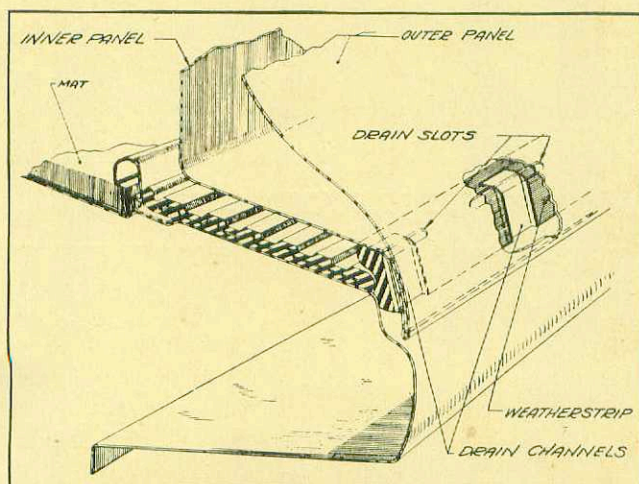
3. Water is also transferred to the floor side sill by the door sponge rubber weatherstrip. This is due to the fact that the weatherstrip closes the door panel drain holes located above and behind the weatherstrip. Consequently, any water in the door is absorbed and retained by the weatherstrip.

Drain channel installed between weatherstrip and door panel.

To insure proper water drainage at the door panel drain holes, the 21st Series Clipper models are equipped with aluminum drain channels. These channels are installed between the weatherstrip and door panel below the drain slots. As the channels can also be installed on the 1951 and 20th Series Clippers, it is advisable to *install them whenever possible, especially* if rust conditions exist or weatherstrips require repair or replacement. The drain

holes can easily be located as the indentations in the back of the weatherstrip mark the location of each drain hole.

To install the channels, piece number 385906, insert a steel rule between the weatherstrip and door panel and up into the drain hole. Apply rubber cement to the back of the drain channel and, using the steel rule as a pilot, push the channel up into position. It should be pushed up

high enough so the flanged end is over the top of the weatherstrip. Close the door and allow the cement to set.

Sedans have three drain holes in each front door and two in each rear door and the Club Sedans have four in each door. The rubber cement, U. S. Rubber Co., or No. 5055, used to secure the weatherstrip to the door is also used to secure the drain channel to the weatherstrip.

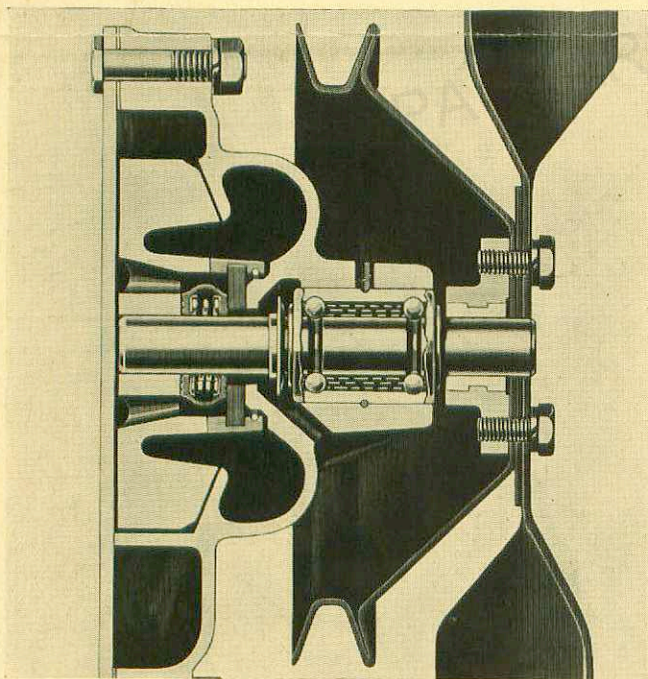
The water pumps used on 21st Series cars have been improved by use of a newly designed seal shown in the accompanying illustration. This new seal is interchangeable with the old and is now being shipped on service orders for all previous models.

The rubber packing and spring guide assembly (356479) and the spring (351548) have been replaced by a seal assembly (384890). In this design the seal spring is inside the rubber seal and holds the seal in contact with the impeller at one end and the thrust washer at the other end. Note that the seal does not contact the shaft.

The impregnated fiber seal thrust washer (351549) formerly used has been replaced by a compounded graphite type, (384891).

When installing the new seal assembly, thoroughly clean any accumulation of rust and scale from the face of the impeller against which the seal rests to provide a smooth even seat.

The new seal spring has less effective length than the old and it is important when refacing the thrust face of the pump body not to remove any more metal than necessary. If too much stock is removed, the spring will not have enough pressure to seal securely and the entire housing will have to be replaced.
