PACKARD

# Service Counselor

VOL. 20, NO. 5

MAY, 1946

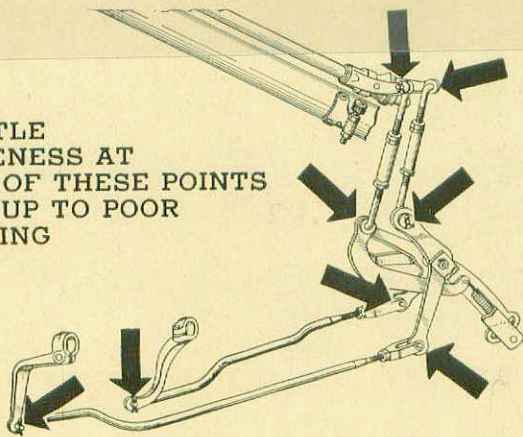
A LITTLE LOOSENESS AT EACH OF THESE POINTS ADDS UP TO POOR SHIFTING

The factory still hears customer complaints about gear shifter linkage having been repaired here and there but the lost motion and sticking still persists.

This, we believe, is due to one of two causes; either you hesitate to spend the customer's money, or you do not make a thorough check of the linkage to determine *every* point at which wear has occurred. There is no such thing as a car that cannot be repaired. The customer would no doubt rather spend a little more when he brings his car in for repair and get a *good* job, than to have to return in a short time with the same complaint with a different cause. Remember that a *little* wear at each point throughout the linkage will add up to the point that the owner may have trouble, although no one point will be badly worn.

By using the following sequence for inspection and repairing or replacing each worn part, the job can be made just as good as new.

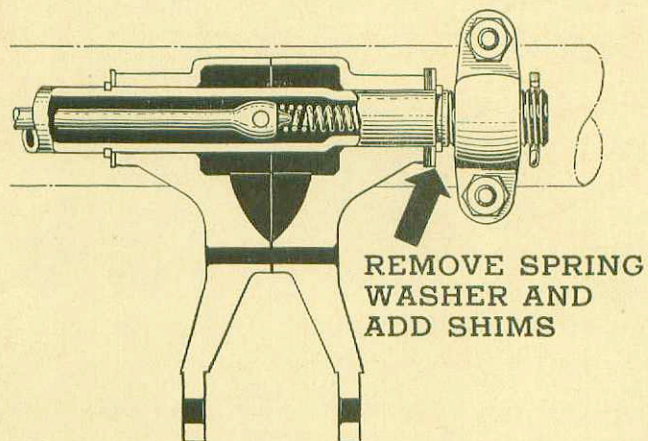
REMOVE SPRING WASHER AND ADD SHIMS

3. Inspect the steering column shifter levers and rods for correct adjustment and wear.

On some models these shifter levers were held in contact with each other by means of a spring

washer, flat washer, and a horseshoe shaped retaining ring. If these parts are found they should be discarded and the space between the lower bracket and the lower lever filled with shims until the desired clearance of 0.002 to 0.007 inch between the levers is obtained. (See Service Letter dated March 1, 1941.)

Forged levers are now available to replace the diecast levers used on early cars. These levers are harder and will withstand the wear and abuse to which they are subjected. In cases where the diecast levers are badly worn, they should be replaced with the forged type and adjusted as outlined above.

Install the aligning pin in the levers and adjust the turn-buckles in the links to properly align the levers.
