PACKARD

# Service Counselor

VOL. 20, NO. 6

JUNE, 1946

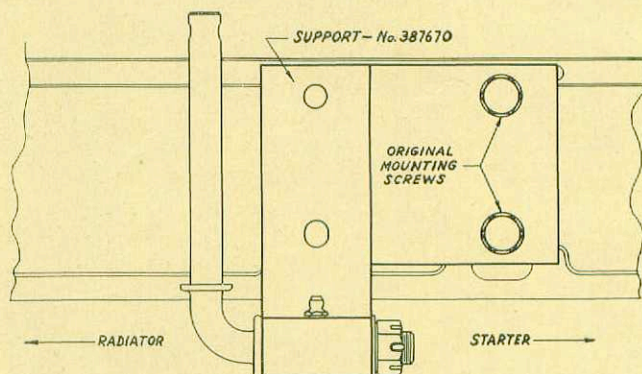
When installing replacement eight cylinder engine in the 1941 Clipper (1951) chassis, it

is necessary to use the special Steering Column Gear Shift Lever Support Assembly, No. 387670, which is now available. This part

is necessary to bring the idler lever shaft into the correct relation with the steering column gear shifter levers. Bolt the special support to the cylinder block with the idler lever shaft bearing end toward the radiator.

Remove the idler lever shaft from the old support and install it in the new support in the reverse position. In the original installation the shaft was on the rear or starter motor side of the support. In the new installation, it is on the front or the radiator side.

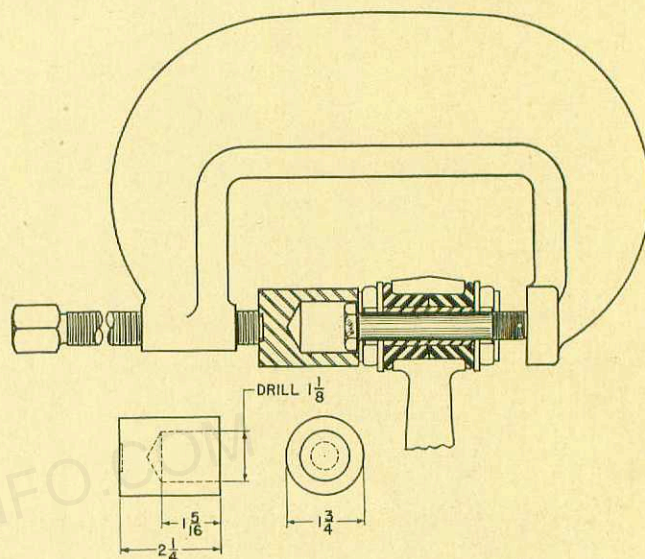
One of the most difficult jobs on the Packard Safe-T-Flex front suspension on Non-Clipper models is the removal of the wheel support upper bushing bolt.

This bolt passes through the wheel support upper bushing and retains the camber pilots and the shock absorber arm to the wheel support. Since the bolt passes through a steel sleeve in the bushing any rust formation at this point makes removal of the bolt extremely difficult.

The adapter to be used must be made locally from 1-3/4 inch diameter cold rolled bar stock to the dimensions shown in the accompanying sketch, when the No. 6 clamp is used, and two inches longer (4-1/4 inch) when the No. 8 clamp is used.

When using the clamp, place the adapter over the head of the bolt, place the set screw of the clamp against the adapter and the clamp seat against the threaded end of the bolt. Apply penetrating oil to the bolt and tighten the clamp with a long handled wrench.

It is sometimes necessary to strike the head of the clamp screw a sharp blow with a hammer to break the bolt loose. Then press out with the clamp screw.
