PACKARD

Service Counselor

VOL. 20, NO. 9

SEPTEMBER, 1946

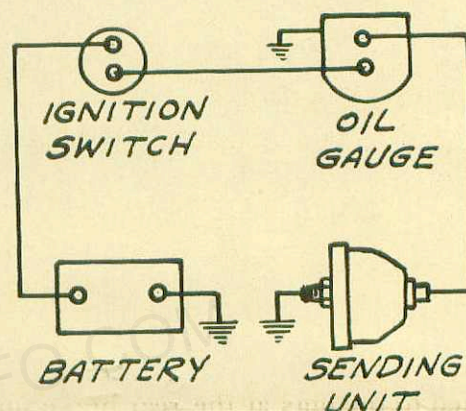
A high oil pressure reading usually indicates a poor ground at the oil pressure gauge case. A poor ground at this point will reduce the

amount of current flowing through the bypass thereby causing the gauge to indicate a higher pressure than is actually being transmitted by the sending unit.

When this condition exists, the gauge should be checked for tightness in the case since a loose gauge will not provide a proper ground for the electrical circuit. If the gauge is found to be tight there is still the possibility of the gauge not being properly grounded. The simplest correction for this is to place a drop of solder on the back of the gauge to insure positive contact between the gauge and instrument case.
