PACKARD

Service Counselor

VOL. 21 NO. 14

AUGUST 1, 1947

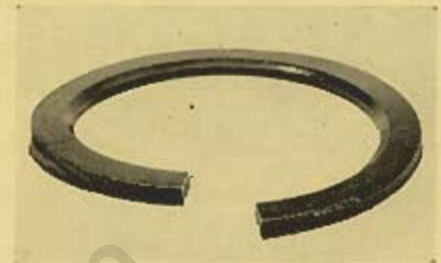
Clipper Front End Strike-Through

You may have occasional reports of Clipper front ends striking through or bottoming when driving over deeply-rutted roads.

You also may encounter cases in which a front spring has sagged to the extent that one side of the car is considerably lower than the opposite side. When this condition exists, it usually is found in cars which have seen a considerable amount of service.

The tendency of front ends to strike through can be substantially reduced by using front spring spacers, part number 326836. This spacer also may be used to equalize front end height in the event one side of the car is lower than the opposite side. Placing one spacer under a front spring will increase the space between the top of the front spring compression bumper and the pad on the bottom of the frame approximately $\frac{1}{4}$ -inch.

stall these spacers. A one-inch section then should be cut out of the spacer and the spacer bent to the shape of the one shown in the accompanying illustration. Bend the spacer

so that the one end is $\frac{1}{2}$ -inch higher than the other end when the spacer is placed on a flat surface. This will form the spacer to the same approximate shape as that of the recess in the spring seat attached to the bottom of the support arm. The spacer then should be installed in the spring seat with the beveled inner edge of the spacer facing downward and the spacer rotated until the lower end is in line with the edge of the drain hole in the spring seat.

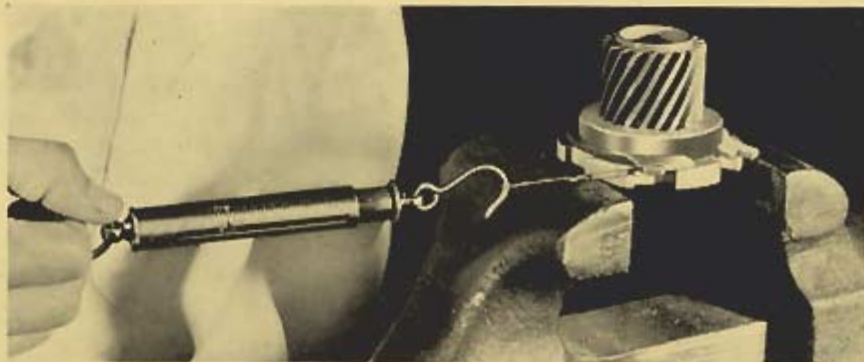
Sluggish Overdrive Engagement

If sluggish engagement exists after the lubricating oil has reached its normal operating temperature and if the engine idle is normal (approximately 450 rpm), the sluggishness may be caused by an insufficient amount of drag or friction between the overdrive stationary gear balk ring and the stationary gear plate. Insufficient friction between these two parts will delay the engagement of the overdrive.

Insufficient friction between the balk ring and the stationary gear plate will prevent the movement of the balk ring with the plate. The sliding pawl then will remain on the step of the balk ring while the stationary gear plate is rotating with a gradual increase in speed. When the pawl finally is released by the balk ring, the stationary gear plate is rotating too fast for the pawl to enter one of the openings in the plate and the pawl just skips over these openings. When the speed of the stationary gear plate has decreased to a point which will permit the pawl to enter one of the openings in the plate, the plate will be stopped so abruptly that a harsh "clunk" will be felt when the shift into overdrive is completed.

When a new balk ring is installed the tension or torque load should be checked as shown in the accompanying illustration. The stationary gear plate and the balk ring should be lubricated with transmission oil and checked for a torque load of $3\frac{1}{2}$ to 5 pounds with a scale held parallel with

the step of the balk ring. The reading on the scale should be taken while turning the balk ring since the initial effort required to start the ring turning may be considerably higher than the specified torque.

If a balk ring is to be installed in an overdrive which has seen a great deal of service, the gear plate should be checked for being excessively worn or grooved. If the plate is grooved, the stationary gear and plate should be replaced.

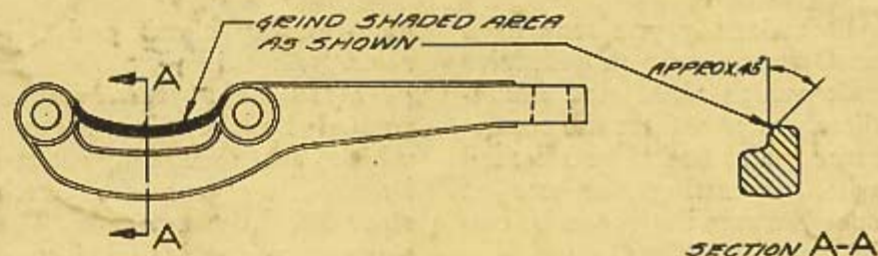
Steering Knuckle Lever Interference

Prior to installing a replacement steering knuckle, a steering knuckle lever, or both, a check should be made to determine whether the lever will interfere with the steering knuckle when the lever is in its normal position.

the steering knuckle at any point other than at the faces of the two retaining bolt hole bosses. Interference at any point may distort the knuckle when the retaining bolt nuts are tightened to their final torque during the reassembly operation.

Distortion of the knuckle will tend to throw the knuckle pin out of alignment and the pin then will bear heavily upon concentrated points in the knuckle pin upper bearing and the lower bushing. This can very easily cause rapid wear in the bearing and bushing which will materially shorten the life of both parts.

The lever may be checked for interference while the steering knuckle is either on the car or on the bench. When the lever is held against the steering knuckle in its normal position, the faces of the bolt hole bosses should be firmly seated against the machined surfaces of the steering knuckle. If a gap exists at either face, or if the lever can be rocked on the steering knuckle, the inner corner of the curved section of the lever and the inner edges of the bolt hole bosses should be ground off as shown in the accompanying illustration.
