PACKARD

Service Counselor

VOL. 21, NO. 22

DECEMBER 1, 1947

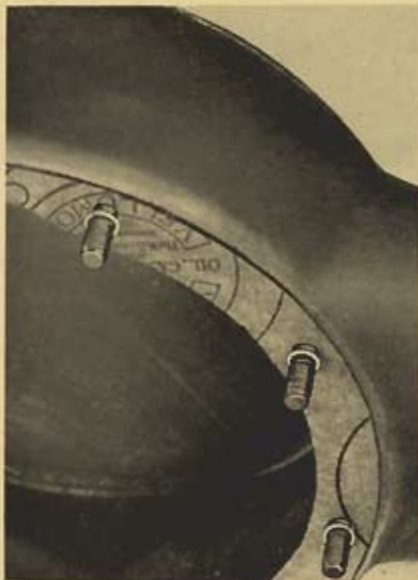
Wire Gasket Designed to Stop Oil Leaks at Differential

To prevent oil leakage at the differential retaining nuts, the rear axles on late 21st Series and all 22nd Series production are equipped with a new type copper wire gasket around all the carrier retaining bolts. The flat type copper gasket, part number 237673, formerly installed between the bolt heads and the flange inside the rear axle housing has been discontinued.

Examination of wire gaskets that have been removed after compressing reveals the soft copper wire flattens out and forms a tight seal around the bolt and in the bolt hole chamfer, thereby preventing any oil from working out along the bolt or around the retaining nuts.

Part number 398505, now being used, is a round copper wire cut to length and bent into a circular shape. In assembly the wire gasket is slipped over each housing bolt after the carrier to housing gasket is installed and then the carrier is mounted and tightened. The wire will then become compressed between the carrier and axle housing faces.

In order to prevent oil leaks from occurring at the retaining nuts on other models in the field, it is recommended that these new gaskets be used whenever carriers are changed for any reason.

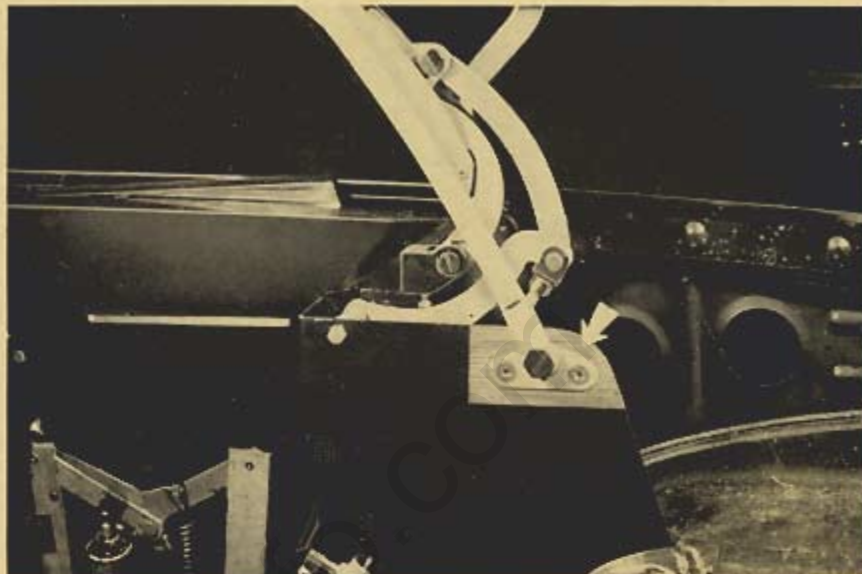
Fig. 22—Side Rail May Be Raised or Lowered by Shifting Serrated Bracket Indicated by Arrow.

If a side rail is too high or too low in relation to the tops of the door window and the quarter window, the affected side rail may be lowered or raised by shifting the serrated bracket indicated in figure 22. The brackets are attached to panels located on each side of the rear quarter and are accessible without removing the rear quarter trim panels.

To raise a side rail, unlock the top and lower the top approximately half-way. Loosen the three retaining nuts which hold the serrated plate and link assembly to the panel and move the plate downward. To lower a side rail, unlock and lower the top approximately half-way, loosen the three retaining nuts, and move the plate upward.

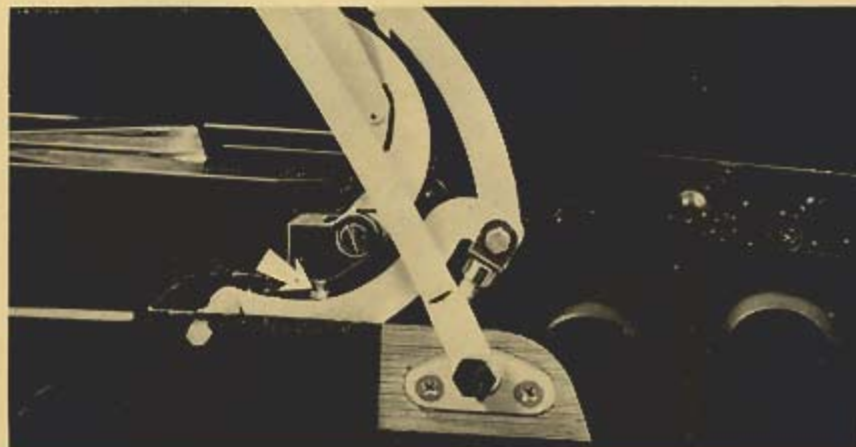
Fig. 24—One of Two Adjusting Screws Controlling Top Forward Movement and Fit at Quarter Window.

Figure 24 shows one of the two adjusting screws which control the forward movement of the top. These screws also control the fit of the top at the curved rear section of the quarter window. While these adjusting screws are hidden from view they are, nevertheless, accessible without removing any of the rear quarter trim.

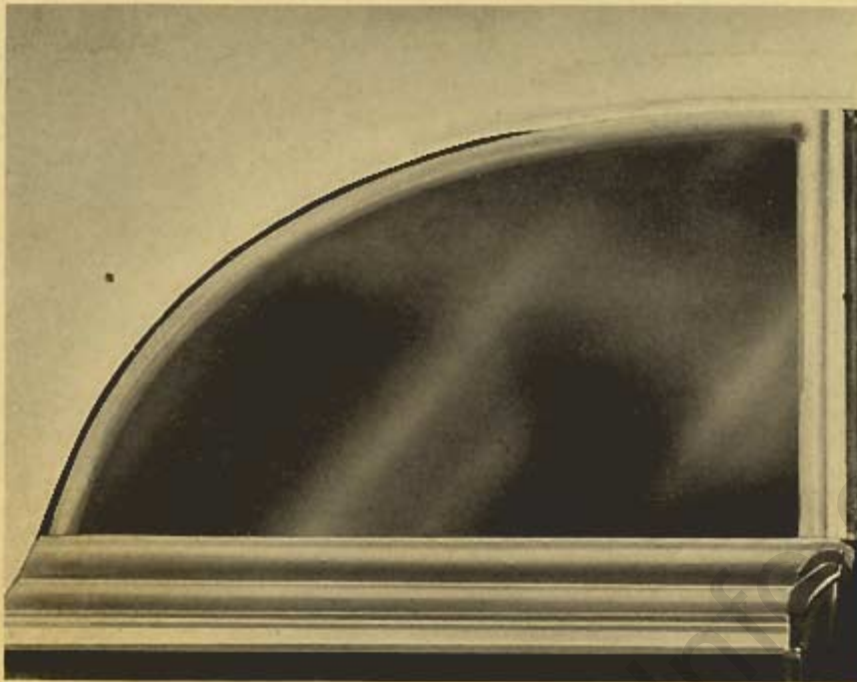
Fig. 25—If Top Gaps as Shown, Turn Adjusting Screws "In". If Too Close, Turn Screws "Out".

If a gap exists, as shown in figure 25, between the curved rear section of the quarter window and the weatherstrip attached to the curved rear top rail, loosen the adjusting screw locknut and turn the screw in until the gap is closed.

If the curved rear top rail fits too tightly against the quarter window at this curved rear section, causing the weatherstrip to be tightly compressed, loosen the locknut and turn the adjusting screw out until the pressure is relieved.

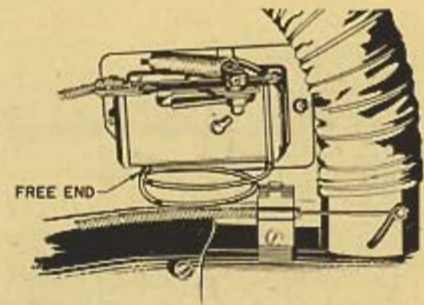
To obtain proper heat from the new fresh air heaters, it has been found necessary to change the position of the pressure tube of the heater thermostatic valve.

The thermostatic valve is located on the inside of the dash behind the glove compartment and above the heat distributing manifold. The thermostat pressure tube is coiled on the lower side of the valve with the free end inserted into the case. The free end is on

the side of the valve nearest the center of the car.

By reaching over the heat distributing manifold and prying downward on the end of the tube with the fingers, the free end may be pulled out of the valve. Unroll the tube and extend out under the glove box.

Drill or punch two $\frac{3}{16}$ -inch holes in the bottom of the glove box $1\frac{3}{8}$ inches from the rear of the box, one $5\frac{1}{2}$ inches from the right-hand edge of the box and the other $1\frac{3}{4}$ inches from the same point.
