PACKARD

Service Counselor

VOL. 22, NO. 10

AUGUST 1, 1948

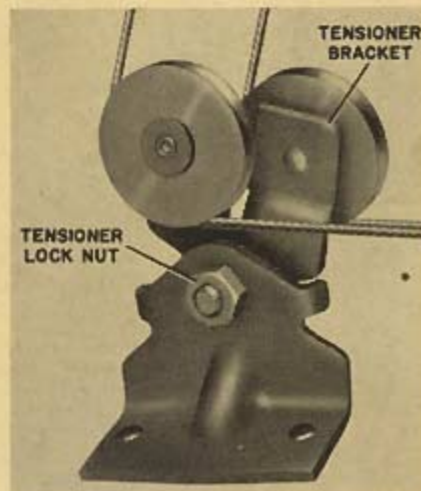
To adjust cable tension on the right-hand assembly, loosen the tensioner lock nut until the pressure is removed from the lock-washer. See illustration. The tension exerted by the spring will then move the pulleys outward and tighten the cables. If loosening the tensioner lock nut does not permit the spring to take up the slack in the cables, it may be necessary to tap the stud slightly to unseat the washer.

When making windshield wiper mechanism inspection, it is suggested that the tensioner assemblies be checked to see if they are tightened firmly to the dash panel. If they are not attached firmly to the dash panel, loose screws may throw the entire assembly out of alignment. When the tensioner assembly is out of alignment, the cables may scuff while running in the pulleys. Therefore, it is necessary that the pulleys run parallel at all times to prevent undue wear of the cables and pulleys.

When the windshield wipers are inoperative, check the cables to see that they are not crossed and run-

After the nut has been loosened and the cables retensioned, tighten the nut to hold the pulleys in their new position.

To tension the left-hand cables, loosen the tensioner lock nut to allow the tensioner spring to take up all the slack. Then hold the tensioner bracket firmly with your hand to prevent the tensioner bracket from turning on the pivot pin when tightening the tensioner

lock nut. It is necessary that the left-hand tensioner bracket be held when tightening the lock nut because turning the lock nut to the right to tighten would tend to wind up the spring and thereby reduce tension.

ning on the wrong pulleys. If they are found crossed, loosen the tensioner lock nut and pull the bracket inward to relieve the tension on the cables. Tighten the lock nut to hold the tensioner bracket in this position while relocating cables on their proper pulleys. Then readjust tension as previously described.
