PACKARD

# Service Counselor

VOL. 22, NO. 11

SEPTEMBER 1, 1948

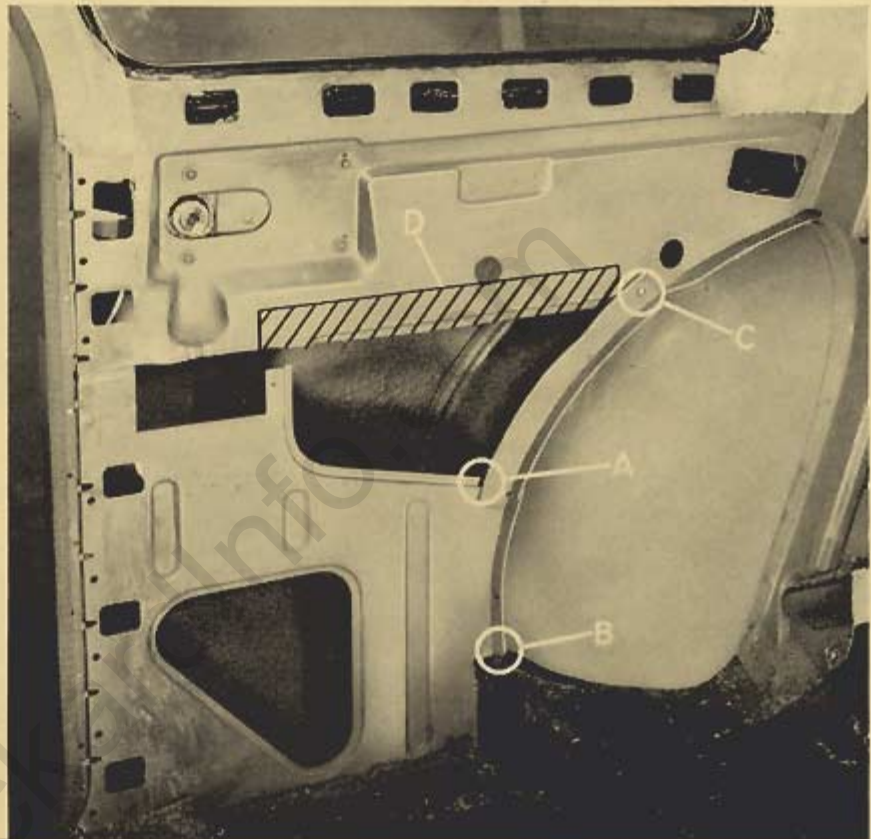
Fig. 1

Numerous Product Reports have been received from the field reporting water leaks at the rear quarters in Club Sedans.

When water enters the rear compartment at the side quarter panels, one or both of the following conditions may exist. 1—Water entering the rear quarter window opening is not being directed to the drain holes provided for the disposal of this water. 2—Insufficient sealing at panel seams and welded joints.

Figure 1 shows the rear quarter panels before starting the sealing operations and water shield installations. You will note that a pocket exists at circle "A" where the lower end of the drain flange is welded to the upper rear corner of the lining panel. It is very important that this pocket be completely filled with "dum-dum." When this pocket is filled, water entering the window opening and following the drain flange will be directed to the outside of the lining panel instead of accumulating in the pocket and falling to the inside of the panel.

Circle "B" indicates a point at which an opening may be found. If

After the seams and openings have been completely sealed, the water shields may be installed. The first step is to break the spot weld at circle "C," figure 1, and bend the upper end of the drain flange away from the window frame panel approximately  $\frac{1}{8}$  inch.

The large water shield now should be installed. Apply cement to the face of window frame panel, cementing over the patches which cover the two holes. The raised or protruding faces of the panel should be completely coated with cement. It is not necessary to apply cement to the channels or indented sections of the panel. However, it is very important that cement be applied behind the panel over the area indicated by the shaded section "D," figure 1.

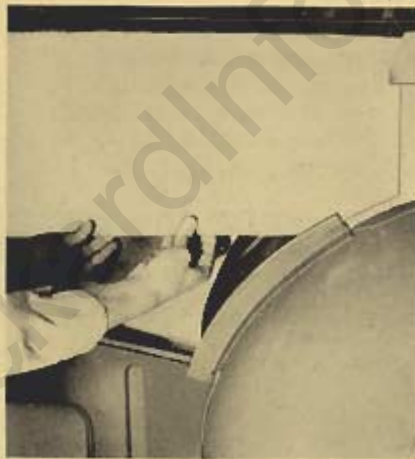
Fig. 5

It is vitally important that the fold in the shield extend upward approximately one inch, otherwise the shield will be punctured by the arm rest hook when the trim panel is installed.

low the lower edge of the frame panel after the shield has been placed on the face of the panel and smoothed out. This cemented section then should be pushed up or folded behind the panel and pressed to the previously cemented section behind the panel as shown in figure 5.

Before installing the trim panel, recheck the fold in the shield, as shown in figure 5, to make sure this section is properly cemented to the back of the panel. To install the trim panel, bend the lower end of the panel inward, as shown in figure 7, while pushing the panel to the rear and upward to engage the arm resthook. When properly positioned, snap the panel fasteners into place and reinstall those parts which were removed to gain access to the rear quarters.

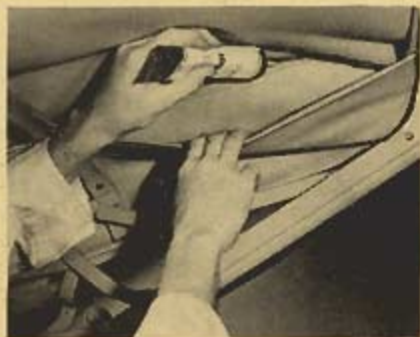
Fig. 1

A new type sealer for correcting water leaks at three possible sources on Convertibles is now available for Service. When leakage is noticeable at the top deck cover seams, the belt rail moulding, or the top front header trim mouldings, it is suggested that this sealer be used at these points.

To service leaking top deck seams where the cover joins the quarter panel side covers, loosen the top at the front bow and raise the top until the tension is released on the top fabric. Then pull the side quarter pads down to gain access to the seams. Insert the sealer tube nozzle against the stitch line as shown in figure 1 and apply the sealer.
