PACKARD

# Service Counselor

VOL. 22, NO. 13

NOVEMBER 1, 1948

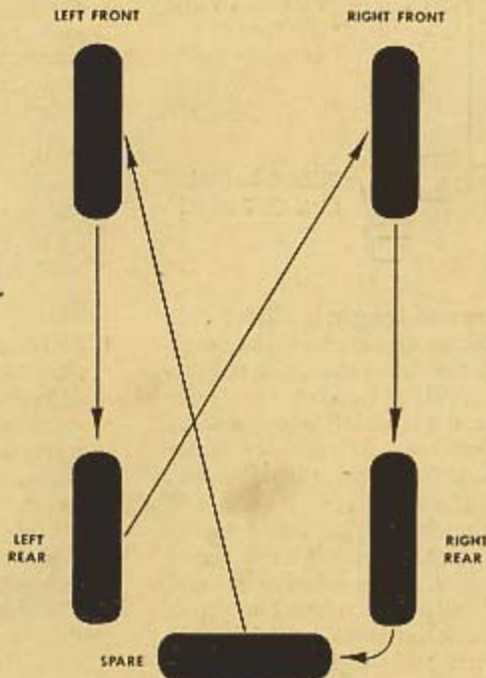
*L.H.P arrangement*

The diagram shows a simple, inexpensive way to rotate wheels around car without demounting tires.

Changing wheel positions of tires, including the spare, every 2000 to 3000 miles, or at very latest not over 4000 to 5000 miles, is essential to EQUALIZED TREAD WEAR — LONGER TIRE LIFE — A SMOOTHER RUNNING CAR — LESS TIRE EXPENSE — GREATER SAFETY.

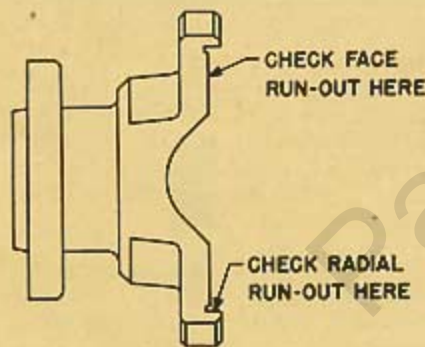
1. Wheel unbalance is a very common cause of roughness and should be the first item to be checked when working on a complaint of this nature.
2. Universal joint flange runout either at the face or a radial runout at the universal joint bearing mounting flange should be checked. The permissible runout at the face is .004 inch and the radial runout at the inside of the bearing mounting flange is .004 inch. This runout should be checked with a dial indicator mounted in such a manner that the flanges may be turned to make the inspection.

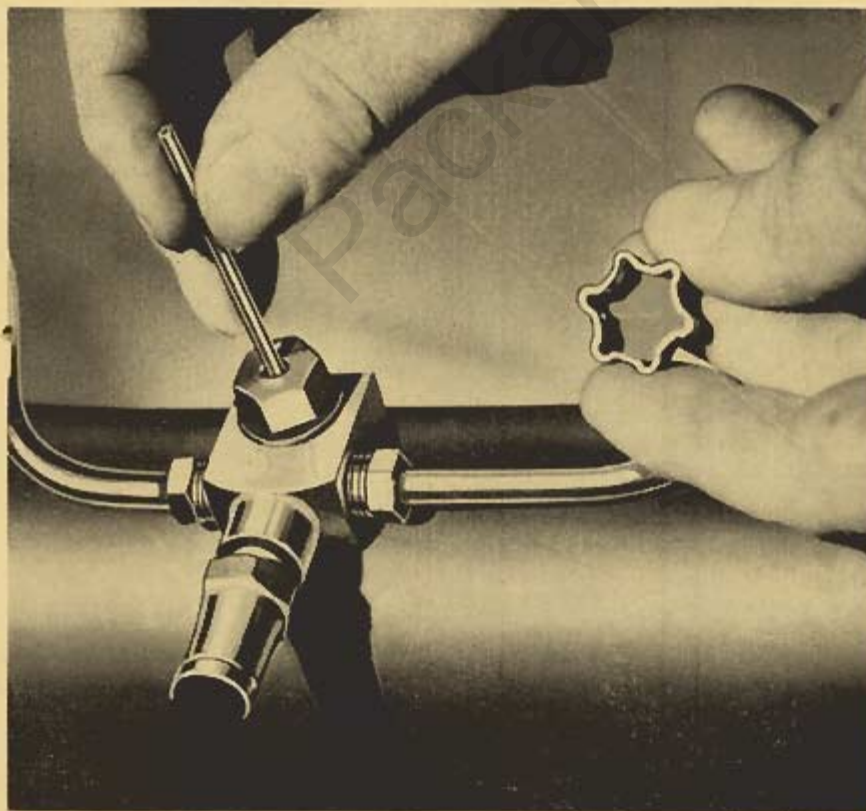
Fig. 1

The axle housing vent or breather should be checked by probing with a piece of wire as shown in figure 1. On cars which have been undercoated, the inside of the breather cap also should be inspected and, if necessary, cleaned to remove any undercoating material which may have lodged in the cap. If the breather vent is plugged or restricted, the normal rear axle heat will create a pressure build-up and may force the oil past the seals.

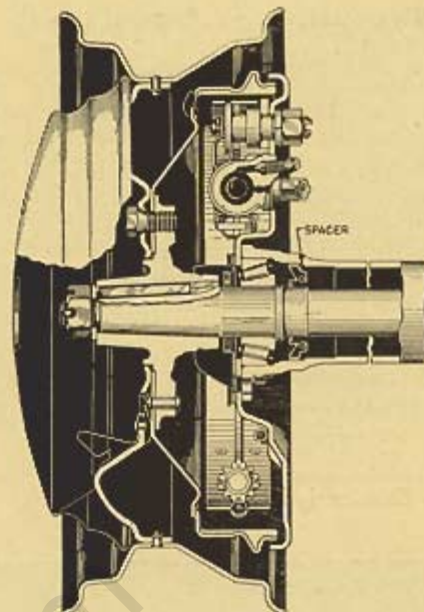
Fig. 2

After removing the axle shaft, closely inspect the seal running surface on the shaft for machine marks, grooves, or roughness and replace the shaft if necessary. If no defects are found, inspect the contact area of the seal where it contacts the shaft running surface. It may be found that the inner edge of the seal is not contacting the running surface but is extending beyond it. If this is the case, the part which contacts the running surface will have a polished or burnished appearance while the inner end will show no signs of contact. When this condition exists, it may be corrected by cutting a single coil from a horn ring spring and using it as a spacer behind the oil seal as shown in figure 2. This will move the seal outward and permit the seal to

fully contact the running surface on the shaft.

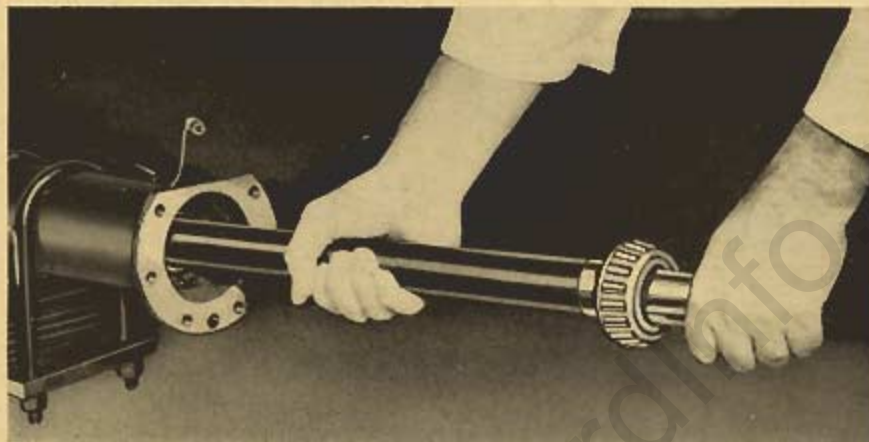
Fig. 3

Carelessly installing an axle shaft

also may cause a leak at the inner oil seal. When installing the shaft, it should be supported as shown in figure 3. If the shaft is just started into the seal and then pushed into the housing while the weight of the shaft is resting on the seal, the seal may become scuffed or the seal retainer may be distorted.
