PACKARD

Service Counselor

VOL. 23, NO. 3

MARCH 1, 1949

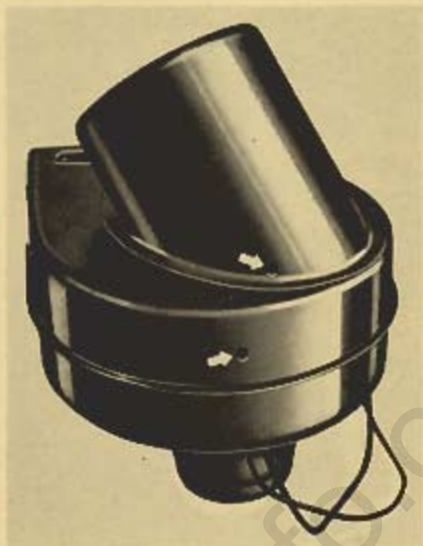
When steam emerges from the heater or defroster outlets in a 22nd Series heater equipped vehicle, the trouble usually may be traced to a leaking heater core or to an accumulation of water in the bottom of the blower housing.

Either condition may cause the inside of the windshield and the windows to steam up when the engine reaches normal operating temperature even though the heater blower is turned off. When the car is in motion and hot coolant is circulating through the heater core, water or coolant emerging from or contacting the core will turn into steam which will be forced out of the heater or defroster outlets by the normal air blast through the air duct. When the blower is turned on, the inside of the car will steam up considerably faster.

Water entering the blower housing is most likely to occur when the

car is being washed or in a heavy rainfall when water may be forced under the bonnet in the vicinity of the large flexible hose between the blower and the air duct adapter. If this water finds its way into the hose at the top, it will travel downward and become trapped in the blower housing.

Core leaks, in most cases, can be eliminated by closing the hole with solder. In the event that water has accumulated in the blower housing, the blower assembly should be removed and two $\frac{1}{8}$ -in holes drilled at the lowest point of the housing and the inlet duct as shown in the accompanying illustration. This will provide an escape for any water which may find its way into the housing.

These holes should be drilled and not punched. Punching the holes will upset the metal on the inside, thereby forming a dam around the hole.

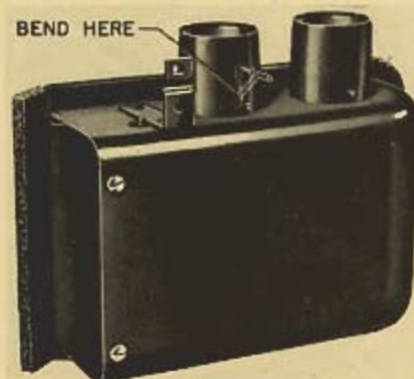
In some cases, when the defroster knob is turned to the full on position, there is an excessive amount of heat escaping through the plenum chamber and a lack of heat from the defrosters caused by improper operation of the distributing valves. The defroster valves are not wide open and the valve to the plenum chamber is not fully closed.

To correct this condition, remove the operating wire from the defroster lever and bend the lever as shown in the illustration. Bend

the lever just enough to line it up with the loop in the control wire with the defroster knob in full on position, and the defroster valves wide open. The defroster valves must open to their full open position in order for the controls to fully close the valve door to the plenum chamber.

CAUTION: Use two pairs of pliers when bending the lever, one pair to hold the shaft from breaking loose at the defroster valve, while making the bend.

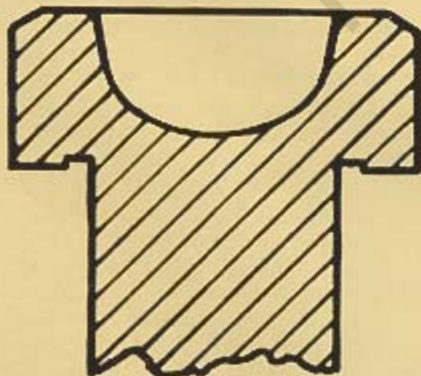
The accompanying illustration shows a cross section through the head of the self-locking type screw. You will note that the center of the head is cup-shaped and that a circular recess extends around the inner portion of the seating face.

When the screw is tightened to its specified torque of 90 to 95 ft. lbs., a stretching action takes place in the head of the screw. The pressure exerted by this stretching or springing action in the head securely locks the screw in place.

Only the self-locking type screws, part number 403517, are being shipped from the Factory. When these screws are used to replace the early type screws, the screw lock plates should be discarded.
