PACKARD

Service Counselor

VOL. 23, NO. 4

APRIL 1, 1949

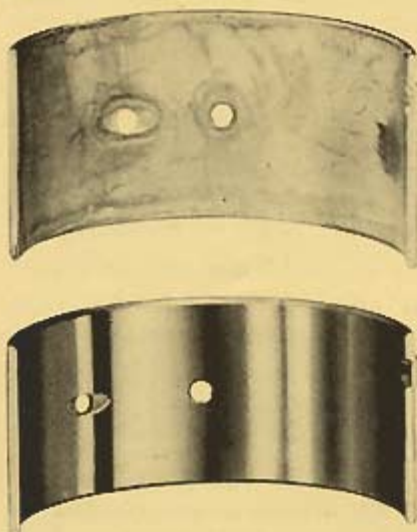
We wish to point out that the bearing surface finish is not the same on all bearings being shipped from the Factory. Some bearings have a bright and shiny finish while others have a flat or dull finish as shown in the accompanying illustration.

The finish of the bearing surface does not affect the quality of these bearings in any way. Either type bearing will give satisfactory service and bearings of the same size may be interchanged without affecting bearing clearance. The shiny bearing is plated simply to improve its appearance.

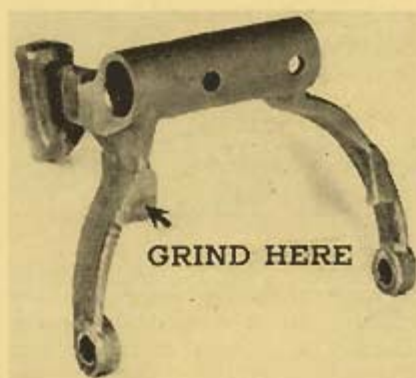
A limited number of R-11 Overdrive equipped cars have been shipped in which either the overdrive reverse plunger or the shifter rail is not of the proper length. If either of these parts is too long the overdrive cannot be engaged since the undercut in the shift rail will not properly align with the solenoid pawl.

To determine which part is defective, drive the car in low gear above governed speed and attempt to shift into overdrive. If the overdrive will engage in low but not in second or high, it indicates that the low and reverse shifter fork is preventing full forward travel of the reverse plunger.

To correct remove the transmission cover and grind approximately .020 inch from the left hand pad as shown in the illustration.
