## Service Product Report Forms

### Front Wheel Bearing Adjustment All Models

## Clutch Fails to Release Properly

## Intake Manifold Drain for Custom Eights

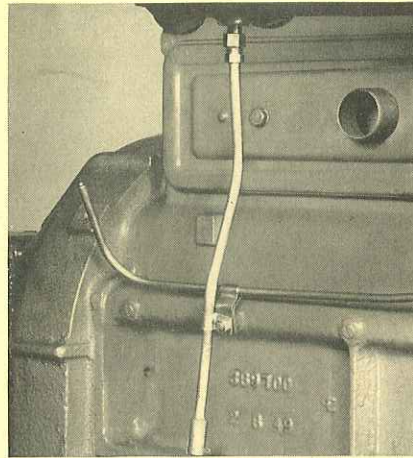
An intake manifold drain valve is now being installed on all Custom Eight engines in production. This valve may be installed on 22nd Series Custom Eights and all prior model Super Eights. It is located at the rear of the manifold for the purpose of draining accumulated fuel from the manifold. In some cases of hard starting fuel settles and accumulates at the rear of the manifold adjacent to numbers 7 and 8 intake ports.

When this condition exists this fuel sometimes enters the cylinder and since it is not compressible causes damage to the piston or connecting rod on the compression stroke.

The valve may be installed on cars not so equipped by drilling the manifold at the point shown in the illustration and tapping with a standard  $\frac{1}{8}$  pipe tap. The manifold should not be tapped deeply since the connector should be as near flush with the inside of the manifold as possible.

The valve is supported by a clip attached to a special pipe plug stud installed in the second oil gallery plug hole from the rear of the gallery.

The necessary parts for this installation are as follows:

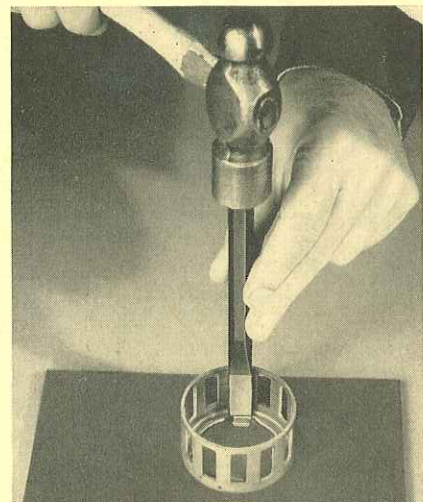
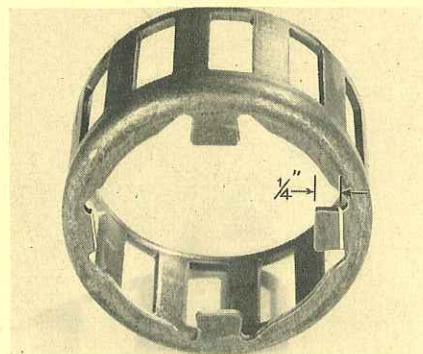
Retainers for the four pinion type R-9 overdrives also were carried under part number 347580 before the adoption of the R-11 unit. However, these retainers differed from those now being shipped in that four stops or tabs were used whereas the present retainer has only two.

These early (four tab) type retainers in Dealer stock may be used in R-11 overdrives after removing the two tabs which are near the retainer spring holes.

To remove the tabs, place the retainer on a hard, flat surface and, using a cold chisel, cut the tab off  $\frac{1}{4}$  inch from its end and repeat the operation on the opposite side. The sharp edges in the retainer then should be filed flat as shown.
