SERVICE COUNSELOR

PACKARD MOTOR CAR COMPANY

VOL. 24, NO. 3

MARCH, 1950

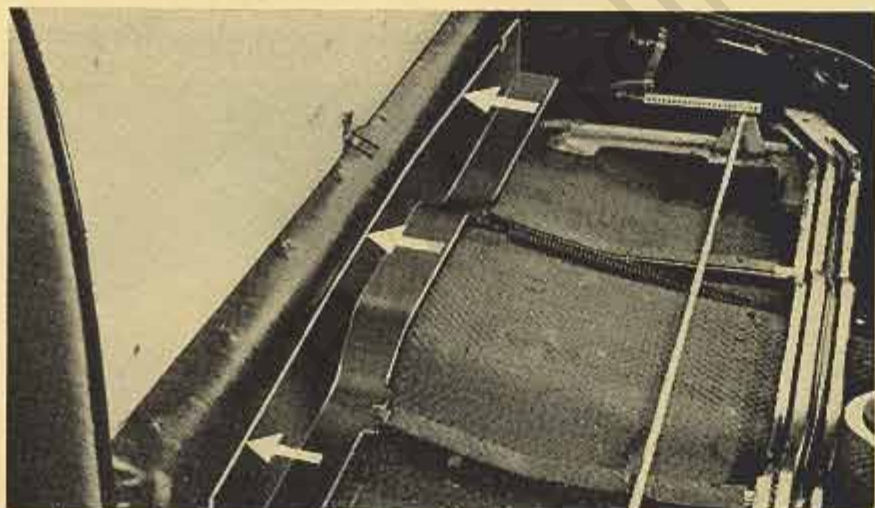
Installing Front Seat Cushion Covers

When installing front seat cushion covers, it is a good idea to inspect the flange shown in the accompanying illustration. Sometimes this flange presents a rough, distorted edge of metal to the seat cover material which, after re-

peated rubbing, will wear through

After inspecting the flange, flatten out any high spots with a hammer and, if necessary, remove the burr with a hand grinder, a file or a piece of coarse emery cloth.

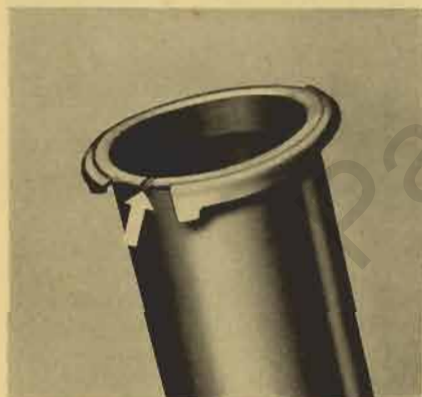
New Fuel Tank Filler Tube and Cap

The design of the gasoline tank inlet tube was recently changed. Before this design change, the locking flange which is engaged by the filler cap was on the inside of the neck, and venting was taken care of through the filler cap.

The locking flange on the new design has been turned outward and this, of course, called for a new design of the filler cap. The new cap is not vented. Instead, a small depression has been stamped across the filler neck flange (see illustration) so that when the filler cap is tightened down this depression prevents an airtight seal.

When spraying undercoating, it is possible for this material to load up under the filler cap, so after undercoating has been applied it is well to inspect both the filler cap and the venting depression. Scrape them clean if any material has adhered to them which would affect venting of the fuel tank.

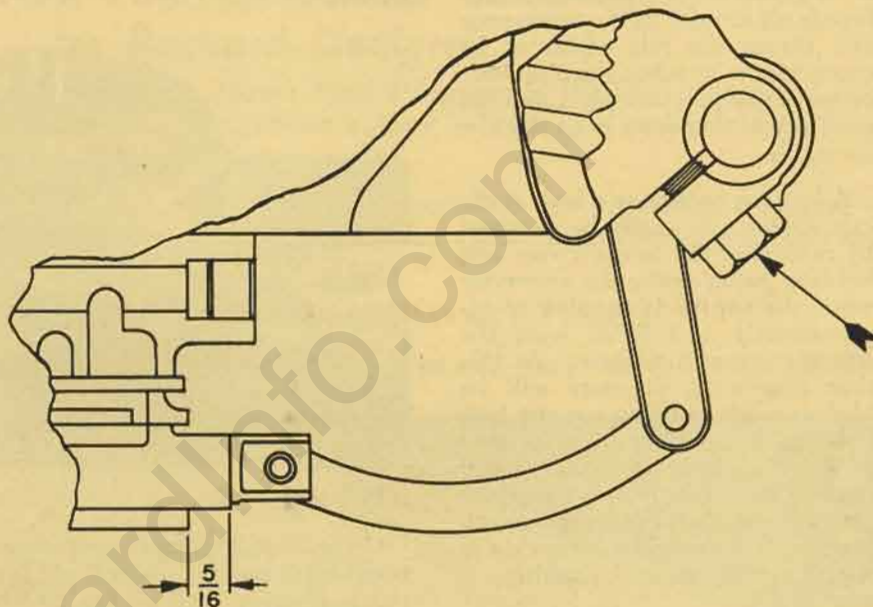
Ultramatic Control Valve Lever and Link

A new type control valve lever and link assembly now is being used in Ultramatic Drive units in production.

The early or first design assembly incorporates a two-piece, adjustable link which is adjusted so that the rear end of the control valve is $\frac{3}{4}$ inch out of the control valve lower body.

The new type valve lever and link assembly, shown in the accompanying illustration, incorporates a solid link in place of the two-piece link. To adjust the new type linkage, loosen the detent lever

cap screw indicated by the arrow. Set the detent lever in the reverse position. Set the control valve to the $\frac{5}{16}$ inch dimension shown and tighten the cap screw to 50 ft. lbs. torque.

The control lever shaft should have approximately .045 inch end play and this also is governed by the position of the detent lever. It may be necessary to again loosen the cap screw and move the detent lever on the shaft to obtain this end play. When this is done, the $\frac{5}{16}$ inch dimension should not be disturbed.

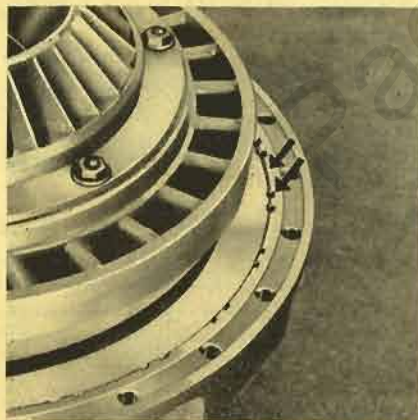
Fig. 1

We have heard of a few instances where an excessive amount of oil was dripping out of the drain hole in the flywheel housing lower cover. An inspection indicated that the oil was not leaking past the bell housing oil seal but past the converter pump gasket. However, replacing the gasket did not correct the leak.

In these particular instances, the oil was not being thrown out past the gasket in a manner which would indicate a defective or crimped gasket; instead, the oil was finding its way past an inner section of the gasket to the cap screws and emerging from under the heads of the screws. This condition can exist if the gasket is not compressed uniformly all around its circumference and across the full width of its contact faces or when the clearance between the pressure plate and the shoulder of the pump is on the low limit side.

After the pump has been removed, inspect the inner edge of the clutch housing flange and the spline ends indicated in figure 1. These should

be chamfered and there is a remote possibility that the chamfering operation may have been omitted. If the sharp edges are not chamfered, they may shave particles of metal off the outside of the shoulder of the pump when it is assembled and these metal particles may hold the inner part of the pump flange away from the gasket and cause a leak.

The first turbine and the reactor and shaft assembly can be lifted out of the clutch housing as an assembly and the parts remaining in the housing should be taken out if it is necessary to file and chamfer the sharp edges. The housing then should be thoroughly cleaned to remove all filings.

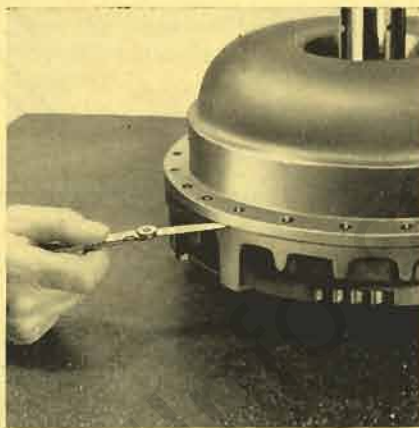
Fig. 2

On reassembly, the desired clearance between the flange of the pump and the face of the clutch housing, when measured without a gasket, is .007 inch or less. This clearance also should be consistent within .002 inch all around the pump flange. Figure 2 shows the clearance being checked.
