# Service Counselor

PACKARD MOTOR CAR COMPANY

VOL. 24, NO. 9

SEPTEMBER, 1950

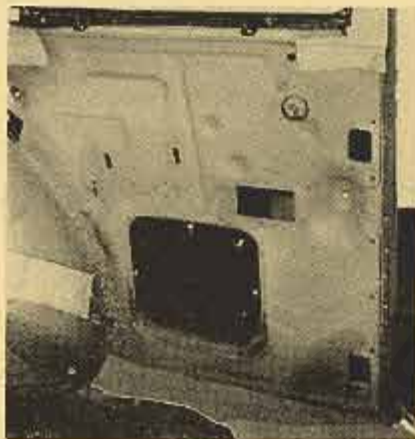
Fig. 1

Water leaks may be encountered at the rear quarter panels in early 24th Series Club Sedans, body models 2465 and 2495.

When this condition exists, water enters the rear quarter window opening, finds its way between the rear quarter inner panel and the trim panel, and then runs down between these panels to the floor.

Remove the rear seat cushion, rear seat back, rear quarter window inside finishing moulding, and the rear quarter side trim panel. Figure 1 shows the quarter panel before starting the sealing operations and water shield installation.

Correcting these leaks, when they exist in early vehicles in service, may be accomplished by installing Rear Quarter Water Shield Kit, part number 436057. Each kit contains two water repellent shields or aprons. Installation instructions and the additional sealing operations involved are as follows:
