# SERVICE Counselor

PACKARD MOTOR CAR COMPANY

VOL. 25, NO. 10

OCTOBER 1, 1951

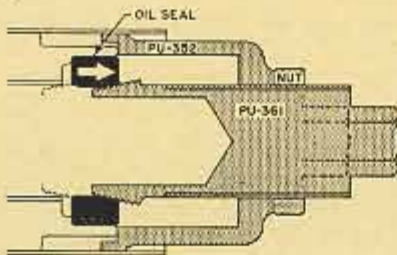
Fig. 1

A remover has been made available for removing the Rear Bearing Oil Seal on all types of transmissions and overdrive. In trying to drive the old oil seal out of the transmission rear bearing housings that have the babbit type bearing using a drift and hammer, we have seen damage caused to the bearing. When the approved tools are used it is not possible to damage the bearing.

Combination Tools PU-361 and PU-352 (Fig. 1) will remove the seal from the rear bearing transmission housing of all units, standard, overdrive and Ultramatic with the exception of the R-11 overdrive.

When using the remover, tighten the tapered end of the screw securely into the seal before applying pressure with the nut against the cup. As the nut is tightened against the cup to remove the seal, tighten the main screw into the seal two or three times as you proceed with the seal removal.

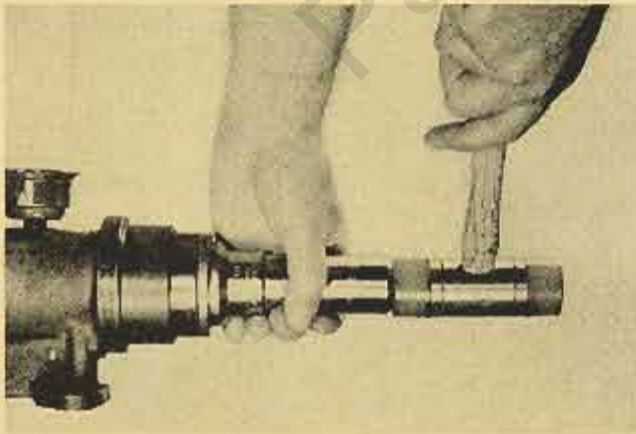
Fig. 2

Combination Tools PU-362 and PU-363 (Fig. 2) will install the rear bearing oil seal in all standard transmissions starting with the 19th Series through the 24th Series inclusive, also the 23rd Series Ultramatic and overdrive.

This tool combination will drive the seal squarely into place, in line with the shaft and to the proper depth. The large washer applies the load against the face of the metal retainer of the seal at the correct point of contact, eliminating the danger of damage, as the seal is driven into place.

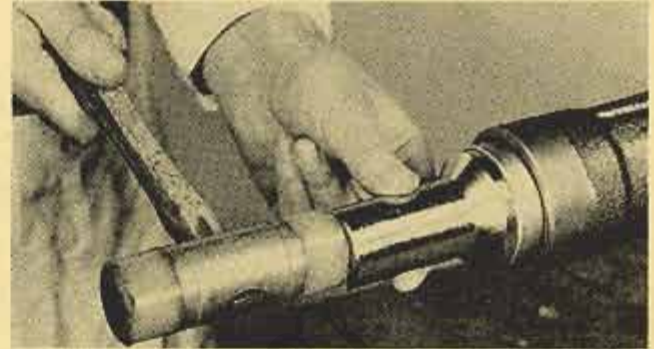
Fig. 3

Replacer PU-367, (Fig. 3), will install the Rear Bearing Oil Seal in all R-9 Overdrives starting with the 19th Series through the 23rd Series inclusive and the 24th Series Ultramatic.

This driver provides a safe method for installing a new seal as the load is applied to the correct point of contact on the retainer face of the seal as a new seal is driven squarely into place and to the correct depth without damage.

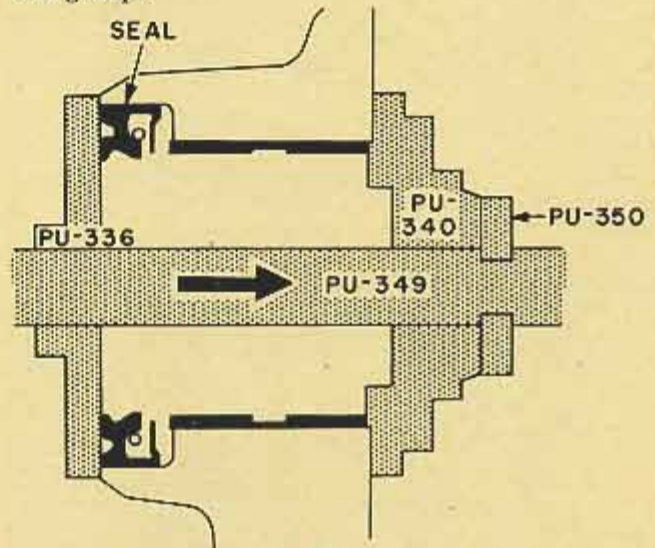
Fig. 4

Replacer PU-336, (Fig. 4), used in conjunction with Replacer PU-340 and Center Screw 349 with the Horseshoe Lock Plate 350 are provided for the installation of the oil seal in the Ultramatic Bell Housing. The Handle Nut PU-351 is provided for pulling the replacers together and drawing the oil seal into place. These tools are all included in the Service Bushing Tool Group PU-335.

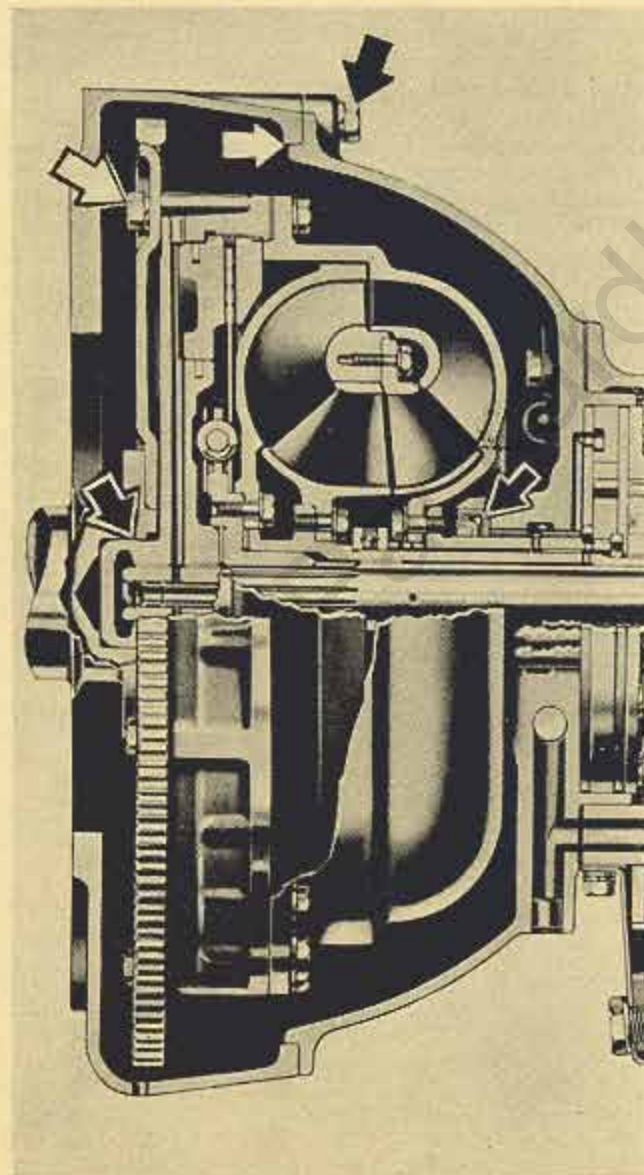
Converter mis-alignment is a contributing factor to front seal oil leaks, and may also cause a vibration at certain periods.

If there is a mis-alignment of the converter assembly, a bell housing oil seal leak may be more prevalent at high speeds than low speeds, due to the pump shaft mis-alignment and a slight run-out at the seal.

Dirt or burrs at the mating surface of the bell housing and flywheel housing may cause a mis-alignment or binding of the converter.

1. Install two pilot studs in the forward side of the clutch housing to guide it into the fly-wheel. Be sure the converter drain plugs line up with the opening in the fly-wheel. Operate the transmission jack up or down, side to side or tilt, so the pilot studs enter the fly-wheel, and the clutch housing pilot enters the bore in the center of the crankshaft.

2. Slide the transmission forward, and start all the bell housing to upper fly-wheel housing cap screws, jack the transmission up until the shoulder on the bell housing flange is tight against the fly-wheel housing opening, torque tighten the bell housing cap screws to 25 to 30 ft. lbs.

3. Move the converter assembly forward and back by hand to see if there is any bind. The pilot on the forward side of the converter clutch housing should move freely in the bore at the rear of the crankshaft. The clearance at this point is .001 to .0025. If the converter binds it may be necessary to loosen the bell housing cap screws and move the transmission up or down or from one side to the other a few thousandths to get a correct free alignment of the converter. Retorque the bell housing cap screws and recheck the converter alignment and free movement by hand.

4. When correct alignment and free forward and back movement is accomplished, remove the two pilot studs and install the clutch housing to fly-wheel cap screws and torque tighten to 25 to 30 ft. lbs.
