SERVICE Counselor

PACKARD MOTOR CAR COMPANY

VOL. 25, NO. 12

NOVEMBER 1, 1951

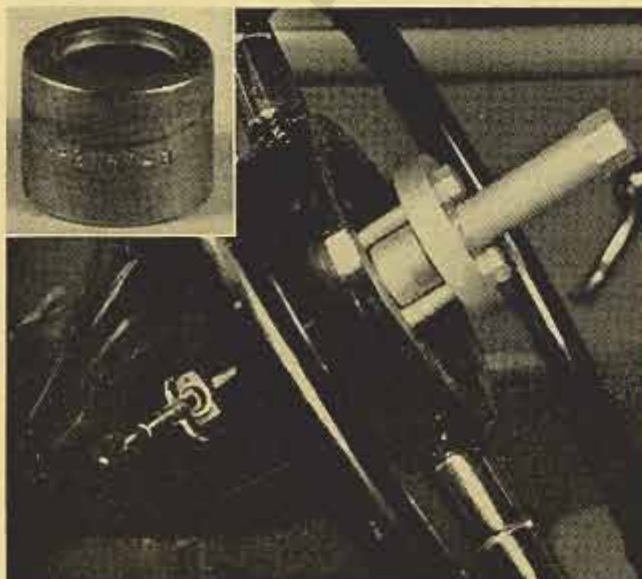
Steering Wheel Puller Adapter

An adapter, J-2557-3, is now available and is used with the Steering Wheel Puller J-2557, as illustrated.

The adapter when threaded on the end of the main steering shaft prevents damage and spreading of the main shaft as the load or tapping is applied through the main screw of the puller.

When using the adapter with the puller, remove the two $\frac{1}{8}$ nuts from the capscrews in the puller as the nuts will not clear the adapter. Loosen the steering wheel until the hub of the wheel strikes against the lower edge of the adapter. Remove the puller and adapter and lift off the steering wheel.

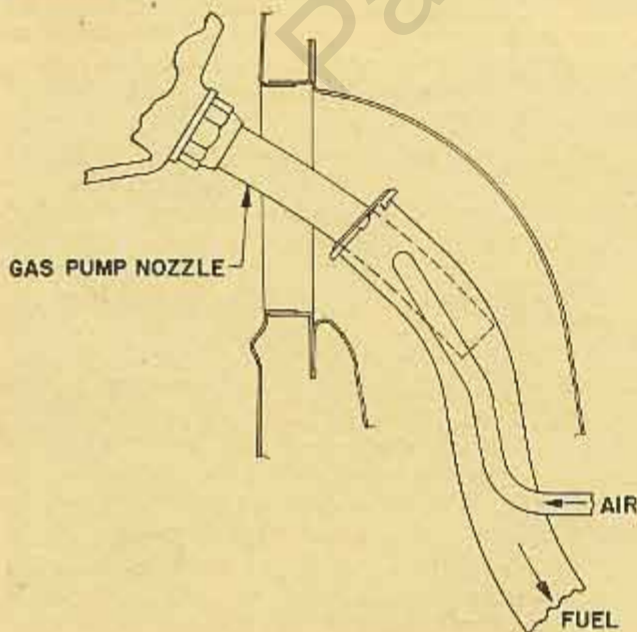
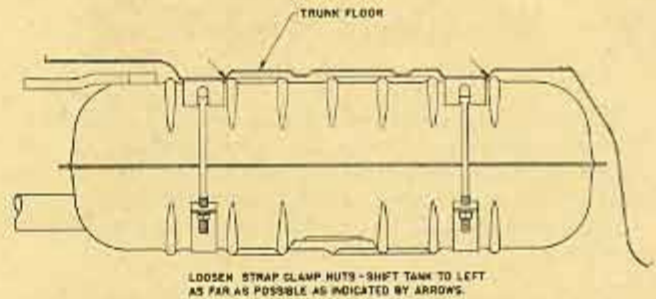
Gasoline Tank Filler Pipe

A few reports have been received that the gasoline tank filler pipe was not aligned with the gasoline filler pipe access door opening.

This makes it difficult to remove the gasoline filler pipe cap, and for the gas station attendant to properly insert the gasoline hose nozzle. If the hose nozzle is not inserted far enough past the vent opening, thus restricting the air vent in the filler pipe, it will contribute to a slow filling of the gasoline tank or spilling out during filling.

Loosen the gasoline tank straps and shift the tank to the left as far as possible, but be sure the tank ribs are not quite touching the ribs of the trunk floor panel, since contact may develop a squeak at this point. (See arrows on illustration.) Moving the tank to the left will move the filler neck outward with relation to the access door opening so the gasoline hose nozzle can be inserted more easily. Note the position of the gasoline hose nozzle in the filler neck shown on the illustration.
