PACKARD MOTOR CAR COMPANY

Counselor

VOL. 25, NO. 14

DECEMBER 1, 1951

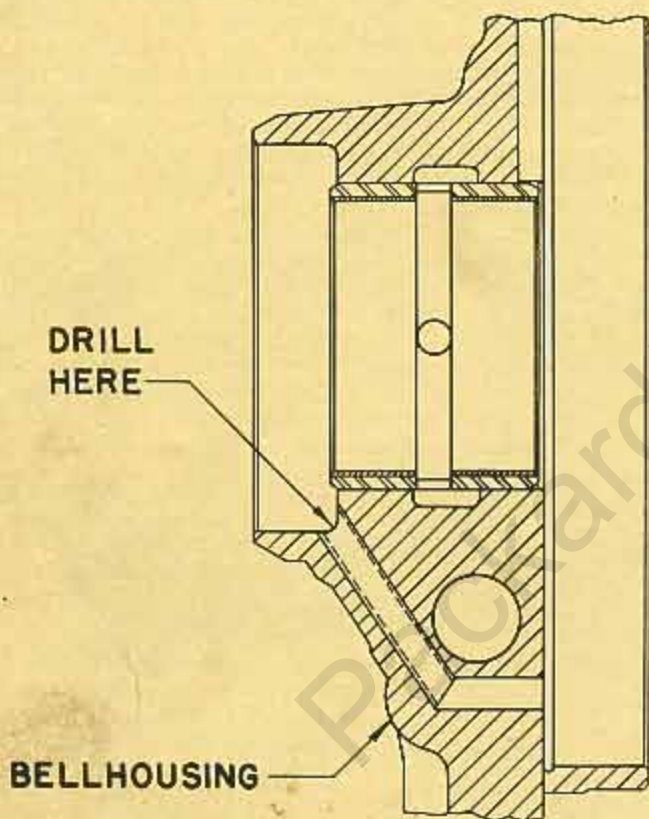
Ultramatic Bell Housing Oil Seal Drain Hole

Recently a change in production was made in the size of the bell housing oil seal drain hole. The drain hole was enlarged from $3/16"$ to $1/4"$ to increase the oil drain area, which will help to prevent oil leaking past the oil seal.

If the occasion should arise whereby the bell housing is removed from the transmission to replace an oil seal or the bushing in the bell housing, it is advisable to enlarge the $3/16"$ hole by redrilling the hole with a $1/4"$ drill. The broken line in the accompanying illustration indicates the area to be redrilled.

Remove the metal chips by blowing through the drain hole with compressed air.

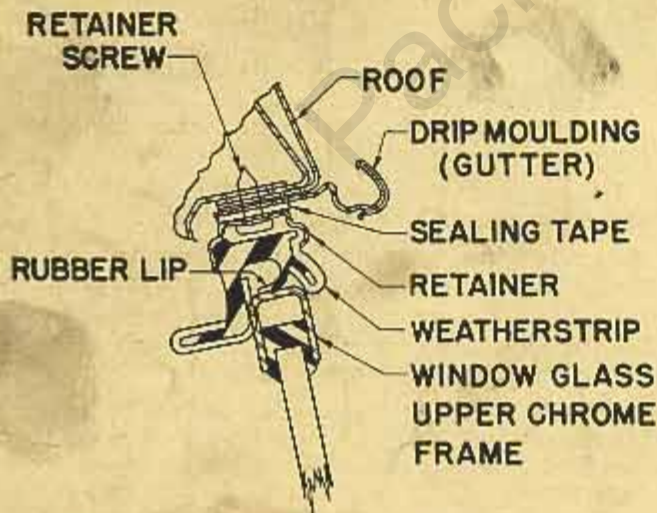
Reports have been received of incorrect alignment of the windshield pillar post and roof rail weatherstrips on the Mayfairs and Convertibles. This incorrect alignment contributes to water and air leaks around the window frames.

The cross section illustration below shows the correct fit and alignment of the weatherstrip to the vent window frame and window frames. Be sure that when closing the door, the chrome window frame rubs lightly on the outer lip of the weatherstrip and does not rub hard enough to fold the lip under. After the door is closed, the chrome window frame should rest firmly against the inner lip of the weatherstrip.

The correct weatherstrip fit and alignment can be accomplished by the following procedure:

- Check the fit and alignment before removing the weatherstrip. Mark the places that need to be lowered or raised, moved in or out.
- Alignment can be obtained at times by adjusting the window stops either up or down or by tilting the window inward or outward with the adjustments that are located inside the door and behind the plugs located at the rear face of the door.
- The weatherstrip can be adjusted toward or away from the window frame by adding or removing a layer of the sealing tape. Part No. 435788 sealer tape (roll) is available through the Zone Parts Warehouse.
- The weatherstrips can be moved inward or outward by loosening the weatherstrip retainer screws and moving the retainers in the direction desired.
