SERVICE Counselor

PACKARD MOTOR CAR COMPANY

VOL. 25, NO. 7

JULY, 1951

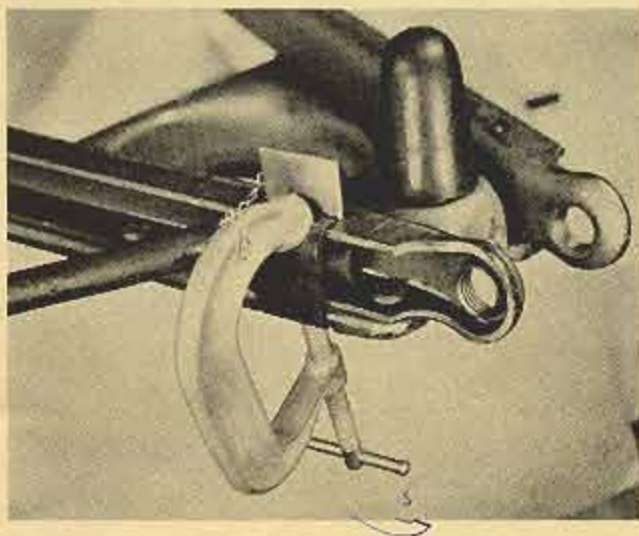
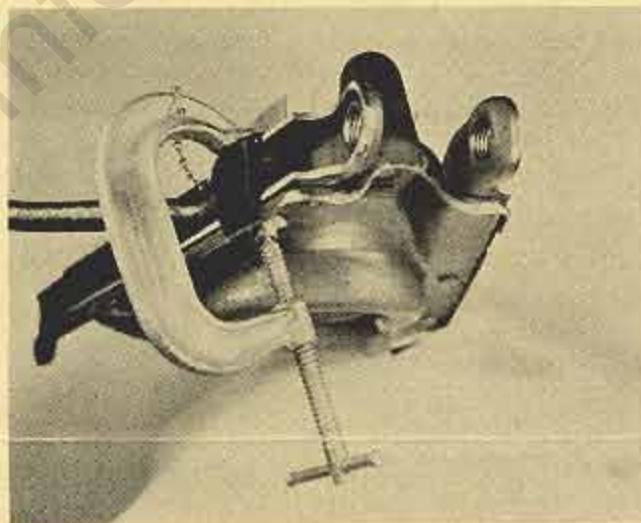
J-4654 Stabilizer Bushing Retainer Clip Installer

There has been some misunderstanding as to the correct application and use of this installing tool for the front stabilizer bushing retainer clips at the lower support arms. The retainer clips for the bushings are difficult to install without a tool because of damage or the danger of clips coming loose because they were not properly installed.

The illustrations show the correct application of this tool. The wedge is placed in the holes on the upper side of the support arm channel to keep the two fingers on the retainer from working back as the clamp applies pressure downward on the retainer clip. The upper outer round corner of the retainer clip fits into the groove on the flat face of the anvil section of the clamp. The movable button end of the clamp screw fits against the flat surface on the

lower side of the support arm behind the outer flange of the support arm.

As heavy pressure is applied to the retainer by tightening the screw of the clamp, the clip is pulled down with a radial action to move or snap the lower flange of the clip into place at the recess on the support arm lower flange.

It may be necessary in some cases, due to slight variations, to tap the lower flange of the retainer clip into place with a hammer, while full application of pressure is being applied by the clamp.

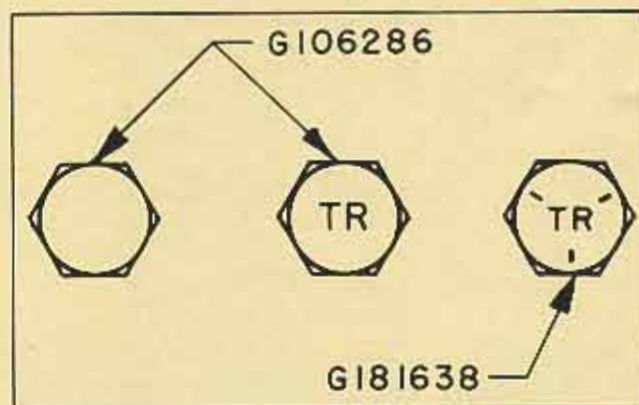
Rear Stabilizer Arm Bolts

A number of reports have been received of the rear stabilizer spring seat arm bolts breaking.

In a few instances, it was found that the wrong bolts had been installed. The bolts used in the steering connecting rod idler lever support are the same size and thread.

The other two bolts shown in illustration under Part No. G106286 have been used in the steering connecting rod idler lever support and are now obsolete.

The bolt, Part No. G181638, is made of special steel and can be identified by the three radial marks on the head shown in illustration. Be sure to install only this type bolt in the stabilizer spring seat arm. Torque tighten to 45 to 55 ft. lbs.

Be sure the two stabilizer grommets, Part No. 418340, are adjusted to give equal pressure on each side of the spring seat arm when car has normal load.

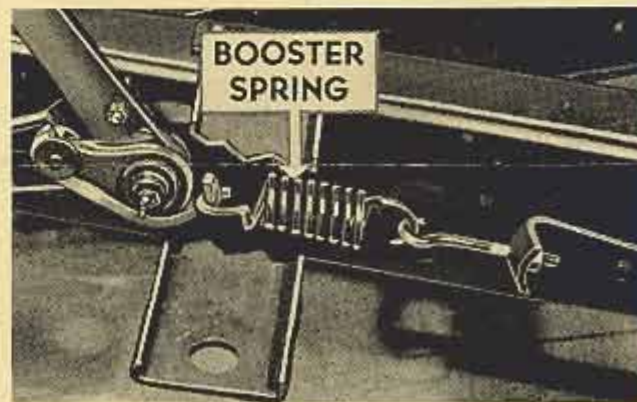
Clutch Pedal Pressure

If complaints of high clutch pedal pressure are received on cars equipped with standard transmissions or overdrives, the pressure may be reduced somewhat by adjustment.

These cars are fitted with a booster spring on the clutch pedal. The spring tension may be adjusted to supply more assistance, and thus decrease the pedal pressure, by turning up on the adjusting nut located on the eye bolt attached to a bracket on the outside of the frame.

Do not tighten the nut so far that the clutch pedal has a slow jerky action when engaging the clutch. The pedal pressure should not be reduced to the point where all sense of feel is lost.

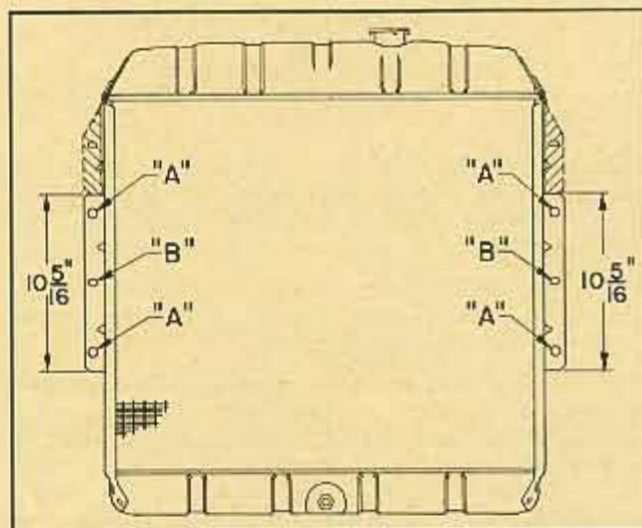
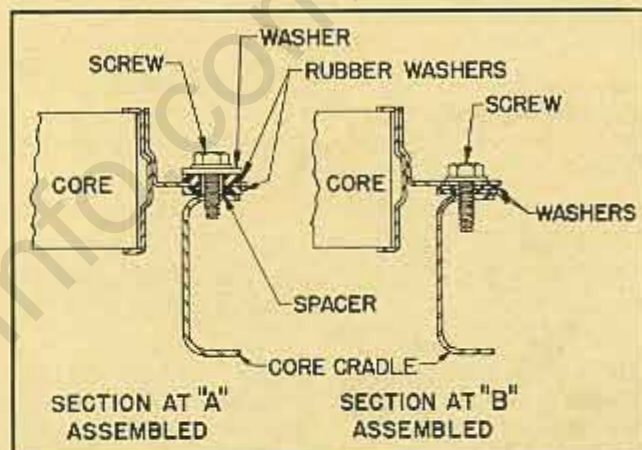
Radiator Core Mounting

A change in design has been made in the 24th Series radiator mounting, reducing the stress in the radiator core.

Radiator core leakage in some instances has been traced to undue stress which might contribute toward the opening up of soldered joints in the core.

The stress can be relieved by reworking the flanges of the core assembly and installing Kit No. 436251. It is suggested that this be done whenever a core is removed for repair of a leak or for any other reason.

1. With radiator core off the car, saw off both upper sections of core flange (see illustration shaded area). **NOTE:** Do not disturb the part of the flange that is spot welded to the core strap or frame.

2. Drill out holes (marked "A") in core flange to $\frac{3}{8}$ inch. Holes (marked "B") are left as is.

3. Install steel spacers (sleeves), rubber washers and steel washers as shown in illustration (marked "A"). Mask tape washers to flange to hold in place.

Two flat steel washers are used as spacers at each hole (marked "B") and must be installed to the front side of the core flange. Mask tape washers to flange.

NOTE: A piece of tag wire may help to hold the washers in place.

4. Set radiator core in place, start all screws slightly and then tighten.
