SERVICE Counselor

PACKARD MOTOR CAR COMPANY

AUGUST, 1951

Servicing the Electric Antenna

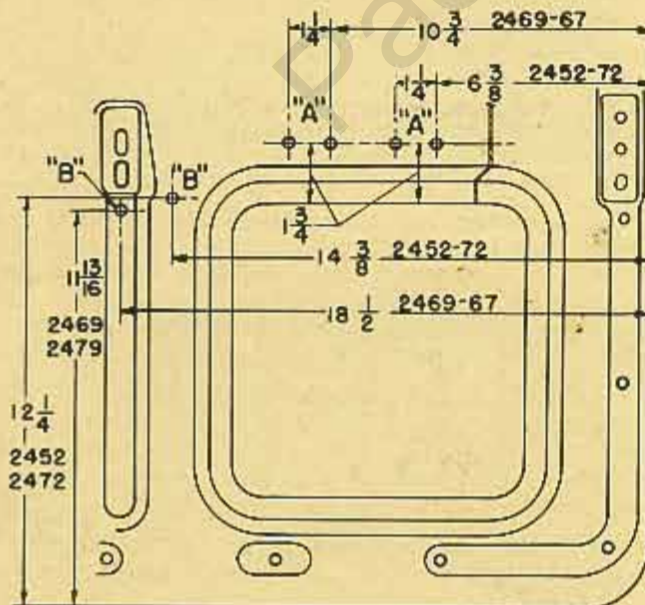
Fig. 1

Reports have been received of glass breakage in the hydraulic window equipped cars. It is generally the door windows in the Convertible and Mayfair, and the front door windows in the "300" and "400" models that break. Reports have also been received about rattles in the doors while driving over rough roads and when closing the doors with the windows part way or all the way down.

This condition is caused by the hydraulic regulator frame striking the glass or the lower lifter.

An anti-rattler bracket assembly and a bolt and spacer are now used in production to prevent the hydraulic regulator assembly from striking the glass.

Part Number 436269 kit is available for correcting this condition when it exists in the "250," "300" and "400" models. The parts are identical except for the length of the spacers. Two spacers are included in the kit. Part number 437813 spacer is $2\frac{5}{16}$ " long and used on the 2469-67 models. Part Number 437812 is $2\frac{1}{2}$ " long and used on the 2452-72 models.

The measurements for locating the points for drilling are from the edges of the door inner panel and the edge of the access door opening. See Fig. 1.

1. Drill two holes $\frac{9}{32}$ " in the door inner panel for the anti-rattler bracket. See "A", Fig. 1. Lower the window and install the bracket assembly as shown on Fig. 2. Put a dab of Lubriplate on the felt end of the bracket where it contacts the regulator frame.

2. Drill one hole $\frac{9}{32}$ " in the door inner panel for the bolt and spacers. See "B", Fig. 1. Insert a block of wood between the door outer panel and the regulator frame, then drill a $\frac{9}{32}$ " hole through the regulator frame. Install the bolt, spacers and nut as shown on Fig. 3. Tighten nut securely.
