# SERVICE Counselor

PACKARD MOTOR CAR COMPANY

VOL. 26, NO. 1

JANUARY, 1952

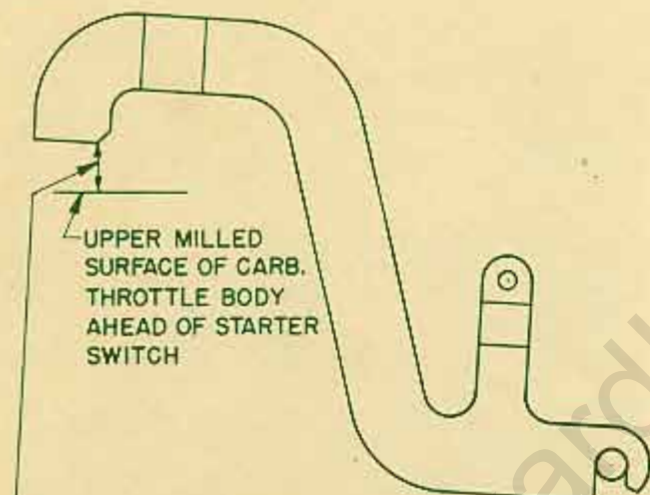
The 23rd Series Ultramatic Drive equipped cars may be affected with low oil pressure to the high range clutch as described for the 24th Series cars in Service Technical Bulletin 51T-35, Dealer 31, October 10, 1951.

DIM.	ULTRA. TOOL N <sup>o</sup>	ENGINE	MODEL
.265 ( <sup>17</sup> / <sub>64</sub> )	PU 333	288 CU. IN.	2301
.250 ( <sup>1</sup> / <sub>4</sub> )	PU 332	327 CU. IN.	2302-22-32
.578 ( <sup>37</sup> / <sub>64</sub> )	PU 312	356 CU. IN.	2306-13-33

The illustration in this article shows a gauge with the end raised above the upper milled surface of the carburetor throttle body. The chart below the gauge shows the amount the tools should be raised for the model car and the tool numbers.

Until new tools or adapter blocks are released, the gauges can be raised by laying the shank of a drill, a short piece of round stock or a flat piece of stock of the *correct dimension* between the milled surface and the gauge as a spacer to get the correct adjustment. NOTE: Be sure to lay the spacer at the rear edge of the gauge as shown, because of the angle the gauge will raise.

- Place the throttle adjusting gauge over the throttle cross shaft and the end of the carburetor throttle rod. When the rod length is properly adjusted, the forward end of the gauge (rear edge of the flat surface on the gauge) will rest on the spacer that was placed on the upper milled surface of the carburetor throttle body. The rod can be lengthened or shortened by loosening the lock nut and turning the spring-loaded throttle override. This adjustment determines the proper length of the carburetor throttle rod and corrects the relation of the throttle valve lever movement on the transmission to the carburetor throttle opening, which will give the proper high range clutch pressure at all speeds.

There has been some mis-interpretation of the amount the gauges should be raised listed under (b) Service Technical Bulletin 51T-35, Dealer 31, October 10, 1951. The gauge is to be raised .050"; in other words, lay a piece of .050" shim stock on each of the milled surfaces on top of the cylinder head and directly ahead of the bracket supporting the cross shaft. The gauge is placed on top of the shim stock, which will raise the gauge .050".
