PACKARD MOTOR CAR COMPANY

counselor

VOL. 26, NO. 10

OCTOBER, 1952

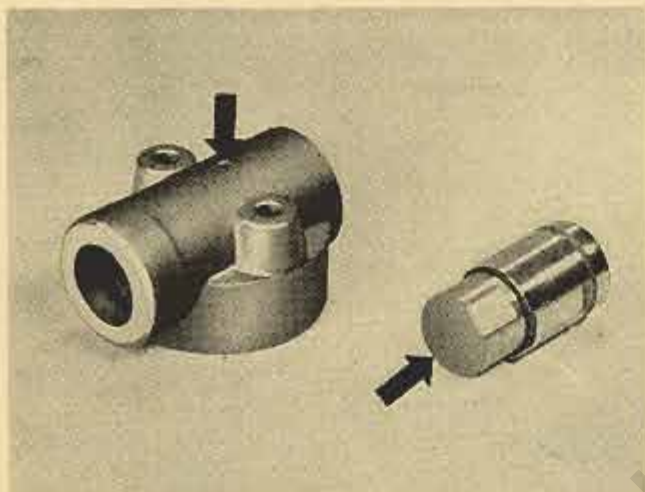
Governor Housing and Inlet Valve

A newly designed and improved Ultramatic governor housing and inlet valve are now used in production. The improvements were made to eliminate a governor rattle that has been encountered with previous governors.

The inlet valve now has a closed end and the venting is accomplished through a .062 hole in the top of the governor housing. (See illustration.)

It will be necessary to install both the governor housing and inlet valve when making replacements as these parts will not interchange individually with the early type governors.

Part No. 434279 Transmission Governor Housing.

Part No. 434278 Transmission Governor Inlet Valve.

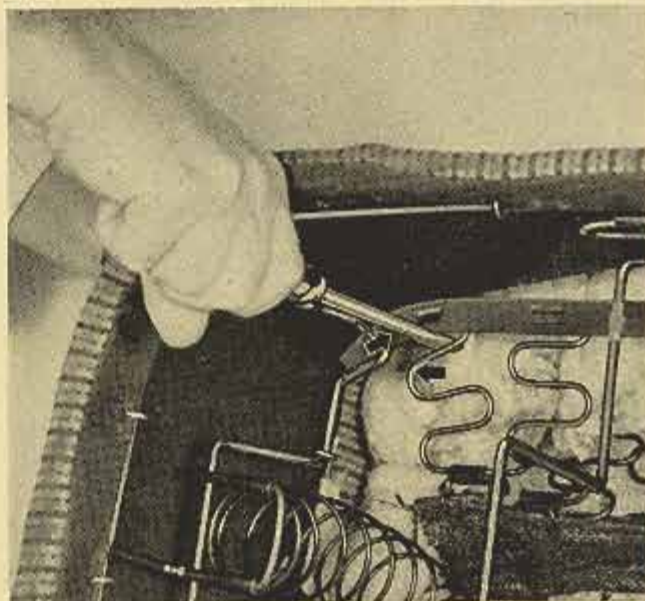
Fig. 1

Occasionally you may encounter a rear seat cushion spring noise (ZIG-ZAG TYPE SPRINGS) when one person sits on the corner of the cushion. This will generally be a snapping or clicking sound.

The loop of the spring was designed to rest on the metal frame when the cushion is depressed, but in some cases, it may be found that the loop of the spring will snap past the cushion frame which will cause a very annoying noise.

A correction can be made by bending the spring loop away from the metal frame with a large screwdriver, as indicated (by arrows) in Fig. 1. Bend the spring far enough so it will clear the seat frame.

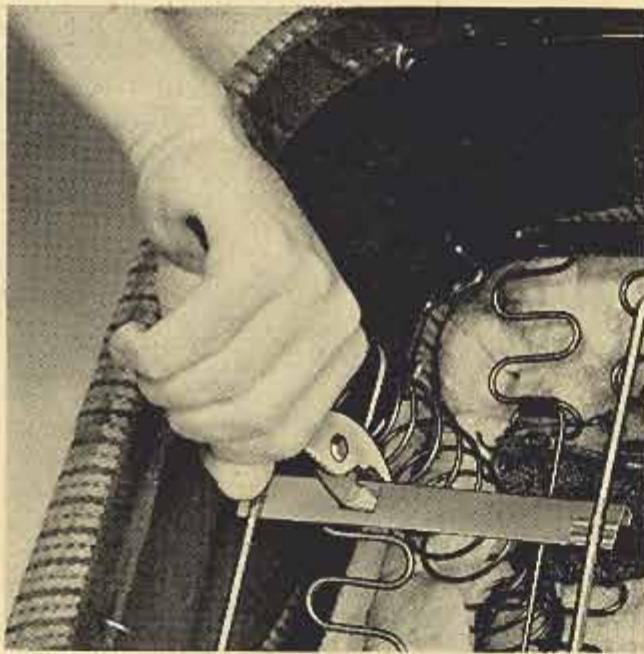
Fig. 2

The end of one of the Zig-Zag springs is clamped in a bracket as shown in Fig. 2, but sometimes it becomes loose in the clamp thus slipping back and forth which makes a snapping noise.

The clamp can be tightened with a pair of pliers as shown in Fig. 2.

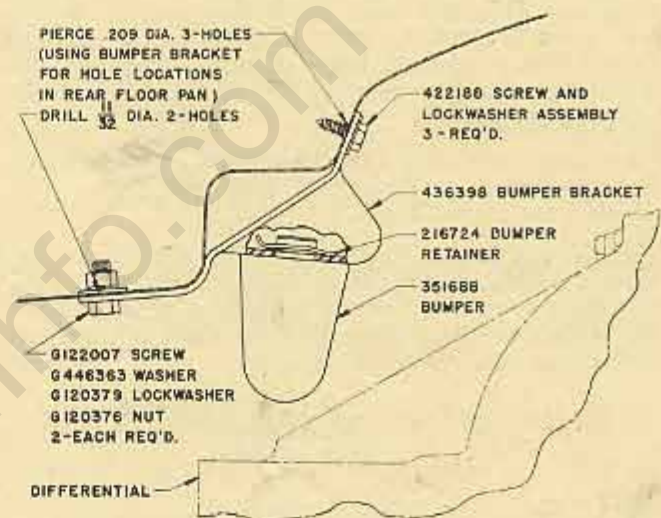
A few reports have been received of the rear universal joint striking the floor pan during full throttle acceleration on Ultramatic Drive equipped, 24th Series cars.

During extreme "sudden" acceleration, the torque reaction of the rear axle housing causes the front end of the rear axle carrier to rise, allowing the rear universal joint to rub the floor pan, which results in a very annoying noise.

A floor bumper kit, part number 436339, is now available, similar to the one used on the standard transmission and overdrive equipped cars. It can be easily installed to correct the condition where the rear universal rubs the floor.

Assemble the rubber bumper to the bracket and secure with the retaining clip. Place the bracket assembly on the lower side of the floor pan directly above the front end of the carrier pinion housing so that the housing can strike the rubber bumper about 1" back of the forward end of the housing. Be sure the bumper and bracket are centered crosswise over the pinion housing. Center punch or scribe mark through all the bracket holes with the bracket held in its proper location; drill two $\frac{11}{32}$ " holes through the floor pan to attach the lower part of the bracket with bolts, washers, and nuts. Using a pointed drift of $\frac{13}{64}$ " diameter, drive three holes through the floor pan to attach the upper part of the bracket with three sheet metal screws and washers. Be sure to use a drift and not a drill so that the sheet metal screws will hold securely with the added thread contact in the turned edges of the holes.
