SERVICE Counselor

PACKARD MOTOR CAR COMPANY

VOL. 26, NO. 12

DECEMBER, 1952

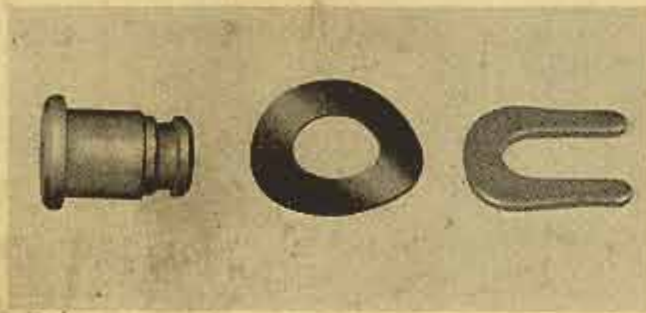
Hand Brake Shoe Strut Lever Pin and Retainer

The retainer is no longer made from spring steel, but is made from a thicker stock and is designed so that the open ends can be closed with a pair of pliers after it is installed on the pin. This locks the pin in place, thus eliminating the possibility of it coming out as has been encountered with the spring steel type retainer. The spring washer keeps a tension on the pin and retainer.

A new hand brake shoe strut lever pin, spring washer and retainer are now used in production and, also, are available for service.

Part No. 433270 Brake shoe strut lever pin

Part No. 446275 Brake shoe strut lever pin retainer

Part No. 446274 Brake shoe strut lever pin spring washer.

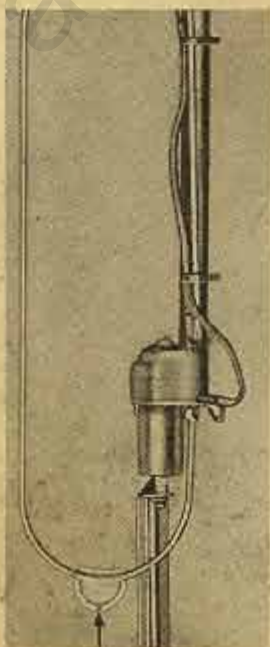
Reports have been received of water getting into the electric antennas which damaged the nylon strip and the drive rollers at the end of the motor.

Antennas returned for our inspection revealed that the drain hole at the lower section of the nylon strip retainer tube was plugged with undercoating. "Arrow on illustration indicates drain hole."

It is suggested that the drain hole be inspected and cleaned out if necessary on new car pre-delivery inspections as well as new antennas installed in service.

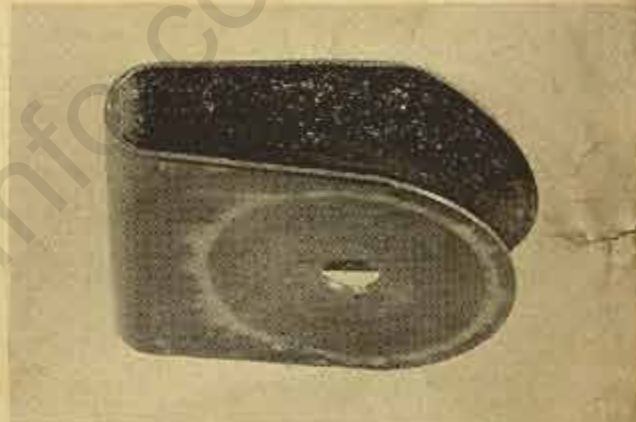
A disturbing noise when driving in reverse has been reported on a few 25th Series Ultramatic equipped cars.

During reverse operation, the rear pump is rotating in reverse direction creating a vacuum on what would be the pressure side of the pump during normal forward operation. This vacuum along with air admitted by the governor vent valve causes an aerated condition of the oil at the rear pump.

To correct this condition it is necessary to supply a greater amount of oil to the rear pump to counteract the vacuum created. This can be accomplished by drilling a $\frac{3}{32}$ " hole in the rear half (flat side) of the rear pump check valve. Insert a piece of wood between the two sides of the valve when drilling so that the shape of the valve will not be distorted. Be sure to drill the hole directly in the center to correspond to the center of the bore opening. "See illustration." Remove all burrs from the edges of the hole.

The parts listing for the rear pump check valve which incorporates the $\frac{3}{32}$ " hole has been changed to Part Number 434527, Pump Check Valve (rear).

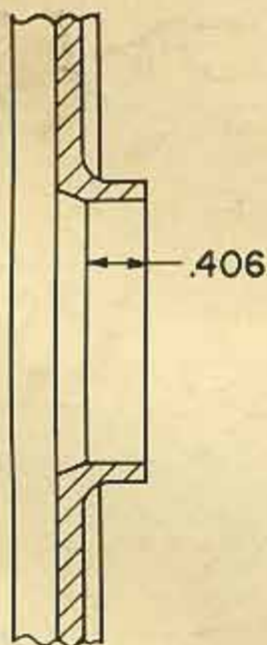
Reports have been received of the direct drive clutch failing to engage in cars having the 9 inch converter.

A direct drive clutch hydraulic pressure test generally shows the pressure is normal when the clutch starts to engage and then gradually drops off to approximately 20 lbs. This condition might also cause the clutch to slip when the engine is accelerated.

A change has been made in the machining of the inner bore of the clutch piston where it slides over the clutch housing hub and ring. The length of the bore has been increased from .281" to .406". "See Illustration".

Whenever this trouble is encountered and the hydraulic pressure to the direct drive clutch drops off, it will be necessary to replace the direct drive clutch piston with the new type.

The new type piston carries the same part number as the previous design piston which has been discontinued; however, only the new type piston is being furnished by the Parts Warehouse, which may be ordered under Part No. 423413 Converter Clutch Piston.

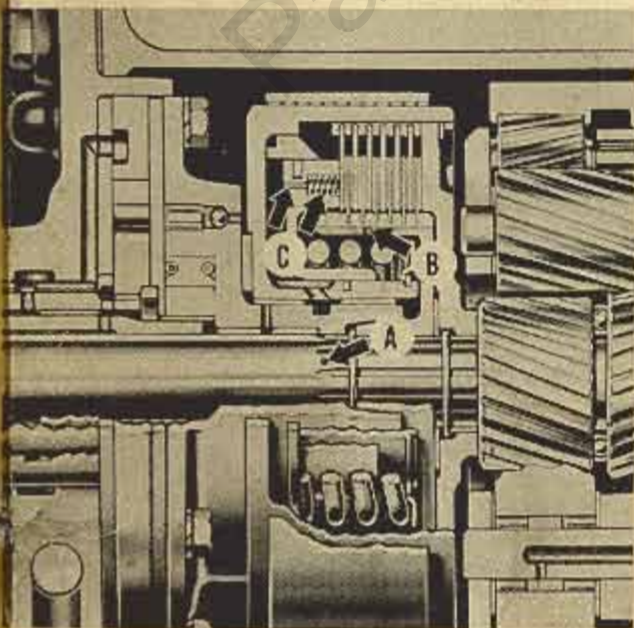
1. A $\frac{3}{32}$ " hole "A" has been added in the end of one of the input shaft splines. Fluid is forced from this passage past the front pump rear extension and

input shaft front snap ring into the clutch hub where the clutch spring is located.

2. Twenty $\frac{3}{32}$ " holes "B" have been drilled through the outer portion of the clutch hub, these holes are spaced around the hub so that fluid can be forced between each plate.

3. The clutch piston vent springs and vent holes "C" have been eliminated, therefore, the venting is accomplished through the outer ring gap. This change in venting provides quicker high range clutch engagement.

NOTE: It is very important that the high range clutch piston outer ring gap be held to a .007" to .012" clearance.

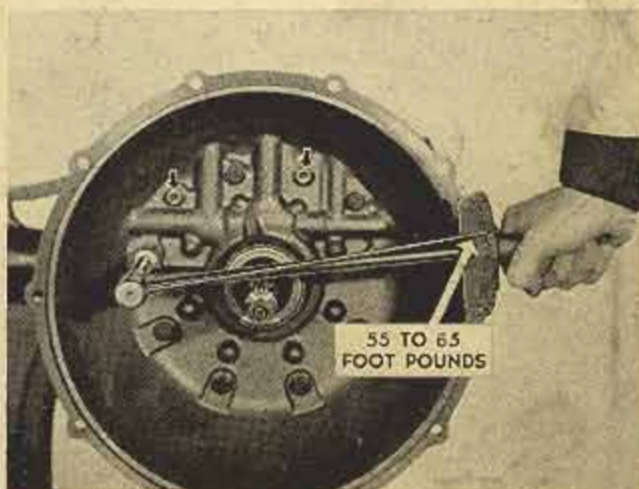
Fig. 1

Two concave head self-locking bolts are used without lock washers in attaching the bell housing to the transmission and to prevent leaks past the threads. They are installed at the locations shown in Fig. 1. NOTE: The transmission in the illustration is upside down as it is mounted on an engine stand.

The low range band lever shaft is installed through the lower right bolt opening. A self-locking bolt is used at this location to seal off any oil leakage past the threads. An oil passage in the forward section of the transmission is very close to one of the bolt holes. Another self-locking bolt is used at this location to prevent any possibility of leakage through the threads.

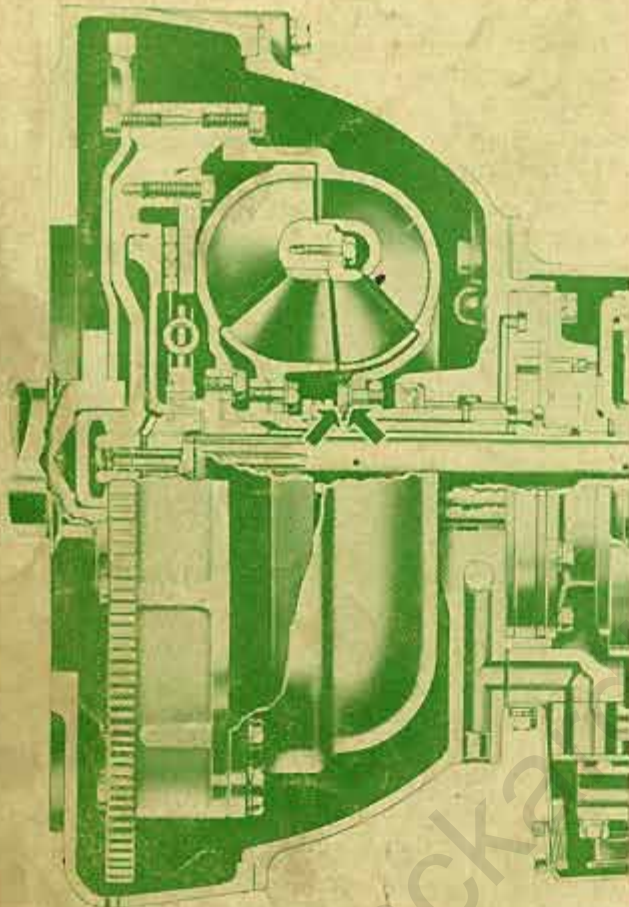
Fig. 2

Another leak that would be difficult to locate is oil leaking past the screws and washers that attach the converter pump shaft to the converter pump. See arrows, Fig. 2. A leak at this point might also be diagnosed as a seal leak.

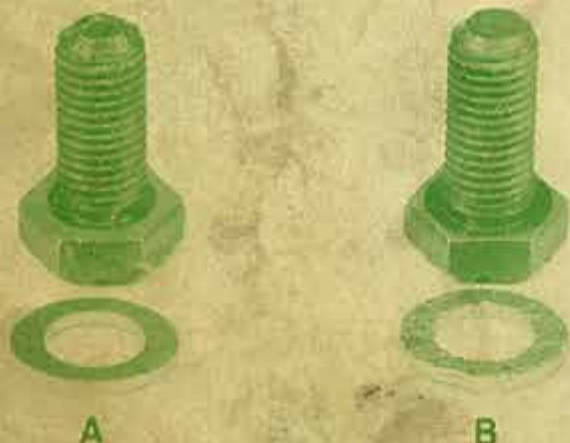
Fig. 3

A leak past the converter pump shaft screws and washers is generally caused by pits in the washers or incorrect machining of the recess on the bolt heads. "A," Fig. 3, shows a bolt and washer that are correctly machined and would seal properly. "B," Fig. 3, shows a bolt and washer condition that would cause leaks.
