SERVICE Counselor

PACKARD MOTOR CAR COMPANY

VOL. 26, NO. 2

FEBRUARY, 1952

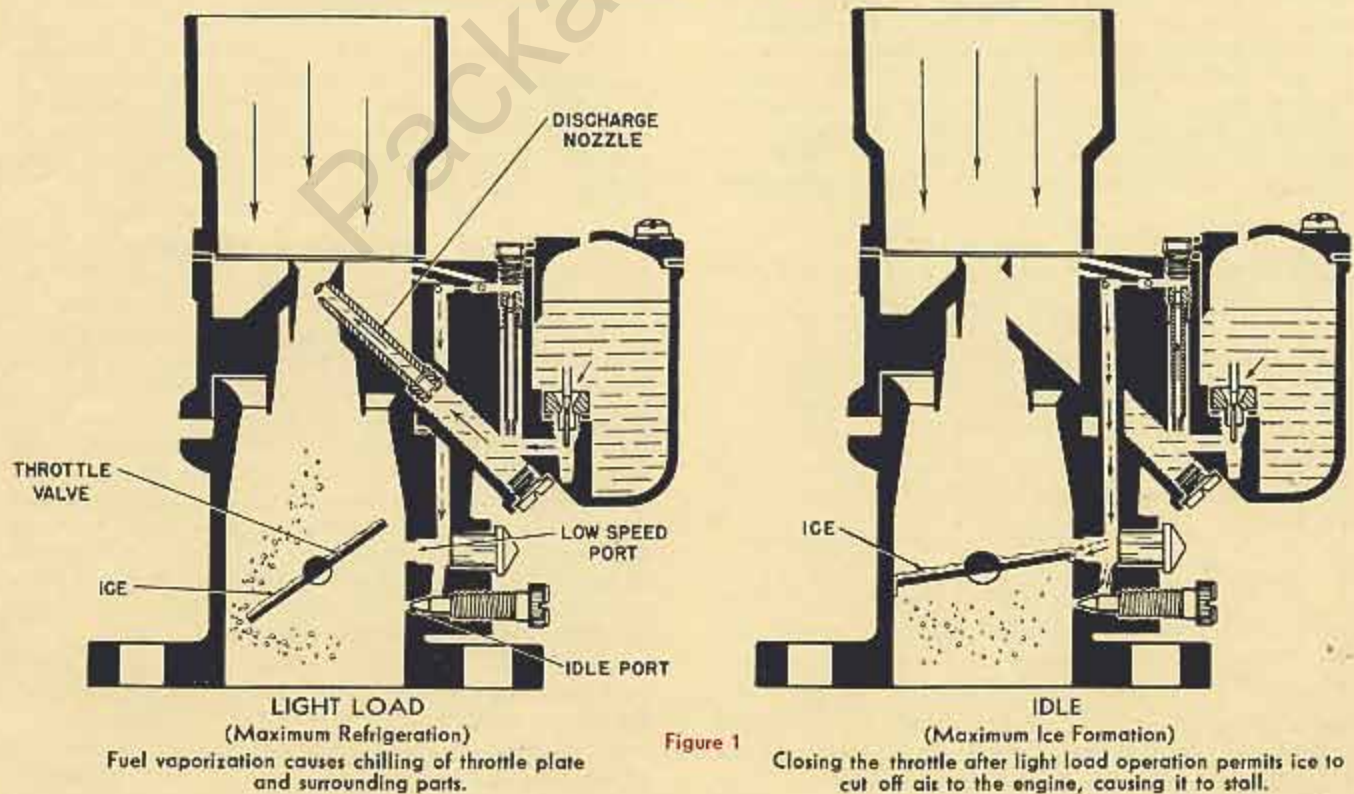
Figure 1

similar to frost, occurring in the carburetor, on the throttle plate as a result of the refrigerating effect of the gasoline as it is vaporized in the throat of the carburetor. The temperature of the mixture as a result of this vaporization may be reduced by as much as 25°F below that of the outside air temperature. This results in chilling the air-fuel mixture and the metal parts of the carburetor in the vicinity of the throttle plate.

Within the range of 65 to 100% relative humidity, enough water is carried through the carburetor with the incoming air to form enough ice or snow on the throttle plate to completely stop the flow of air-fuel mixture through the carburetor when the throttle plate is in the idle position (Figure 1.)

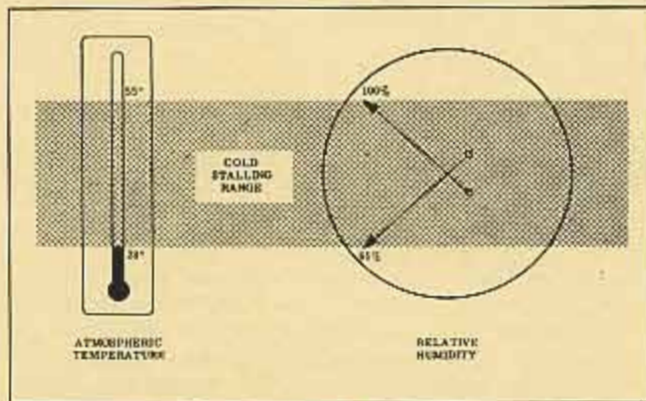
Fig. 2

The common occurrence of carburetor icing which results in cold stalling is *not* freezing due to cold weather nor is it due to moisture in the gasoline tank or lines. It occurs principally during cool humid weather which may or may not be rainy, and at temperatures *above* freezing. It has been established that cold stalling can occur at any temperature between 28 and 55°F when the relative humidity is between 65 and 100% (Figure 2). The most critical combination is a temperature of approximately 40°F together with the relative humidity of 100%, although the trouble will occur frequently enough to be bother-

some under any of the combinations of temperature and humidity just mentioned and illustrated in Figure 2.

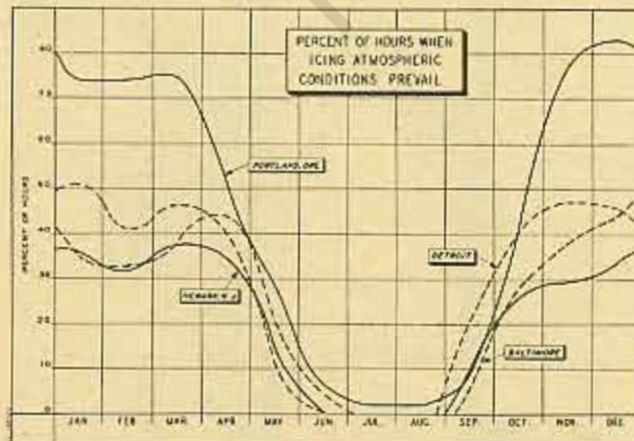
Fig. 3

Weather Bureau figures show that atmospheric conditions producing this problem are prevalent during all but midsummer months for most areas in the United States. Certain areas are, of course, more critical. As indicated in Figure 3, conditions suitable for cold stalling may be encountered for as much as 40 to 70% of the time throughout a considerable portion of the year.

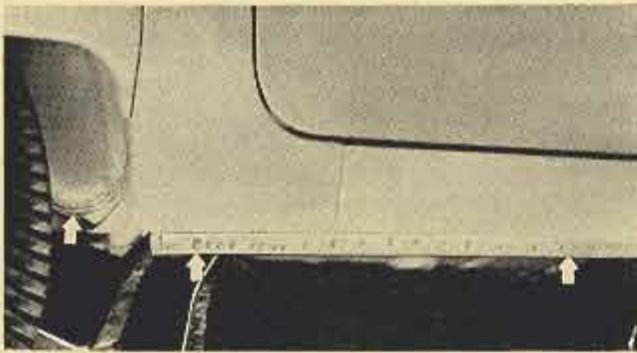
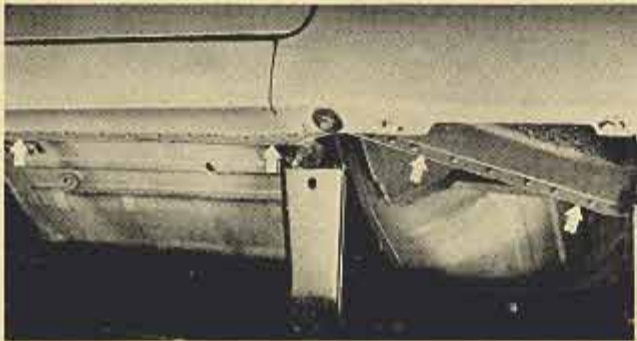
In a few instances it was found that the side sill panels and body panels were not properly welded to the floor panel or that the welds were broken.

The arrows in the two illustrations show the location of the welds.

When a body shake condition exists, the welds should be inspected for number of welds and spacing between welds, which is approximately $1\frac{1}{2}$ ". A feeler gauge or a thin bladed screwdriver can be inserted between the panel flanges to check for broken welds.

The rewelding operation can be accomplished by clamping the panel edges together with vise grip pliers and then spot welding the lower edges of the panels each side of the pliers. Continue this operation wherever welding is necessary. The welding can be done with either an electric arc welder or an acetylene torch.

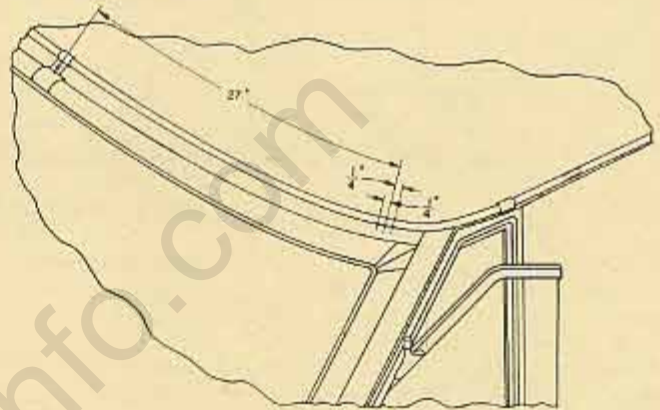
When the car stands on level ground during a rain, the gutters at the front corners of the roof fill with water and do not drain off. After the owner gets into the car, lowers the windows, opens the vent windows while driving, and when turning either to right or left, the water runs over the top of the gutters and through the windows and into the car.

The illustration shows the measurements to be used in locating the points to drill.

This can be corrected by drilling three $3/16$ " holes through the rain gutter at each front corner to allow the water to drain off.

- (a) Measure 27" from the screw head that attaches the moulding clip at the center of the windshield. Use a flexible rule and follow the curve of the rain gutter. Mark the location to drill.
- (b) Drill a $3/16$ " hole through the rain gutter from the top.

- (c) Drill a $3/16$ " hole, $1/4$ " each side of the hole you have just drilled. Be sure to use the measurements shown so that the water will drain down over the windshield and not over the vent window and weatherstrip.
- (d) Perform this operation on both front corners of the rain gutter. Remove any burrs with a file and touch up the paint if necessary.

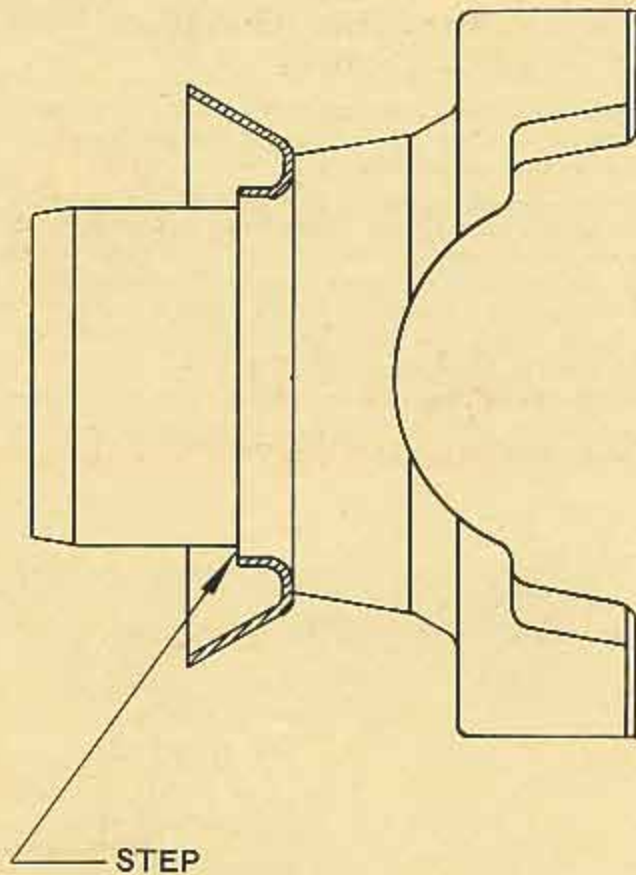
Reports have been received of differential pinion seals leaking due to scratches on the seal surface of the pinion flange.

It was found that the dust shield was scratching the seal surface when the shield was pressed on. This was due to the hole in the dust shield being the same diameter as the pinion flange seal surface.

All pinion flanges now in production will have a .010 raised step machined for the dust shield. This

will eliminate the possibility of scratching the seal surface.

A new dust shield Part No. 443187 that has a larger diameter hole will be used with the flanges that have the raised step. Part No. 309525 dust shield is retained to use with flanges without the raised step.

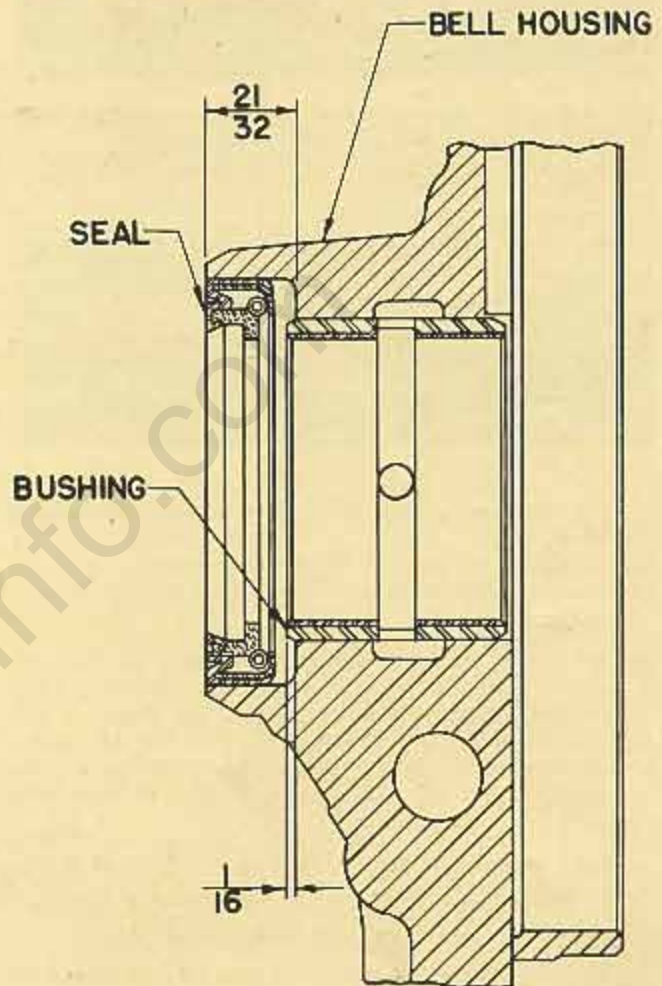
A change in production has been made in the bell housing and bushing assembly. The depth of the oil seal hole in the bell housing was increased from 19/32 to 21/32 of an inch. This permits the bell housing bushing to extend out 1/16 of an inch beyond the face of the bell housing at the oil seal end. See accompanying illustration.

When replacing a bushing in the new type bell housing it is important to remember that the bushing extends 1/16 of an inch beyond the face of the bell housing instead of flush with the face as previously.
