# SERVICE Counselor

PACKARD MOTOR CAR COMPANY

VOL. 26, NO. 3

MARCH, 1952

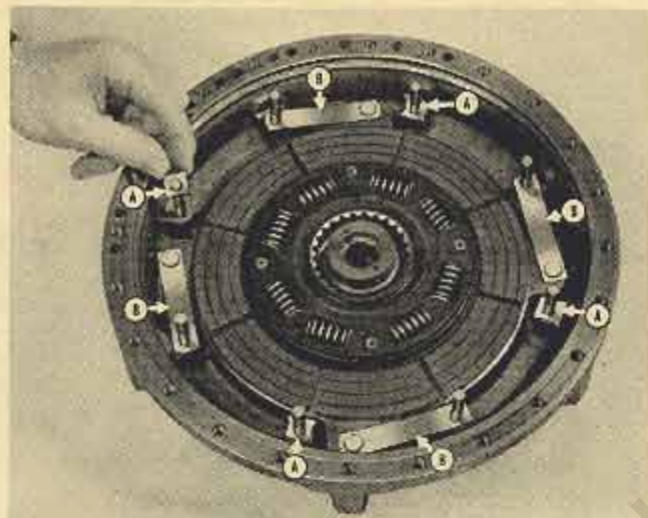
Fig. 2

The direct drive clutch combination piston and driving plate is of new design, having four steel driving straps "B" Fig. 2, instead of lugs or splines as previously used. The reason for the change is that the lugs or splines caused the piston to drag or bind in the housing and consequently resulted in a sluggish release of the direct drive clutch.

The piston is placed in the direct drive clutch housing with the holes in the clutch piston driving straps lined up with four of the eight threaded holes in bosses of the clutch housing. Spacers "A" Fig. 2, are placed on the four bosses where no driving straps are located to compensate for the thickness of the straps so that the pressure plate can be attached evenly. The eight pilot studs shown in figure 2 are used to hold the straps and spacers in place while installing the pressure plate. After the pressure plate is in place, the pilot studs are removed and the capscrews are installed and torque tightened.

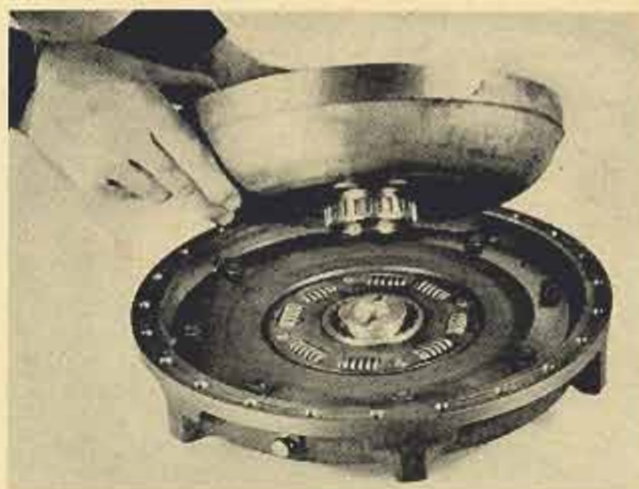
Fig. 3

The 24th Series converter assembly incorporated a 11 $\frac{3}{4}$ " or 11 $\frac{1}{4}$ " direct drive clutch plate and can be identified by the two oil drain plugs which are located at the *forward face* of the clutch housing.

The 25th Series converter assembly, which incorporates a 9" direct drive clutch plate, can be identified by the two oil drain plugs which are located in the *outer diameter* of the clutch housing. Fig. 3.
