PACKARD MOTOR CAR COMPANY

VOL. 26, NO. 7

JULY, 1952

New Universal Joint Dust Cover Kit Installation Instructions

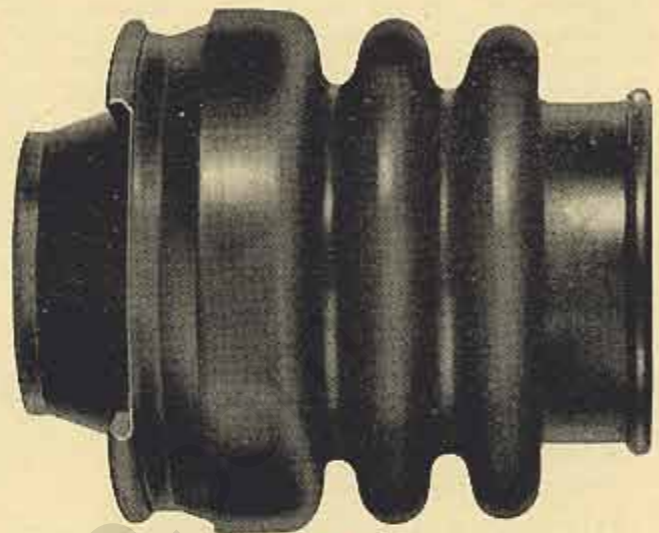
Fig. 3

Figure 3 illustrates the dust cover that is supplied in the kit which can be installed through the body (note flat surface at the larger diameter).

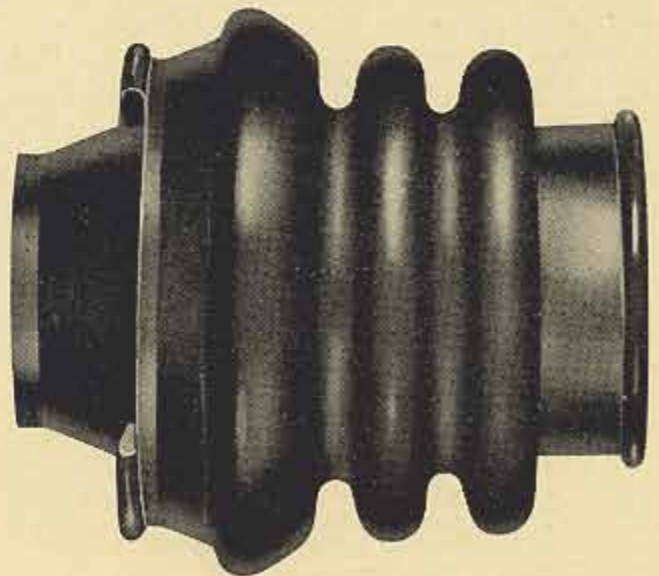
Fig. 4

Figure 4 illustrates the dust cover that is used in production and cannot be installed through the body.
