SERVICE Counselor

PACKARD MOTOR CAR COMPANY

VOL. 27, NO. 11

NOVEMBER, 1953

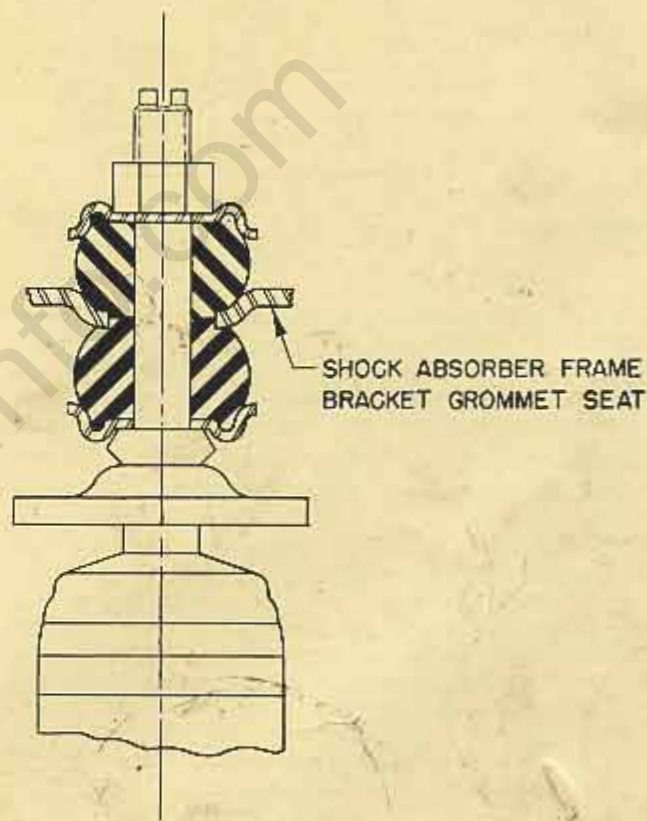
Shock Absorber Grommets

A few reports have been received of shock absorber rattles which were caused by worn or mutilated grommets.

Inspection of shock absorber grommets returned on R.F.A.'s from the field indicates that the grommets were not properly centered in their seats in the frame.

When replacing shock absorber grommets, it is very important that they be centered in their seats as shown on the illustration. This can best be accomplished by following the procedure outlined:—

1. Attach the upper end of the shock absorber to the frame with the retainers, grommets and retaining nut.

Tighten the retaining nut just enough to force a light tension of the grommets on the seat. Rotate the shock absorber and grommets several turns so that the shoulder on the grommets will be in place and properly centered.

After the grommets are properly centered in the frame seat, tighten the retaining nut until the threads bottom.

2. The grommets at the lower end of the shock absorber are easy to see; therefore, they can be properly centered by sight. After the grommets are centered, tighten the retaining nuts until the threads bottom.

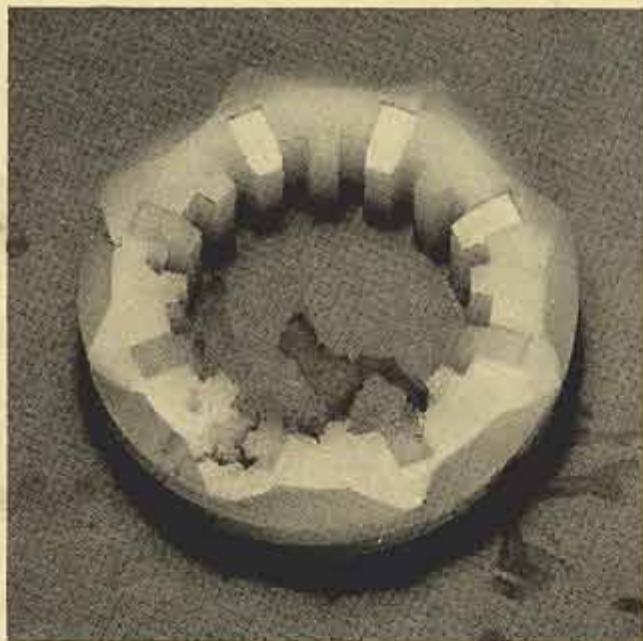
Ultramatic Breather Oil Leaks

A few reports have been received of oil being thrown out of the Ultramatic Transmission breather at speeds of 30 MPH and above.

The speedometer driving gear has radial grooves machined on the rear side. "See illustration." The purpose of the grooves is to direct a spray of oil on the parking gear bushing in the rear housing.

If the speedometer driving gear is installed with the grooves toward the front, the spray of oil will be directed to the breather causing a severe oil leak.

When a leak is encountered at the breather, the speedometer driving gear should be checked for proper installation. This can be accomplished by removing the transmission rear housing and output shaft assembly, parking gear and speedometer driving gear spacer.

The speedometer driving gear can then be pulled off of the planetary cage shaft and reinstalled with the grooves toward the rear.

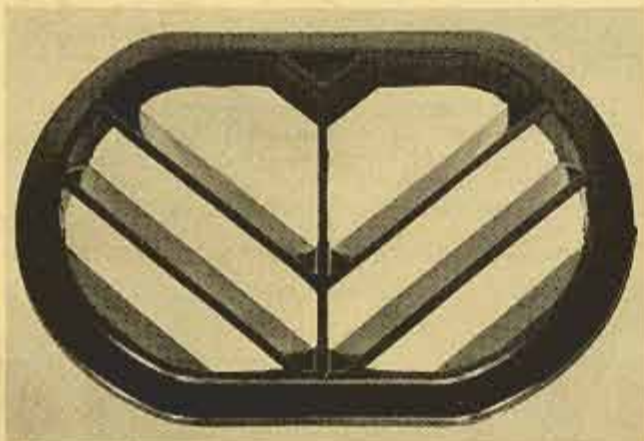
Fresh Air Grilles

A more direct flow of fresh air on the passenger and driver's knees can be obtained by removing the two upper blades from the fresh air grille.

By using a hack saw blade, the two upper grille blades can be cut off as shown in the illustration without removing the grille from the dash panel.

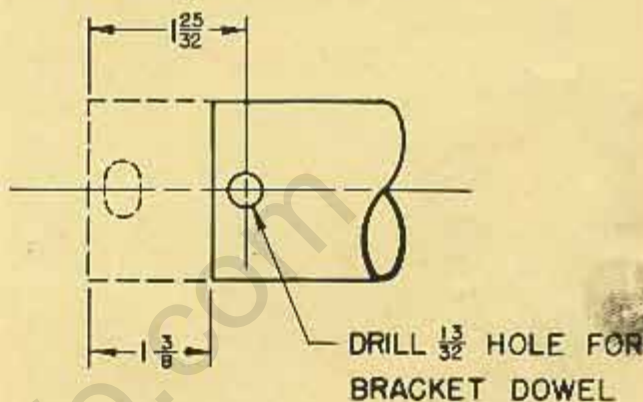
Muffler Outlet Tube

Part number 373868 muffler outlet tube will be cancelled for service replacement when present stock is exhausted. This cancellation affects the following models: 2003-06, 2103-06, 2206-33.

Part number 403419 muffler outlet tube which is used on models 2201-11-02-32 will be shipped in place of No. 373868. It will be necessary to rework the forward end of outlet tube No. 403419 before it can be used on models: 2003-06, 2103-06, 2206-33.

1. Measure $1 \frac{25}{32}$ " from the forward end of the tube to locate a new dowel hole. Drill a $\frac{13}{32}$ " hole in the tube at this location directly in line with the forward dowel hole.
2. Using a hack saw, cut off $1 \frac{3}{8}$ " of the forward end of the tube and remove all burrs with a file.

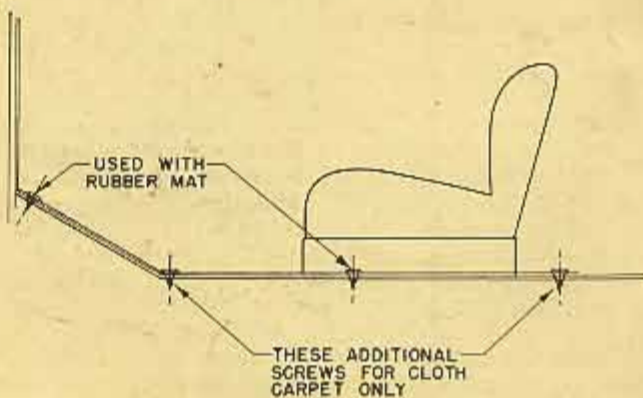
Carpet Screws

In some instances it may be necessary to install similar type screws and ferrules in the rear carpet to obtain a satisfactory fit.

Illustration shows location and attachment of the screws and ferrules.
