PACKARD MOTOR CAR COMPANY

VOL. 27, NO. 6

JUNE, 1953

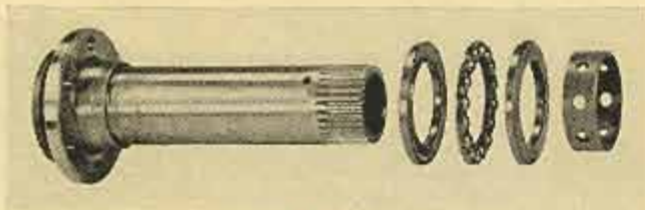
Fig. 1 shows the early type converter reactor shaft, thrust ball bearing and spacer.

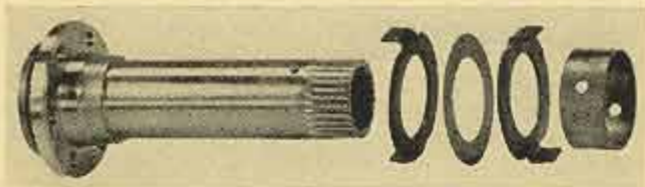
Fig. 2 shows the new type converter reactor shaft, thrust washer kit and spacer—note the longer shoulder on the new reactor shaft.

If occasion should arise whereby the converter reactor shaft is replaced on 24th, 25th and early 26th Series cars having a 9" clutch, it will be necessary to use the new type thrust washer kit omitting spacer part number 423228 which is included in the kit. The installation will be as shown in Fig. 2.

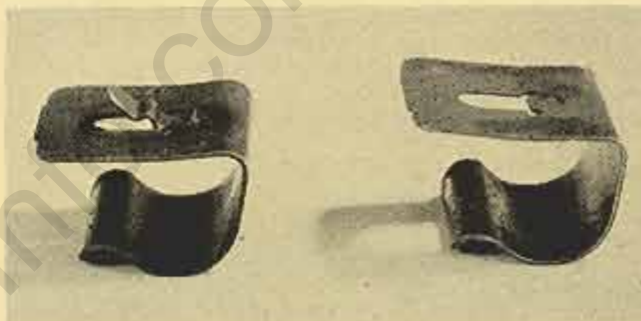
Some difficulty is being encountered in holding the differential carrier sealing ring in place while installing the carrier in the rear axle case.

Sealing ring holding clips can be made from wiring harness clips, Part Number 416396, by breaking off the small tang and grinding the flat surface smooth as shown in the illustration.

Several of these clips can then be clipped over the carrier flange to hold the seal in place. After the carrier is tightened enough so that the sealing ring contacts the rear axle case, the clips can be pryed off with a screw driver or small punch.

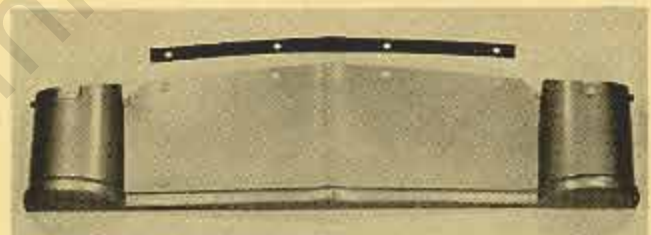
A few reports have been received of rattles, squeaks or a vibration in the front bumper splasher. It is most noticeable when the engine is running slow on a hard pull.

A liner has been added between the splasher and the bumper guard cross bar on cars in production to eliminate this condition.

Be sure to torque tighten the cross bar to splasher stud nuts 3 to 3½ ft. lbs. Over-torquing the stud nuts may dimple the chrome on the cross bar.

The liner is available for service and may be ordered under Part No. 446457, Bumper Guard Cross Bar Extension Liner.
