SERVICE Counselor

PACKARD MOTOR CAR COMPANY

VOL. 28, NO. 1

JANUARY, 1954

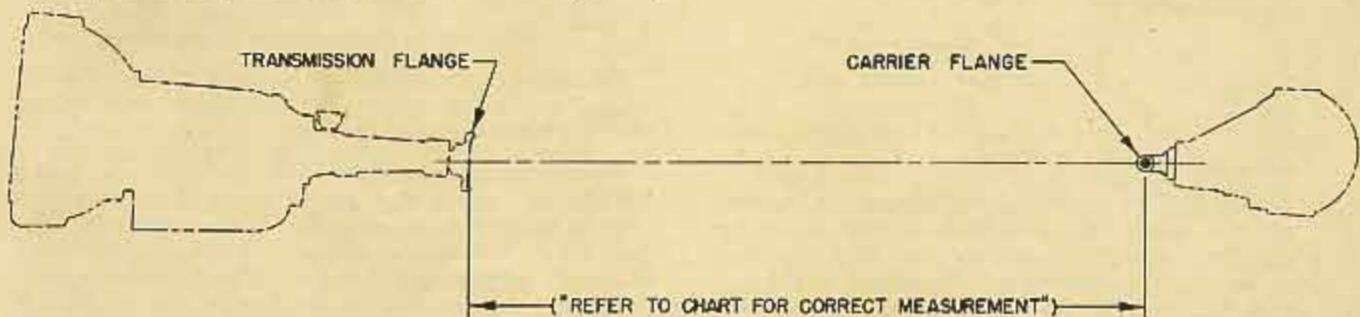
We have found in most cases of front universal joint noise after a repair kit has been installed, that the engine had shifted forward a half inch or more (by an accident of some kind) thus causing the trunion balls to strike the rear of the trunion body. This will also cause premature dust cover failure.

During the middle of 25th Series production, the front universal joint trunion body was shortened $\frac{3}{8}$ " (from 4" to $3\frac{5}{8}$ ") for greater rigidity, as there was excessive space between the rear of the trunion body and the trunion ball and roller assemblies. Therefore, with the shorter trunion body that is used in production and also supplied in the repair kits, it is *very* important that the engine be properly located.

25th, 26th and 54th Series measurements taken from the rear face of the Ultramatic Transmission universal joint flange to the center of a trunion bearing hole in the rear axle universal joint flange. "See illustration."

Whenever front universal joint dust cover failure or universal joint noise due to the trunion ball striking the rear of the trunion body is encountered, the following items should be checked.

1. Measure the distance from the rear face of the transmission universal joint flange to a trunion bearing hole in the rear axle universal joint flange.
2. If measurement is excessive, check the rear spring center bolts for proper centering in the rear axle case spring pads. Check the engine mounting brackets for being bent or distorted.
3. The engine can be shifted back by loosening all front motor mount bolts and the two rear lower stud nuts that attach the rear support to the frame cross channel. Using a pinch bar against the vibration damper, push the engine back until the proper measurement is obtained and while holding the engine in this position tighten the rear support nuts securely. Release the pinch bar and then tighten the front motor support bolts and nuts securely.

NOTE: In some instances it will be necessary to readjust the throttle and transmission control linkage.

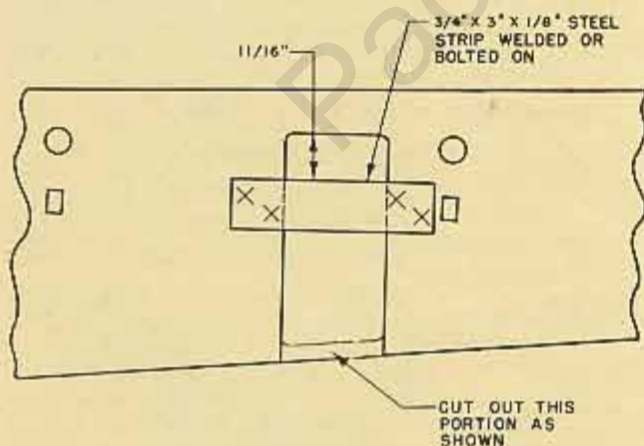
Part No. 370320 front fender (right) and Part No. 370321 front fender (left) will be shipped in place of No. 383572 and No. 383573. It will be necessary to rework these front fenders slightly to provide clearance for the front bumper supports. "See illustration."

1. Using a hack saw, cut out the lower portion of the front fender at the front bumper support hole.
2. Attach a piece of strap iron across the bumper support hole using the measurements shown on the illustration. The strap iron can be welded or bolted on as it is below the gravel shield and will not show.

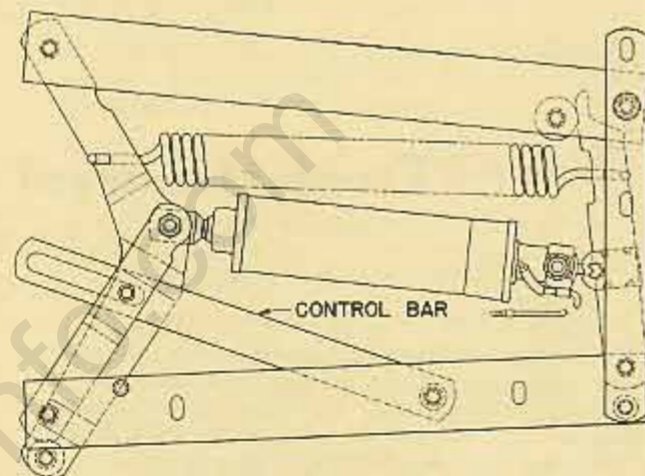
REAR QUARTER WINDOW REGULATOR

In checking rear quarter window hydraulic cylinders that were returned from the field because of fluid leaks, it has been found that most of the cylinders were leaking at the end plates because the plates were loose, cracked or distorted.

If the window pivot bracket does not contact the stop screw when the window is in the raised position, the piston is permitted to travel to the extreme end of the cylinder. When this occurs and the car is subjected to a temperature rise, the hydraulic fluid expands enough to move the piston against the end plate with such force that the plate is distorted and loosened.

A control bar with a slotted end has been added to the hydraulic window regulator which controls the amount of cylinder travel. "See illustration." Stop screw adjustments are still required to control window travel.

Whenever rear quarter window hydraulic cylinder failure is encountered due to end plate leaks, it is suggested that a new regulator having the control bar also be installed.

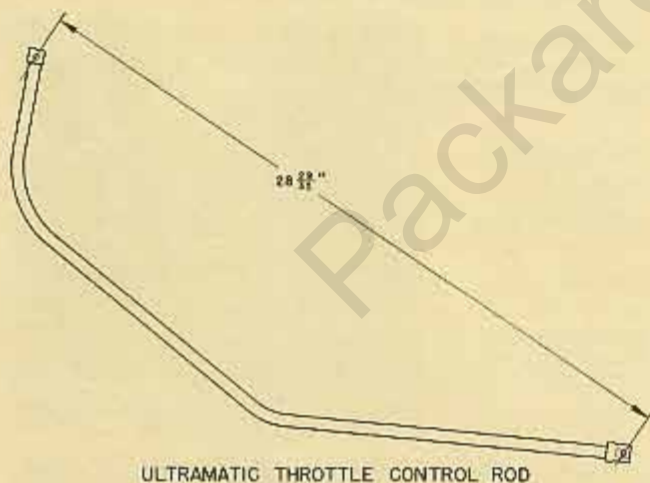
Occasionally the Ultramatic transmission throttle control rod becomes bent due to an accident of some kind. Due to its peculiar shape, it is difficult to determine whether or not it is bent.

Because of its function in controlling throttle pressure, which affects modulated pressures as well as clutch engagements, it is very important that the rod be of the proper length.

The illustration shows the proper length of the rod used on all 24th, 25th, 26th and 54th Series models.

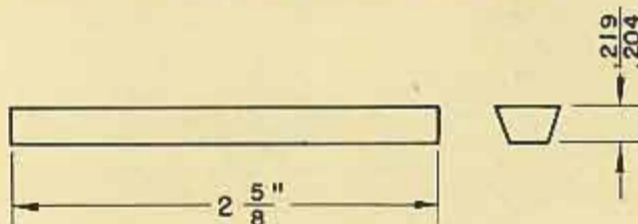
A few reports have been received of rear main bearing oil leaks that could not be corrected by installing new oil seals, Part No. 300191.

If the seals have been soaked in oil and properly installed but still leak, then it is possible that the seals may have been undersize.

To avoid the possibility of leaks recurring, it is suggested that replacement seals be checked for proper size. The seals should be checked with a micrometer across the flats as shown in the illustration. Measure the seals before soaking them in oil.

Any seals that measure under .204" should not be used. Be sure the measurement is approximately the same the entire length of the seal, also make sure the wood is clear, soft textured and not coarse grained. Do not use coarse grained seals as they will not seal properly.
