PACKARD MOTOR CAR COMPANY

VOL. 28, NO. 10

OCTOBER, 1954

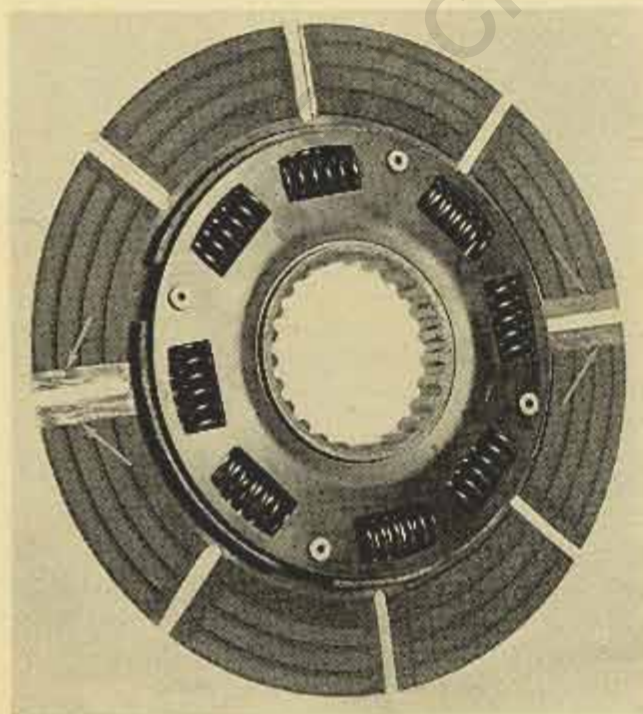
Direct Drive Clutch Slippage

Gear Start Ultramatic Transmissions

Direct drive clutch slippage may be encountered occasionally on early production Gear-Start Ultramatic Transmissions.

The ends of the clutch facings are chamfered at the slots in the driven plate to retain an oil cushion between the plate, pressure plate and the clutch piston, however, in some instances, this oil cushion has caused the clutch to slip.

If direct drive clutch slippage is encountered on early production units and the converter "in" and direct drive clutch pressures are within specifications, it is suggested that the direct drive clutch plate be removed and reworked as follows:

Using a razor blade, cut the chamfer portion off the ends of four facings at two slots on the rear side of the plate directly opposite each other as shown in the illustration. Be sure to leave a sharp square edge on the facings.

Cut off the chamfered ends of four facings at two slots directly opposite each other on the forward side of the plate.

When the direct drive clutch is engaging, the sharp ends of the facings will wipe the oil film from the pressure plate and piston thereby reducing clutch slippage.

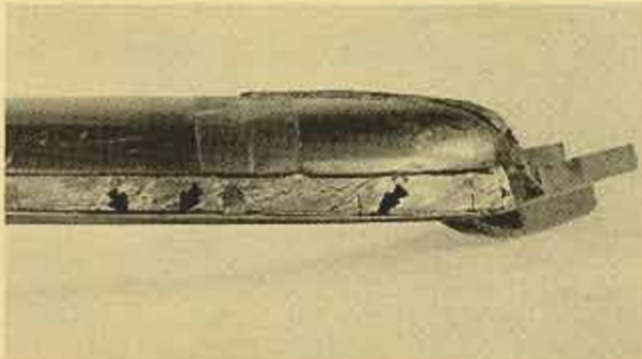
Folding Top Header Water Leaks

A few reports have been received of water leaks at the folding top side rails. These cases of leaks have been in the minority but in most instances, the source has been very difficult to locate.

If water should drip out of the forward ends of the side rails where they are bolted to the header, its

source may be traced to an opening at the forward lower edge of the header. "See arrows on the illustration." Water entering the header will flow back through the ends of the header and into the side rails.

Openings in the leading edge of the header can be sealed with Dolphinite Non-Drying Sealer by following the procedure outlined:

1. Remove the header trim mouldings and moulding retainers. Remove the tacks that attach the top covering to the header and remove the header trim welt. Do not remove the header weatherstrip unless it is necessary to reinsert it in place.

2. Carefully, work some sealer into any openings found along the leading edge of the header where the upper and lower panels are spot welded. Fill in the lower edge and ends of the tacking strip with sealer.

3. With the top lifted slightly from the windshield, tack the trim welt in place so that the welt bead will bear downward against the weatherstrip. Tack the top covering in place. Install the trim moulding retainers in place so that the trim mouldings when installed, will bear downward against the welt bead.
