PACKARD MOTOR CAR COMPANY

**Counselor**

VOL. 28, NO. 2

FEBRUARY, 1954

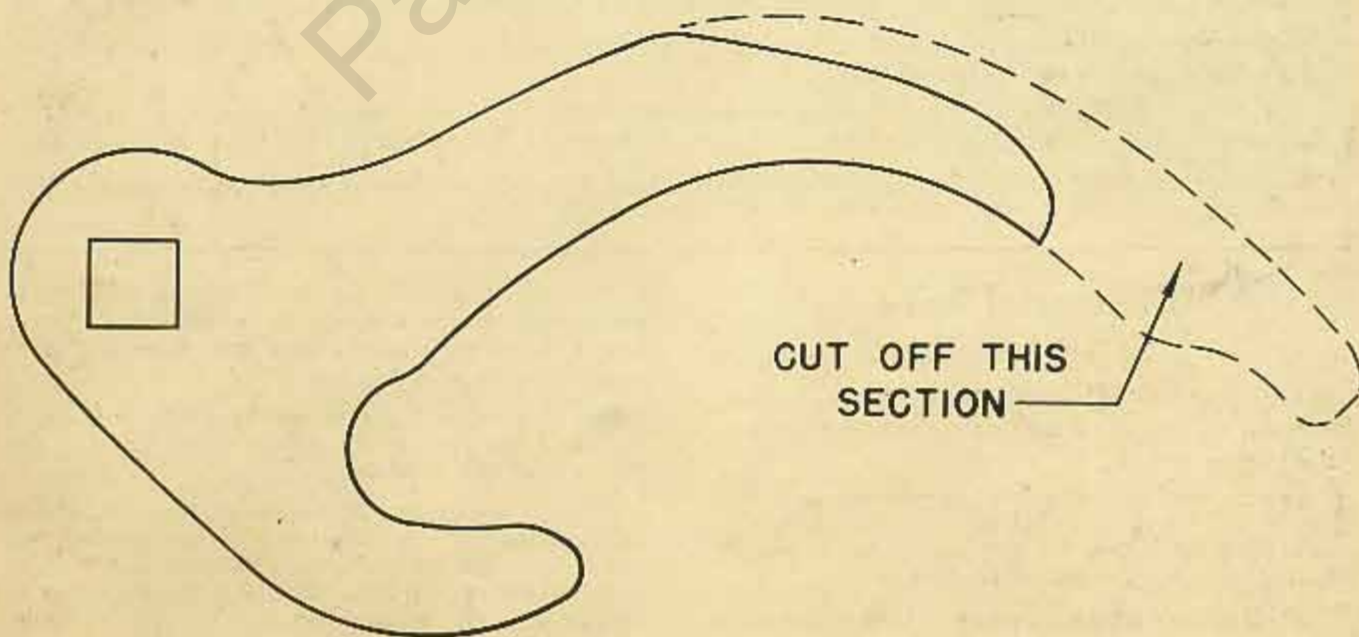
The power steering pump bracket assembly has been redesigned to prevent breakage and started in production with the 54th Series cars.

To adjust the belt tension on a power steering pump which has the new bracket, it will be necessary to rework the adjusting tool "PK-12" by cutting and grinding off the section indicated by the dotted line as shown on the illustration.

NOTE: Illustration is actual size of the tool.

The reworked tool can still be used with the old type bracket.

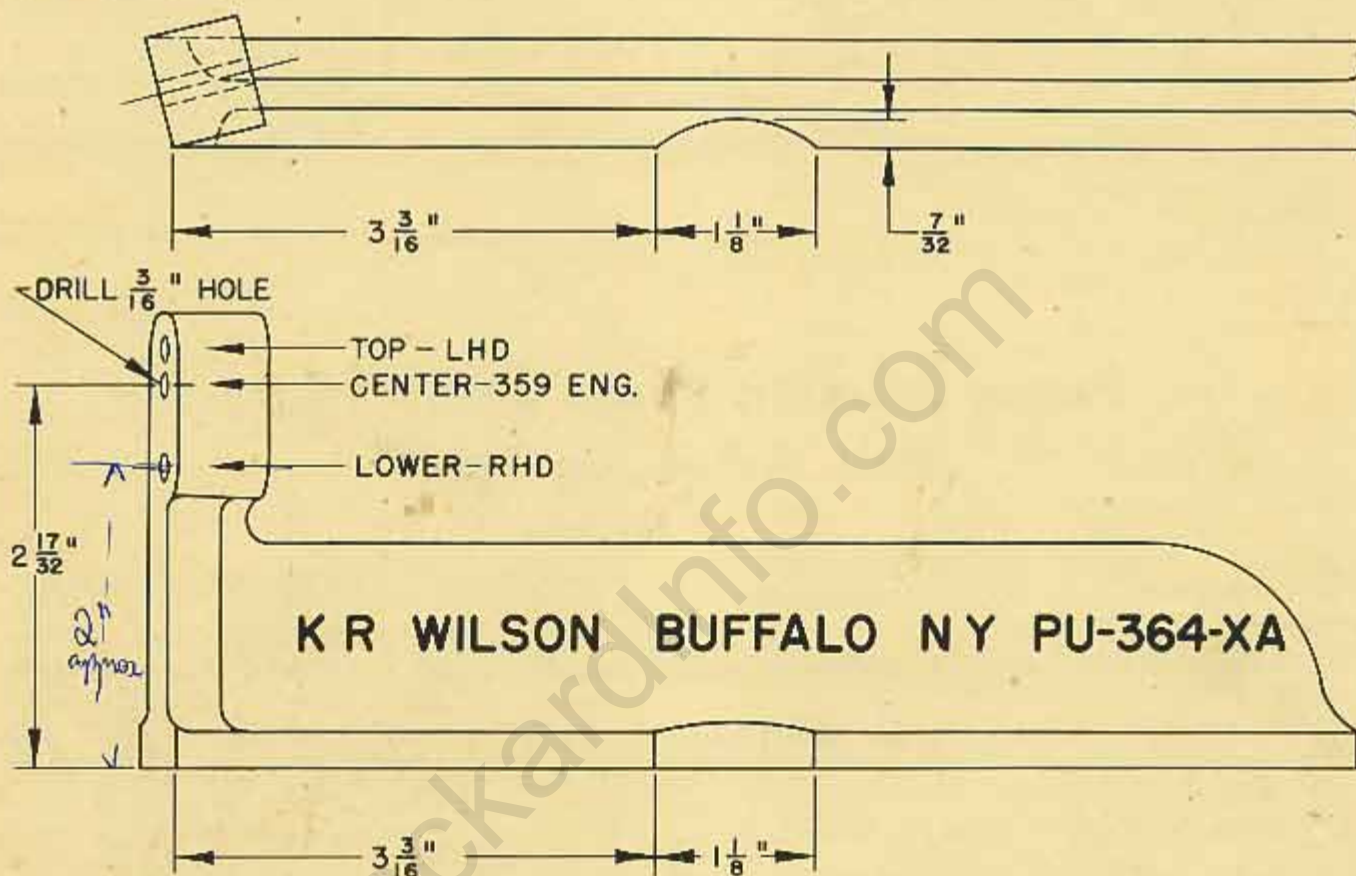
The throttle cross shaft and carburetor throttle rod has been changed slightly on the 359 cu. inch engine.

Because of the throttle linkage change, it will be necessary to rework your present throttle adjusting gauge PU-364 to properly make this adjustment on all 54th Series cars that are equipped with the 359 cu. in. engine and Ultramatic Drive.

Using the measurements on the illustration, carefully drill a $\frac{3}{16}$ " hole through the gauge as shown.

Grind out a section from the forward side of the gauge base $1\frac{1}{8}$ " long and $\frac{7}{32}$ " deep $3\frac{3}{16}$ " from the end of the gauge as shown on the illustration.

Do not use .050" shim stock under the gauge with either the old or new gauges when setting the throttle linkage on a 359 cu. in. engine as described on page 10 of Volume 27, No. 2, February 1953 Service Counselor.

It is suggested that the $\frac{3}{16}$ " gauge holes be identified by stamping the following information on the back side of the gauge "TOP-LHD," "Center-359 Eng.," "Lower-RHD."

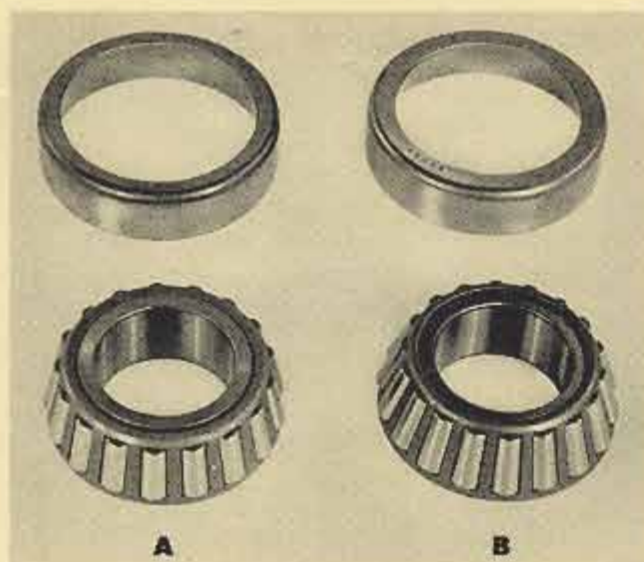
1. Fig. 1 shows the 25° rear pinion bearing and cup indicated by "A." The 40° rear pinion bearing and cup is indicated by "B." Note the difference in the angle of the rollers, also that the flat end section is wider on the 40° bearing cup.

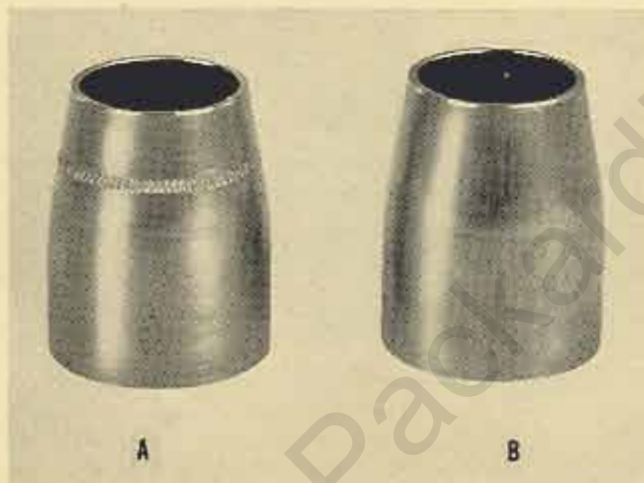
Fig. 2 shows the pinion bearing sleeve used with the 25° bearing indicated by "A." The sleeve used with the 40° bearing is indicated by "B." The knurled section on the 25° bearing sleeve (A) is provided for identification purposes.

It is permissible to use either the 25° or 40° rear pinion bearings in the 54th Series differentials provided the proper sleeve is also used.

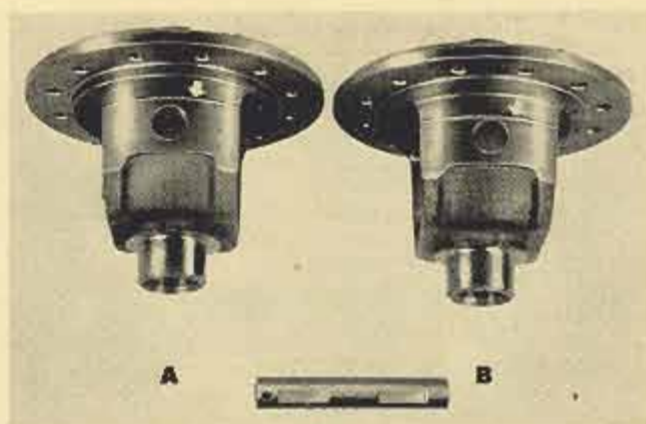
Fig. 3 illustrates the two differential cases which can be identified as follows:

"A" shows a differential case that has the diameter near the pinion pin hole machined down to give

clearance for the long pinion gear. Note the ridge indicated by the arrow is approximately $\frac{1}{4}$ " from the pin hole.

"B" shows a differential case that has not had the diameter reduced. Note the ridge indicated by the arrow is quite close to the pin hole.

Ring and pinion gear sets with the long pinion gear teeth *cannot* be used on the differential case "B."

Ring and pinion gear sets either long or short can be used on the differential case "A." Do not use a long pinion pin in differential case "A."

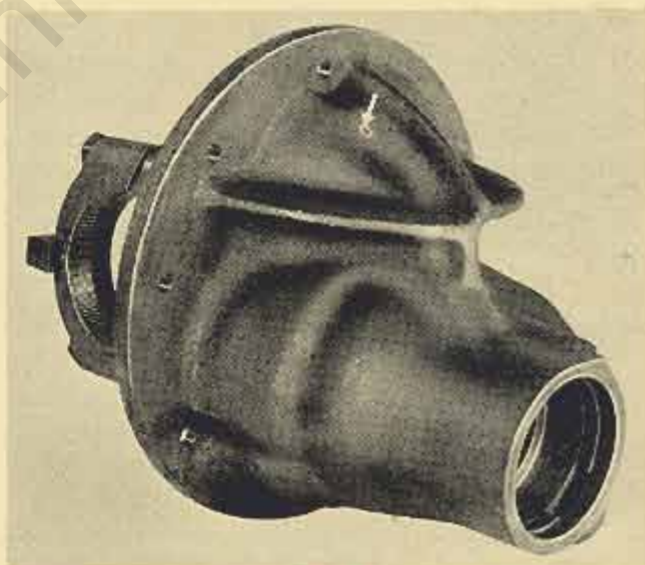
Fig. 4

3. All 54th Series differentials that are equipped with a long driving pinion gear and the smaller diameter differential case are stamped with the letter "O" as shown in Fig. 4.
