PACKARD MOTOR CAR COMPANY

## counselor

VOL. 28, NO. 3

MARCH, 1954

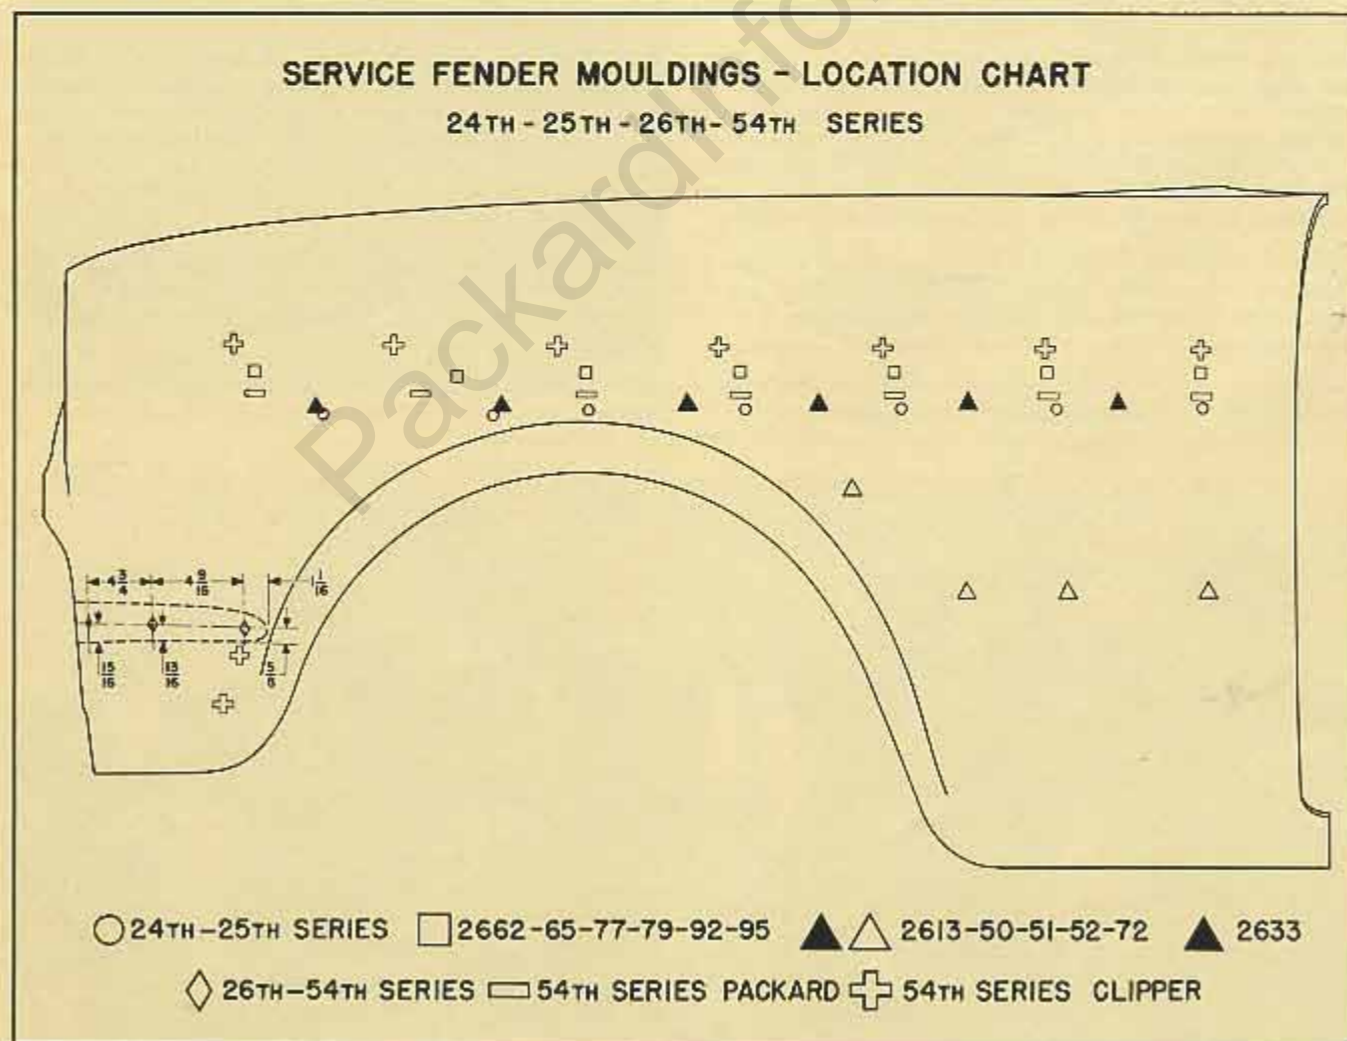
The location for drilling the moulding attaching screw holes will be identified with paint marks of round, square, triangle, cross and rectangular design for the different model cars. The grille extension moulding holes used on the 26th and 54th Series cars will not be indicated on the service fenders; therefore, it will be necessary to lay out the location for drilling these holes.

Insert the forward end of the moulding into the grille opening. Hold the moulding in place against the fender so it is in alignment and fits the contour of the fender. Mark the outline of the moulding with a pencil as shown by the dotted line on the illustration.

Measure up from the bottom pencil mark to the measurements shown and mark a center line as shown.

Measure  $1\frac{1}{16}$ " from rear pencil mark (end of

moulding) forward to locate rear screw hole and center punch this location. Measure  $4\frac{9}{16}$ " forward of rear punch mark and center punch center screw hole location. Measure  $4\frac{3}{4}$ " forward of center punch mark and center punch front screw hole location.

Drill three  $\frac{1}{2}$ " holes through the fender at the locations just described.

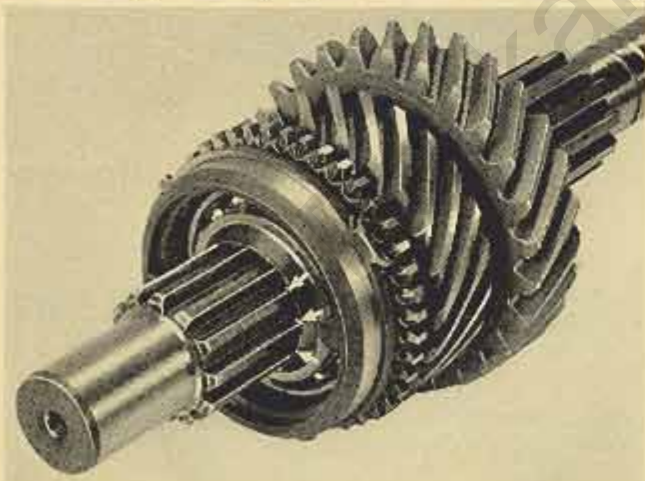
A few reports have been received of gear clash when shifting into second gear on standard transmission or overdrive equipped cars.

If the clutch is adjusted properly and is also functioning properly, the gear clash is probably caused by incorrect operation of the synchronizer brakes.

Gear clash caused by incorrect synchronizer brake operation may be due to burrs on the rolled lock ring which preloads the bearings on the driving shaft gear and bearing assembly. (See arrows on illustration).

Any burrs found on the lock ring should be removed with a file as they will prevent the direct and second speed clutch gear from shifting rearward far enough to apply the synchronizer brake.

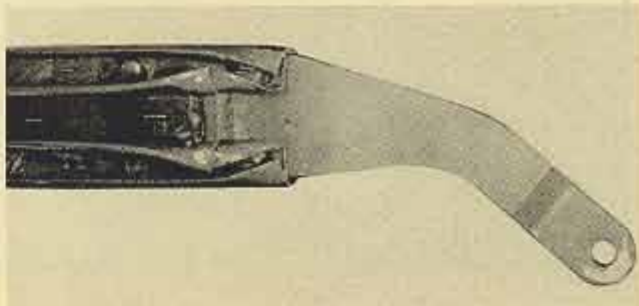
A few reports have been received where a number of small holes have appeared in the rear quarter section of the convertible top after it has been raised and lowered several times.

This damage is generally caused by sharp corners at the ends of the center section of No. 4 bow where it attaches to the end pieces.

Before replacing convertible top material, the No. 4 bow should be inspected for sharp corners and if necessary they should be hammered down as shown in the illustration.
